# **A New Paradigm for the Design of Sustainable Buildings**

Warren Knowles, P.Eng., Brian Hubbs, P.Eng., Paul Kernan, MAIBC, Graham Finch, MASc, <sup>1</sup>

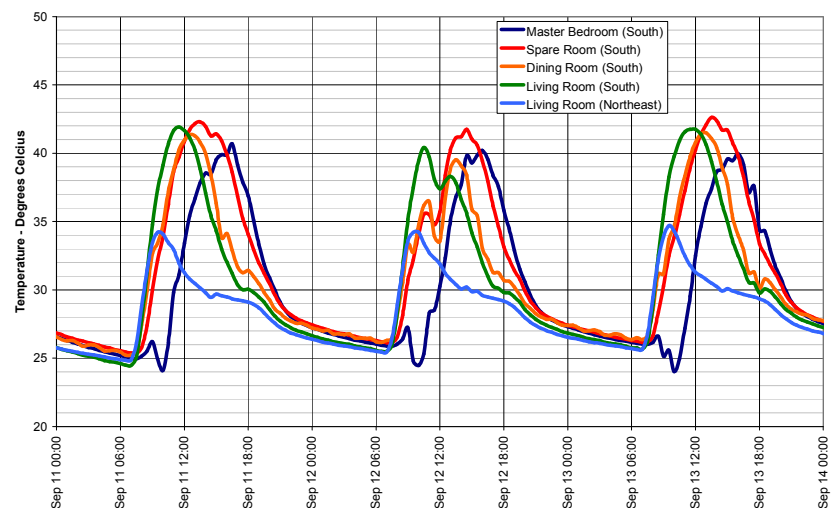
Figure 13 shows the temperature readings near the glazing panels in a sample suite on three sunny days in September. The suite heating, ventilation and air conditioning system was set to 21 degrees Celsius. The interior air temperatures at these locations reached 40 degrees Celsius during this time period.

Figure 13: Suite Temperatures, September 11 through 14, 2008

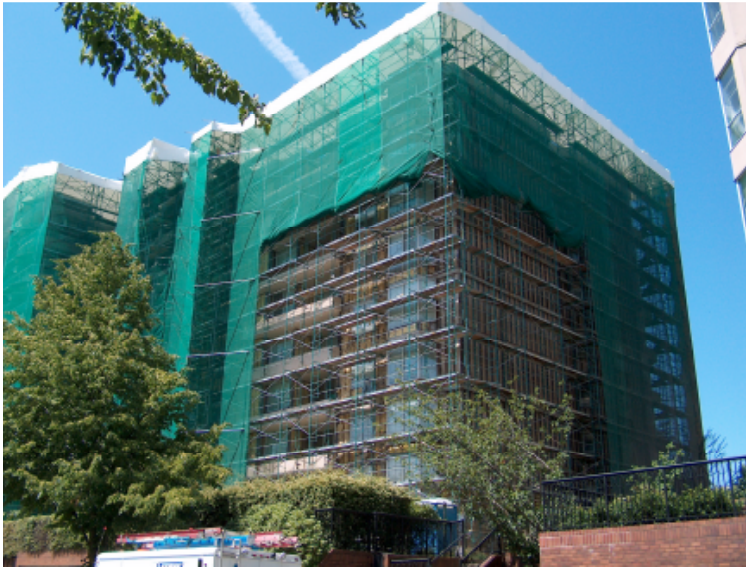
Building 19 of the Study is an example where the building failed to meet expectations. It is a 10 storey mid-rise residential building. It was originally intended that the building incorporate improved building enclosure, with the use of higher performance 'Thermo Stucco'. The use of the improved stucco cladding, along with the incorporation of a relatively low window percentage was expected to increase the overall R-value of the building enclosure. However, the actual overall building enclosure R-value was less than 3, and the as-built arrangements resulted in extensive water ingress related damage including severe corrosion of the supporting steel stud framing as shown in the Figures 15 and 16.

Figure 15: Overall corrosion of the exterior steel stud wall assemblies at Building 19.

Rehabilitation of the building enclosure assemblies was required to correct the damage.
