## Technical Bulletin

No. 003

### Aluminum Window Frames: Paint Failures

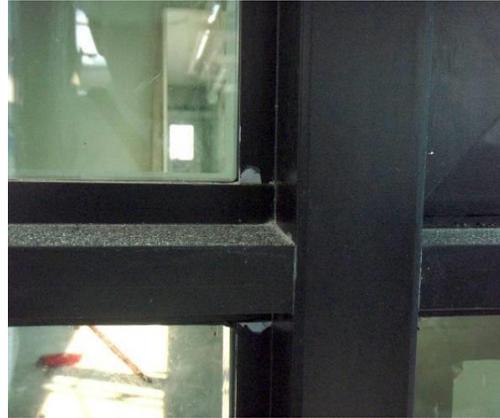
Midway through the construction phase, we noted chipped paint on the new window frames. The chipped paint was isolated to the cut edges of the vertical mullion glazing flanges at the horizontal mullion intersection, shown in Figure 1. The damage was not the result of abrasion or impact, due to the sheltered location of the paint chips.

*Figure 1: Typical chipped paint on a vertical mullion at the intersection with the horizontal mullion.*

The window manufacturer determined it was in the best interest of the project to **replace** all of the windows on the building rather than attempt to repair or recoat the frames in the field.

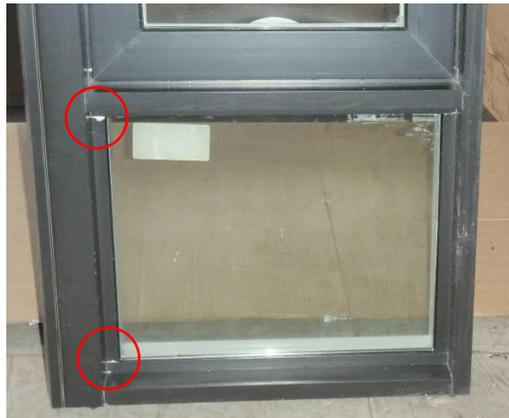
*Figure 2: Example of chipped paint on the left frame member but not the right.*

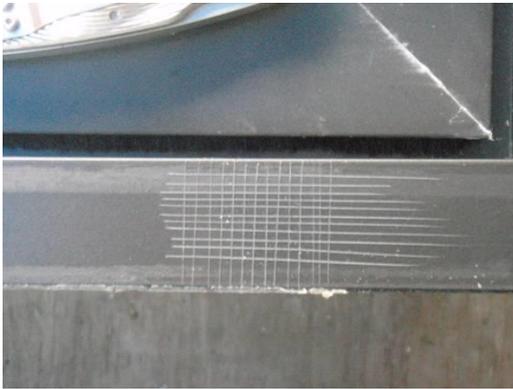
Per AAMA 2604, a crosshatch pattern was scored using a utility knife to create one hundred, 1mm x 1mm, squares as shown in Figure 3. The test requires standardized Permacell 99 tape applied to the crosshatch area and pulled off rapidly. Failure of the test is defined as removal of any one square of paint from the test area.

Figure 3: Cross-hatch pattern as outlined in AAMA 2604. This sample location is on a frame member without chipped paint.

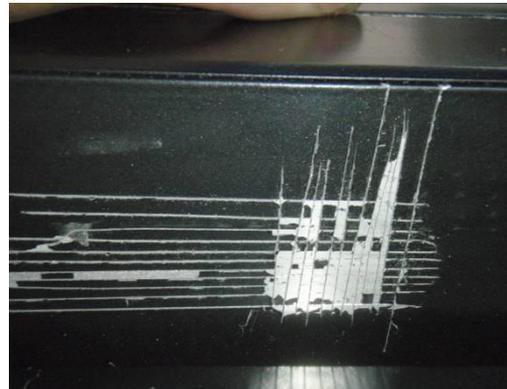
Figure 4: Cross-hatch pattern tested as outlined in AAMA 2604. This sample location is on a window frame member with chipped paint.

The test demonstrated that frame members with chipped paint failed the AAMA 2604 adhesion criteria. The results of RDH's testing justified rejecting windows with chipped paint.

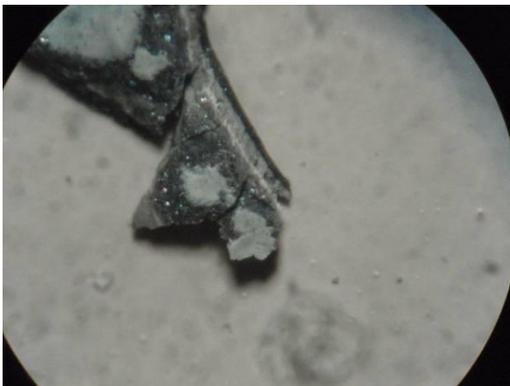
The window manufacturer reported that the frame extrusions had been previously painted a different colour for another project but were not made into window frames. The application of an additional primer and finish coat over existing paint contradicts the paint manufacturer's recommendations. Figures 5 and 6 show microscopic views of paint samples retrieved from window frame members that failed the paint adhesion test.

Figure 5: Microscopic view of paint chip samples.

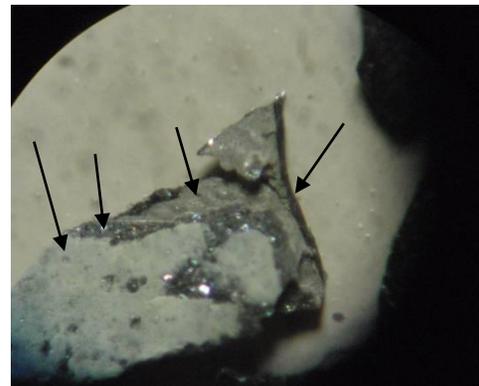
Figure 6: Closer microscopic view of paint chip samples. Note four distinct paint layers.

The frame painting process involves oven heating to cure the paint. The additional heating and cooling cycle likely contributed to the paint failure; however, RDH did not determine the exact cause of the failure.

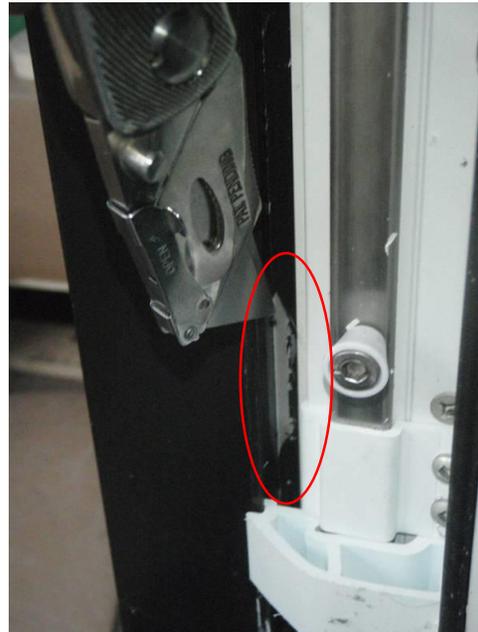
*Figure 7: Inside of the jamb extrusion on an operable vent frame. This paint flaked off with a fingernail.*
