To Ms. Denisa Ionescu  
Homeowner Protection Office  
1701 - 4555 Kingsway  
Burnaby BC V5H 4V8

Submitted March 31, 2022 by  
RDH Building Science Inc.  
4333 Still Creek Drive  
Burnaby, BC V5C 6S6

# Executive Summary

# 0 Introduction

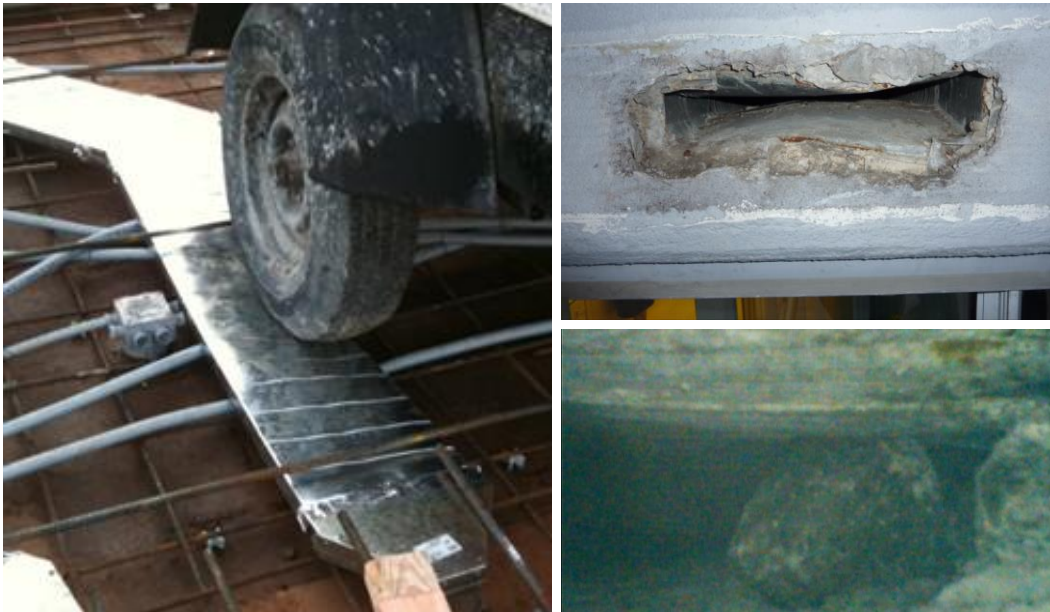
**Figure 1.2:** In-slab duct damaged during construction (left & upper right), and damaged during concrete pour (bottom right)

If the ducts are not protected during construction, airflow can be reduced or in some cases fully prevented. Poorly sealed or damaged ducts also increase the risk of moisture migrating from the duct to the ceiling in the event of moisture buildup.

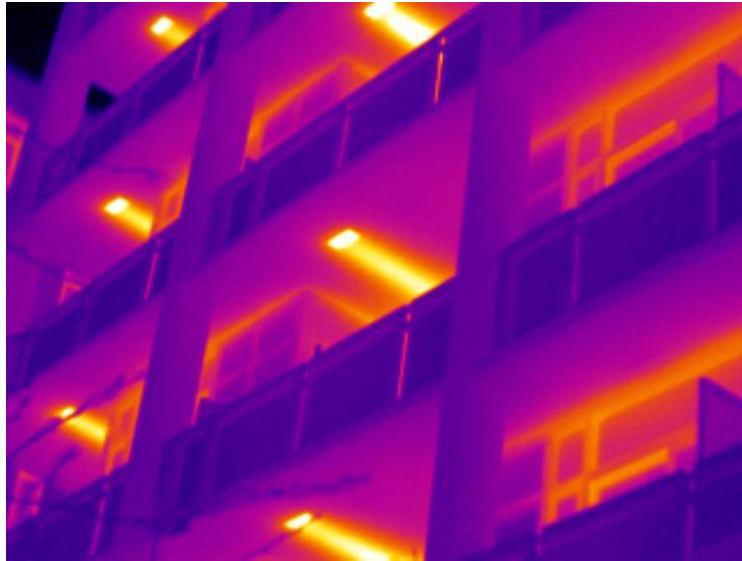
The temperature profile of in-slab ducts has also been observed in the field using infrared thermography. The photo in Figure 1.6 clearly shows the outline of multiple in-slab ducts which appear brighter (hotter) based on the colour infrared image. Figure 1.7 also highlights that if ducts extend out into otherwise cold exterior elements such as balconies, the length of duct exposed to condensation risk is increased.

**Figure 1.7:** Exterior thermographic image showing the outline of several in-slab ducts exiting the underside of concrete balconies.

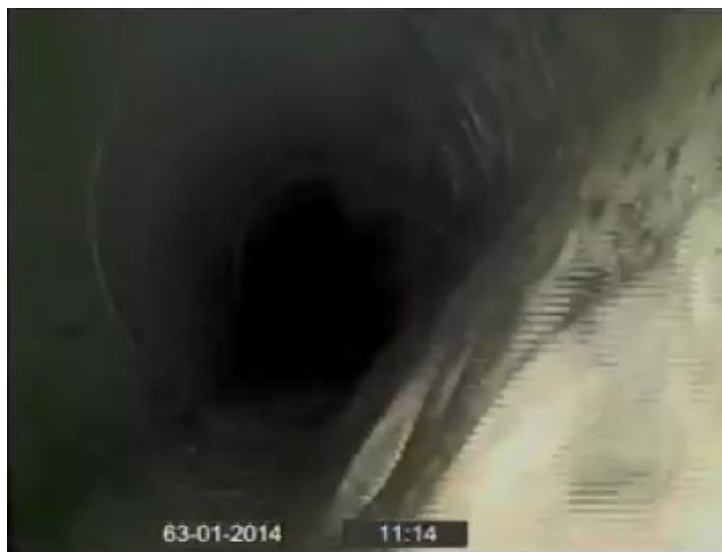
Relative to the number of investigated ducts, heavy water buildup is rare, but poor airflow rates coupled with repeated operation cycles can lead to significant amounts of water as shown in Figure 1.9.

*Figure 1.8: Screen capture taken from a borescope video of an in-slab duct with severe moisture buildup. Note the standing water (> 1" depth) on the bottom right corner of the image (bottom of the duct).*

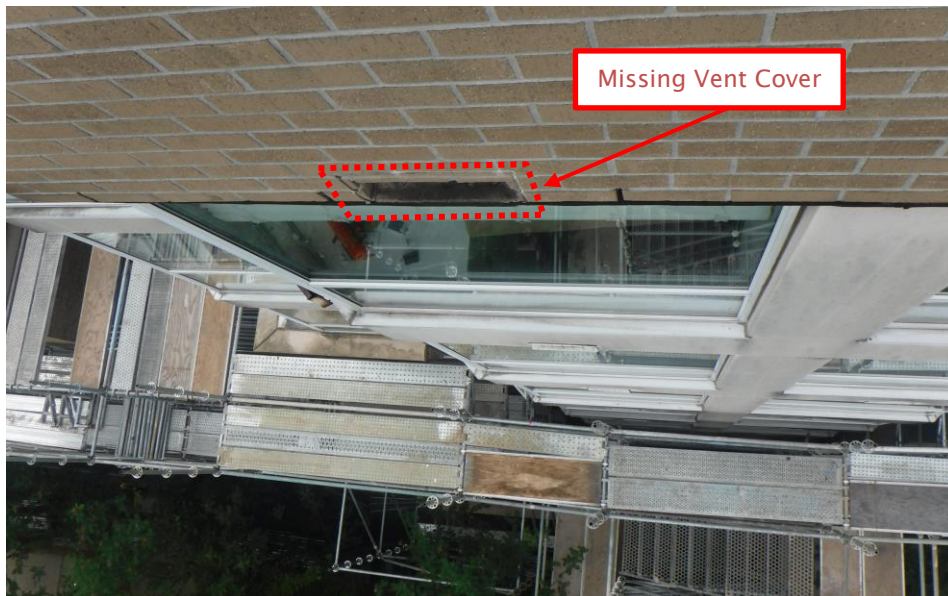
Moisture accumulation in a duct can also occur as a result of water ingress from the exterior. For example, rainwater may enter ducts through a combination of wind pressure, gravity, and surface tension. It is common practice to prevent water ingress at vent openings using protective hoods, grilles, overhangs, or other architectural details (e.g., balconies). Significant issues can arise when these details are insufficient or are removed (Figure 1.10).

**Figure 1.10:** Photograph taken of a wall from above showing an exhaust vent opening. Note the vent cover has been removed and the duct is therefore exposed to rainwater.

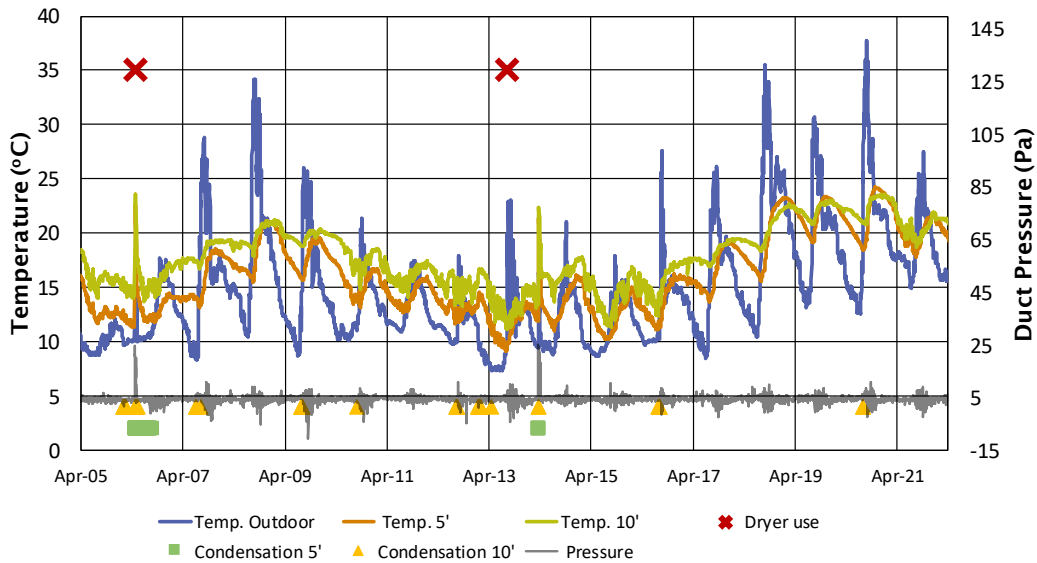
Visual inspection of the duct at Site B revealed minor moisture buildup. Per **Figure 2.3**, condensation was predicted at both 5' (1.5 m) and 10' (3.0 m) from the exterior vent. Additionally, moisture buildup at the end of the duct (within the exposed concrete balcony) was observed during a period of inactivity, implying another source of moisture (e.g., air exfiltration) or evaporation of residual moisture and re-condensation further toward the exterior. The data suggests that cool duct temperatures due to the exposed slab edge may have contributed to the observed moisture.

**Figure 2.3:** Site B – Graph showing air temperature and periods of predicted condensation within the duct as well as the outdoor temperature and duct pressure.

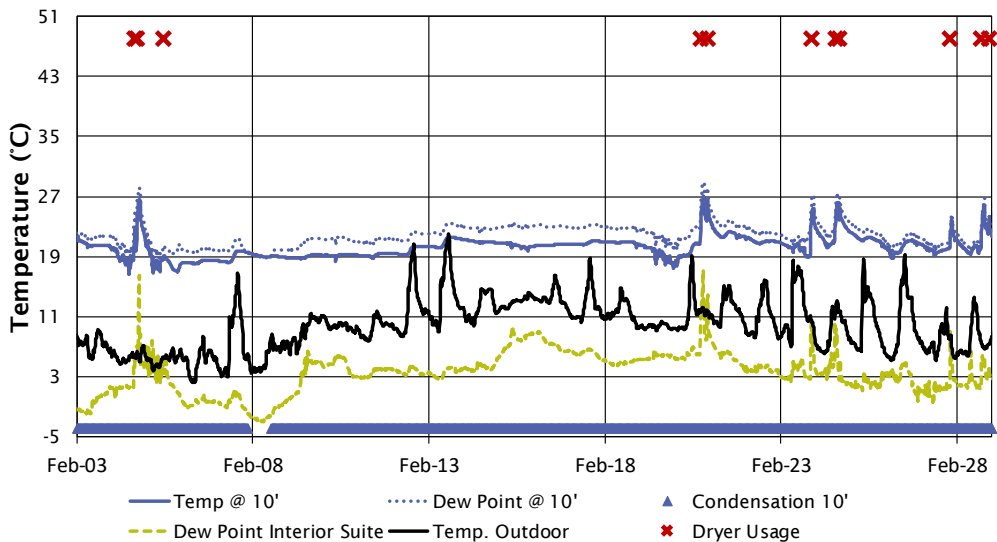
The observed moisture buildup at Site C was the most severe, with a steady stream of water exiting the vent cover onto the balcony when the dryer was in use. Per the results from **Figure 2.4**, condensation was predicted almost continuously throughout the entire monitored length of the duct. The indoor dew point temperature was consistently lower than the measured temperature of the duct, which suggests that the moisture buildup is related to activities such as laundry.

**Figure 2.4:** Site C – Graph showing temperature and dew point of the air 10' (3.0 m) from the exterior of the duct as well as the outdoor air temperature and indoor dew point temperature. Dryer usage and periods of predicted condensation are shown.

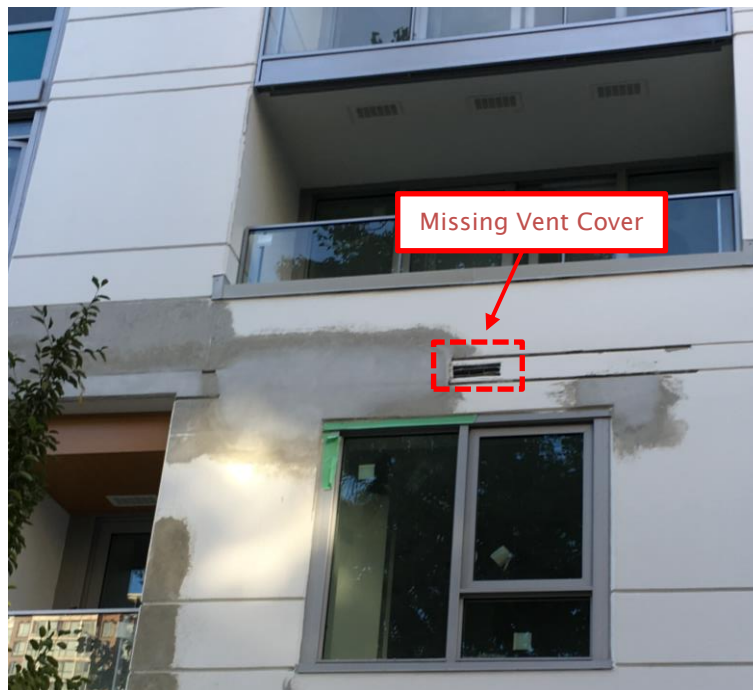
**Figure 3.1:** Photo of the exterior of a building with the exhaust vent cover removed (red), exposing the duct to rain.

Repair or replace the exhaust vent cover with a suitable cover detail including a hood or wind driven rain resistant louver along with sealant and membrane as appropriate. Unprotected vertical grilles that are flush with the vertical enclosure should generally be avoided.

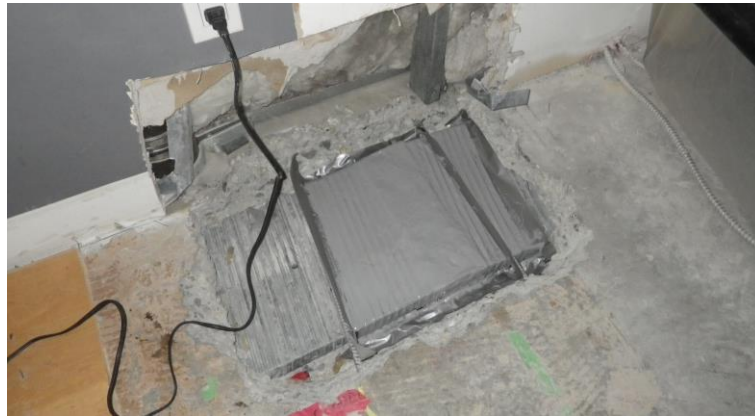
*Figure 3.2: Photo of a duct which has been remediated by chipping out the concrete and sealing the duct with liquid-applied waterproofing. Extensive work to both the suite above and below was required in order to carry out the repair.*

Chip out the concrete and waterproofing between duct segments. Alternatively, waterproof the ductwork from the inside. This approach does not remove the root moisture buildup issue, but may prevent water from leaking into the interior where it can cause visible damage. Waterproofing a duct after construction is disruptive, and costly, and other remedial actions should be attempted first.

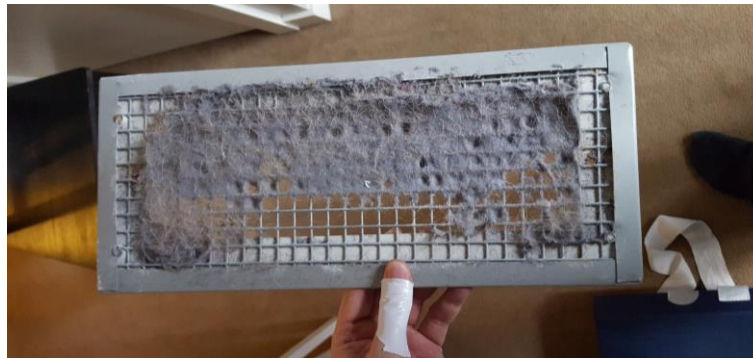
**Figure 3.3:** Photo of an exhaust vent cover with extensive lint buildup. Grilles and exhaust ducts should be cleaned regularly.

Lint buildup is common with dryer exhaust vents and regular cleaning was recommended by all the reviewed manufacturers. Hire a duct cleaning service to inspect and clean the duct system. Some cleaning services provide airflow testing before and after cleaning which can help identify additional issues with the system (leaks, blocks, etc.). There is a large body of anecdotal evidence that supports regular duct cleaning as a successful remediation approach. Along with fixing obvious leaks from the exterior, this action is often considered to be a first step when moisture issues are observed.

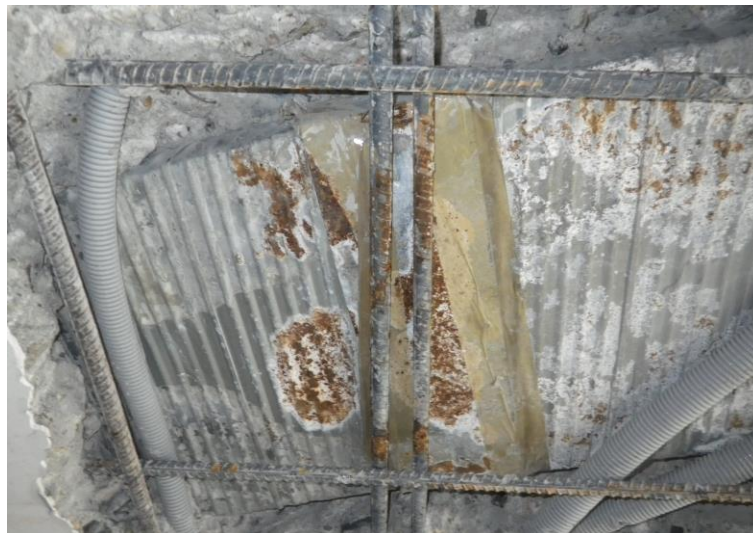
**Figure 3.4:** Photo of a chip and replace repair. Work consisted of mapping out the concrete reinforcing, chipping away the concrete in the suite above and below the duct, sealing the duct with liquid-applied sealant, replacing the concrete, and repairing the interior finishes.

Chip out the concrete and replace damaged (i.e., collapsed) portions the duct. This remediation strategy has been successful when blockages are located at the extreme end of the slab and only minor lengths of duct require repair. Generally, a full replacement of the duct in this manner is economically unfeasible.

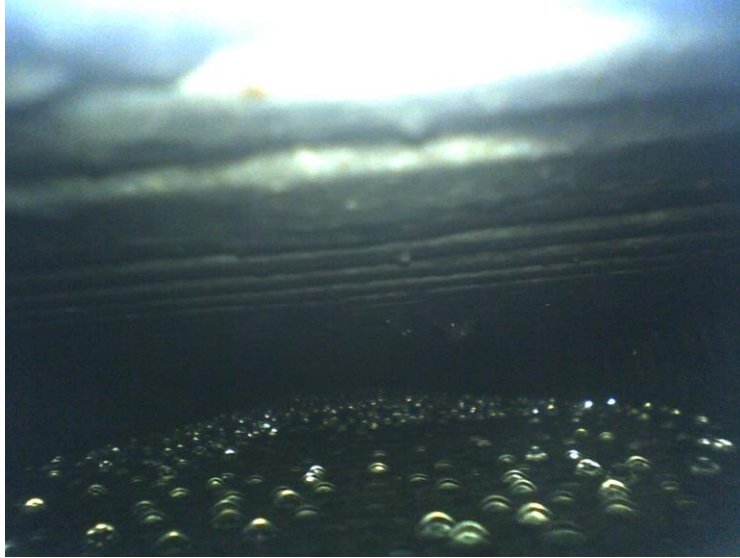
Three-bedroom apartment with minor moisture build-up within the duct (droplets). Building was constructed in 1995. The dryer exhaust vents at the end of an exposed concrete balcony.

*Figure A.6: Photo of moisture build-up at Site B, observed during sensor installation.*
