Failing Forward: Learning from Forensic Investigations

Brian Hubbs, P.Eng.
John Straube, PhD, P.Eng.

Case Study: High-Rise Condensation

40

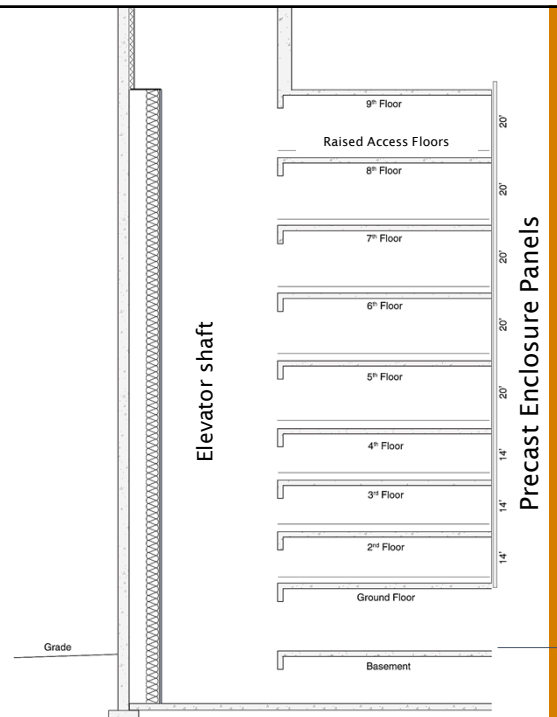
- Construction underway
- “Water is cascading down our elevator shaft!”

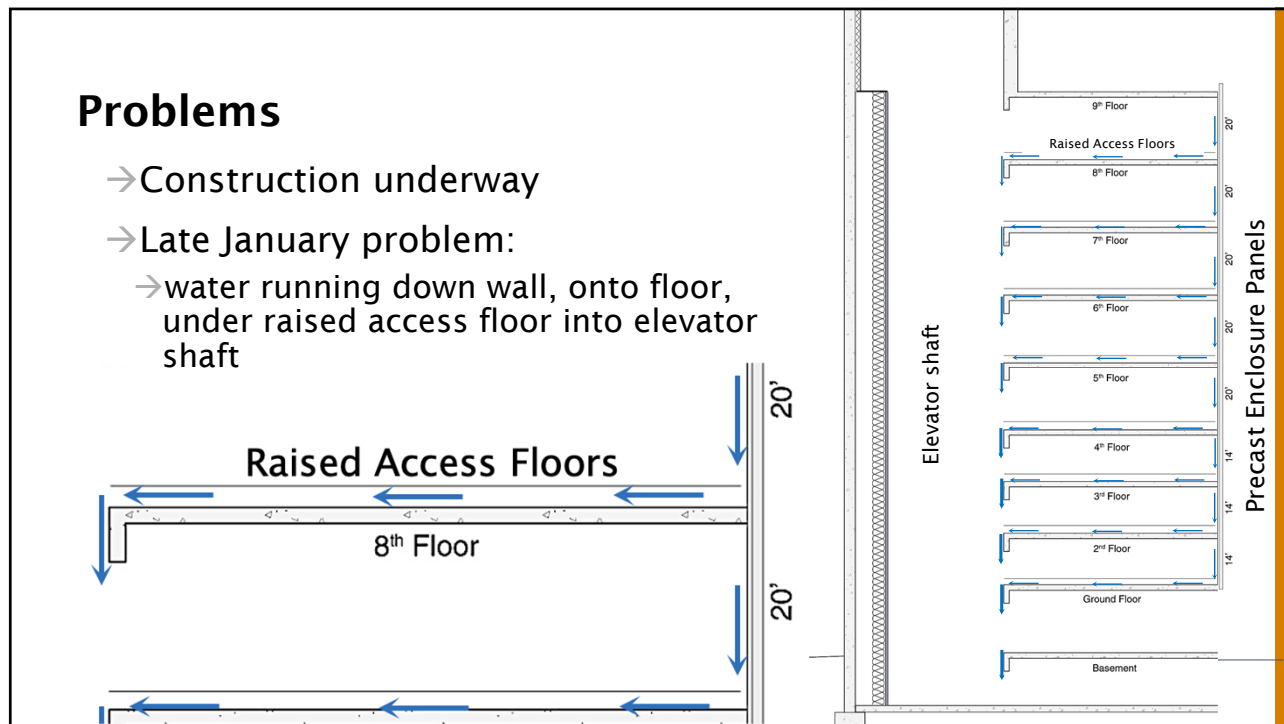
- Construction underway
- Late January problem:
 - water running down wall, onto floor, under raised access floor into elevator shaft

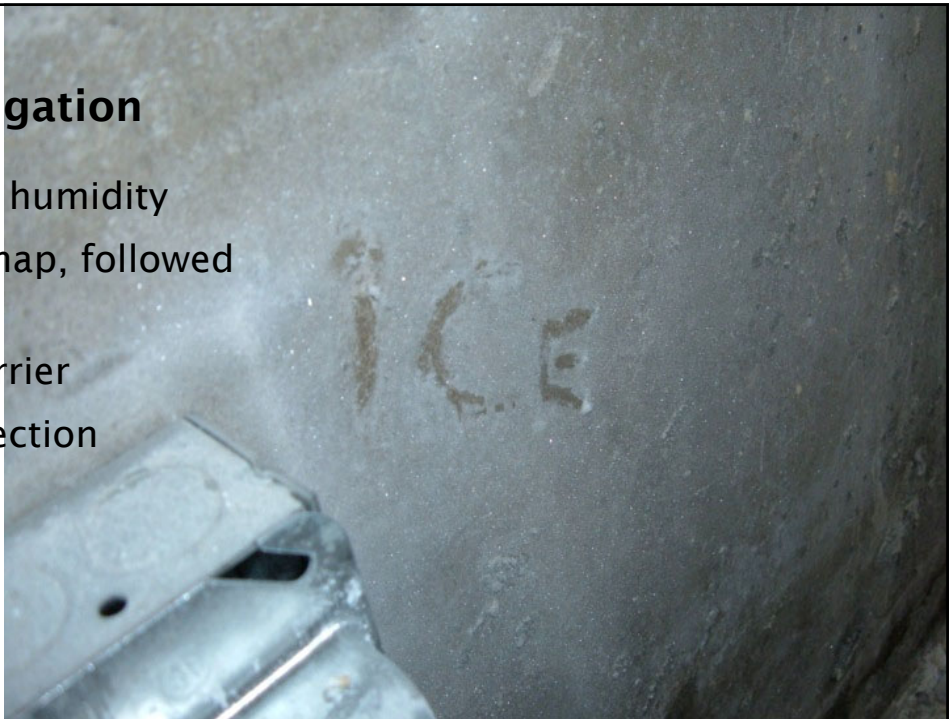
- High indoor humidity
- Long cold snap, followed by warming
- Good air barrier
- ... but convection

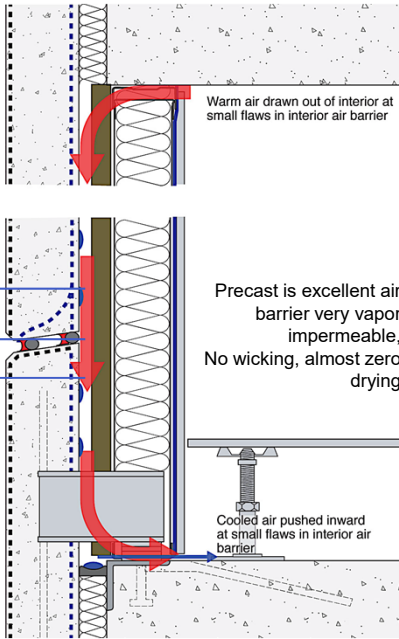
- Air gap intentionally provided in design!
- Imperfect air seal at upper and lower levels allowed

- **Cavity air pushes into building at bottom**
- **Drags warm indoor air into cavity at top**

Experience has shown this to be a common problem

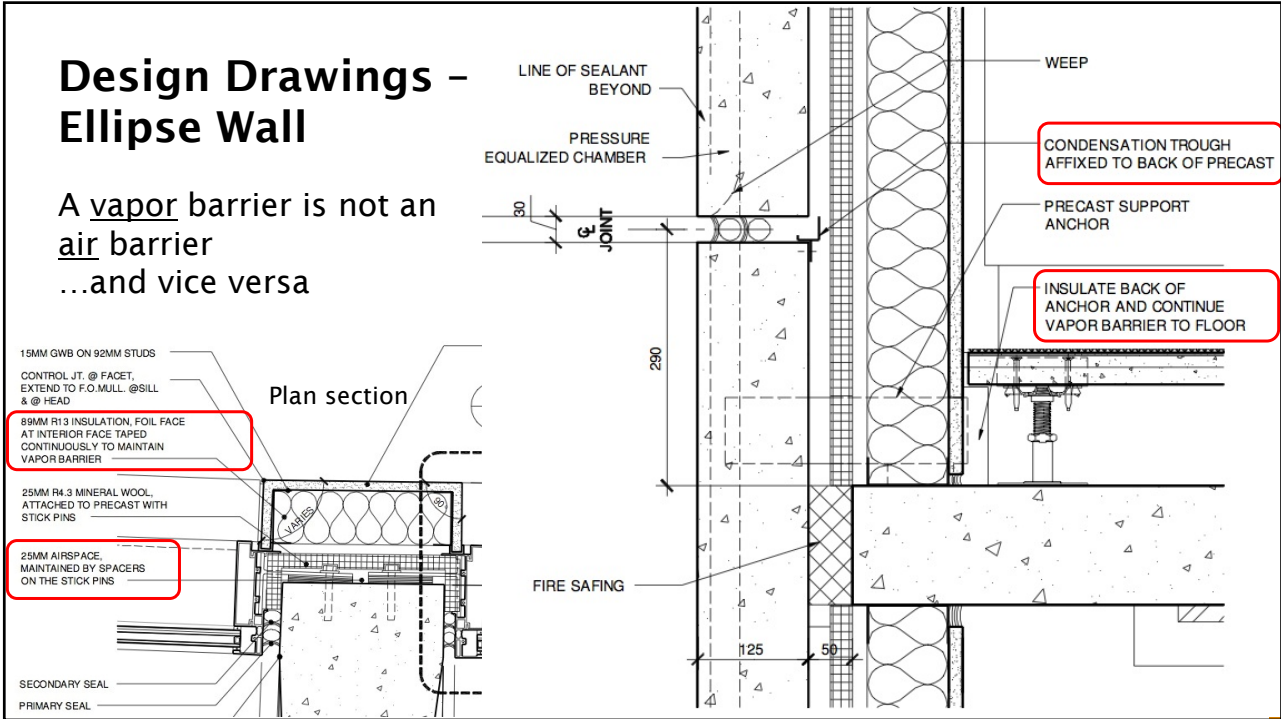
Design Drawings - Ellipse Wall

A vapor barrier is not an air barrier
...and vice versa

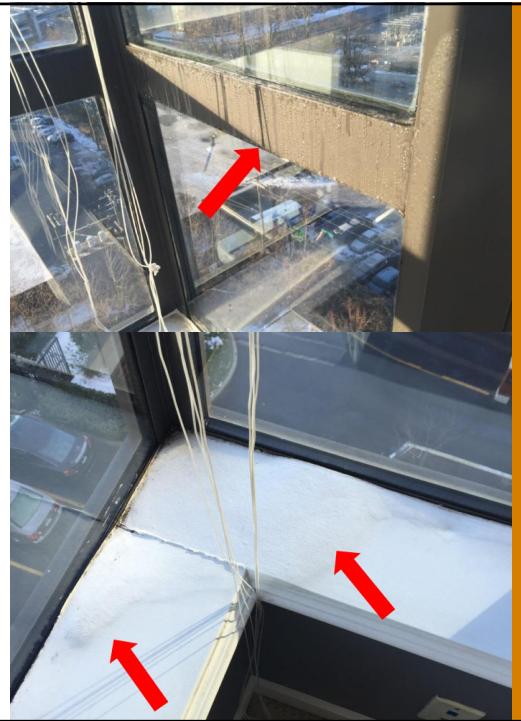
- Severe condensation issues noted in Five Year Performance Review
- Extent and severity of issues documented in forensic investigation reports by 2 other consultants
- Window system, installation configuration, and interior conditions noted as cause.
- RDH retained to provide a 2nd opinion

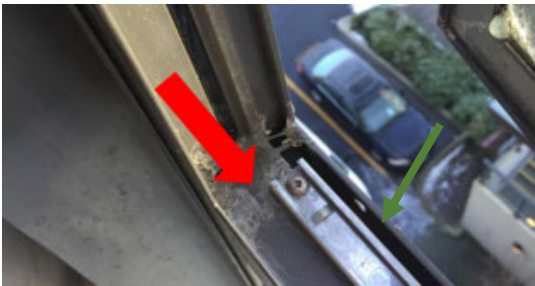
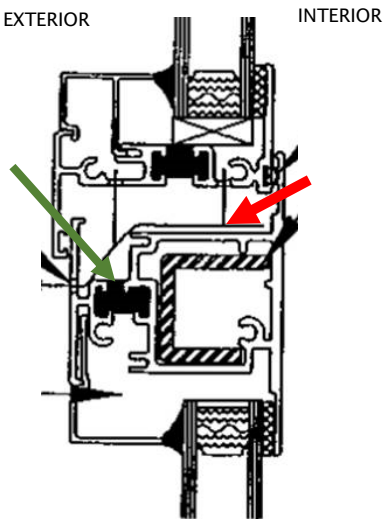
- Shop drawings show thermal break at all mullions, including horizontal mullion previously reported to have a missing thermal break

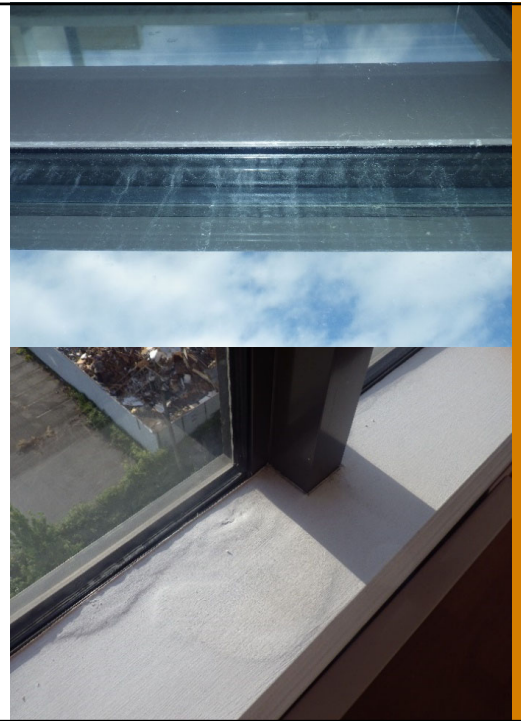
- IGUs reviewed and tested for signs of failure
- Interior surfaces reviewed for damage due to wetting from both condensation and possible leakage
- Discussion with owners experiencing severe condensation

- No failed IGUs found through visual review/testing
 - Glazing units are not systemically failing and do not need to be replaced
 - Some small percentage will fail and should be replaced under warranty
- Signs of severe condensation visible on glass surfaces
- Damage to interior window sills
- Condensation most severe in bedrooms
- Attempts to improve suite ventilation with fans unsuccessful
- Fairly standard window system and installation detail—though not ideal, it works on many other projects in BC

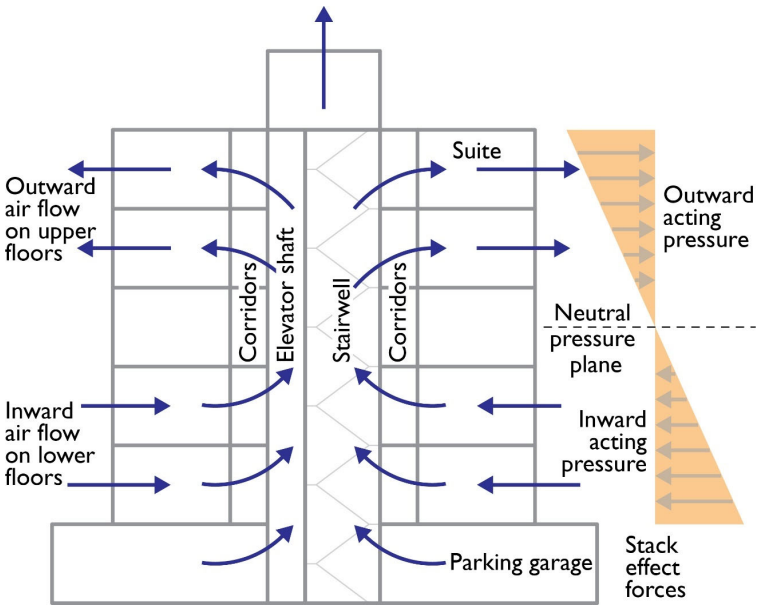
- Ventilation is hindered by improper HVAC balancing and stack effect forces
- Static HVAC balancing only works perfectly when not heavily influenced by stack effect.

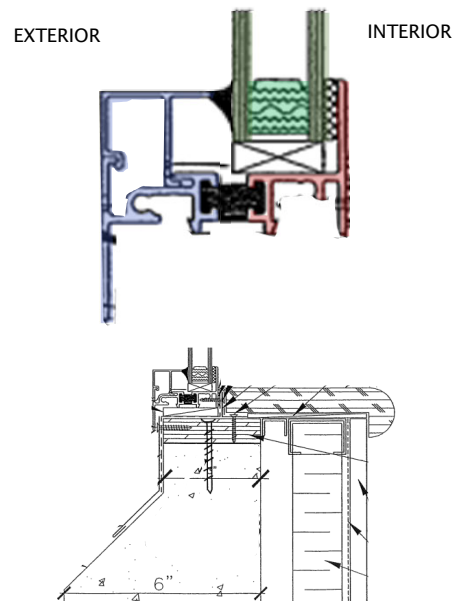
- Windows are not great, but not the worst
- Window moisture leakage not reported to date
- Windows use thermally improved glass units, thermal breaks, and are installed in a standard arrangement at the sill
- Operable vents are not airtight and should receive adjustments and new gaskets
