Reprinted from Innovation, official journal of the Association of Professional Engineers and Geoscientists of BC, March 1999 issue, with permission

Water Got In ...

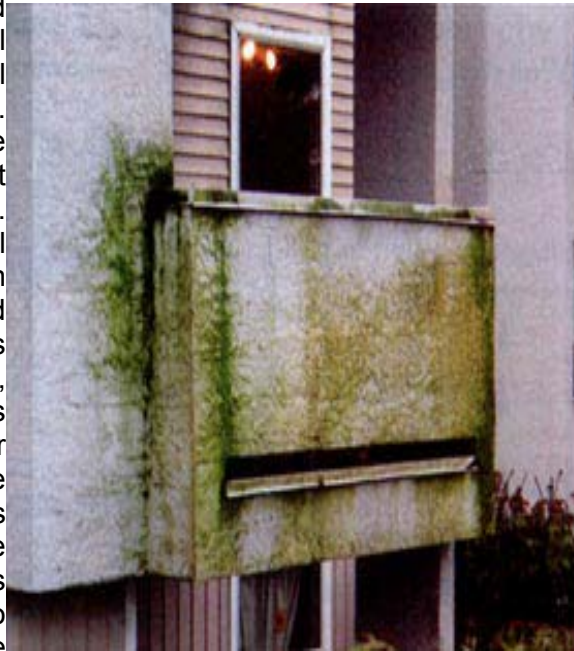
Facing page: Extensive wood decay in the framing and sheathing of walkways and exterior walls illustrates the damage caused by moisture penetration; left: extensive green staining on this balcony's stucco cladding is indicative of high moisture content in the wall assembly.

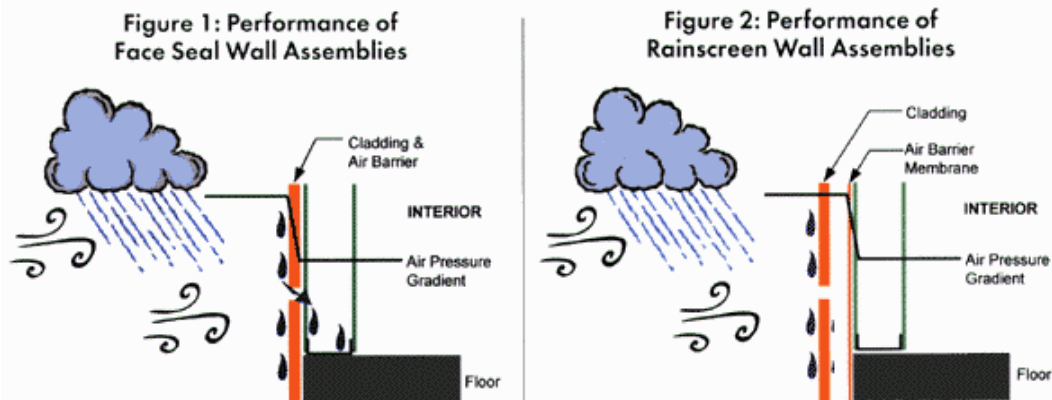
The fact that there is little or no pressure drop across the cladding means that the driving force is eliminated; therefore, very little moisture is drawn into the cavity behind the cladding. Very little, if any, water is present on the air barrier membrane surface on the other side of the cavity, meaning that the source of water is eliminated. Thus, a minor imperfection in the air barrier usually does not result in water infiltration. In addition, the air barrier exists in a protected environment behind the cladding and therefore is expected to be more durable.

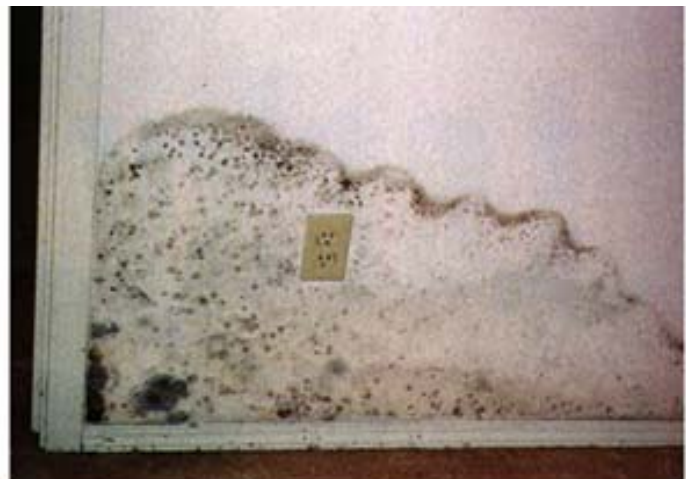
Mould growth on the interior surface of gypsum board resulting from high moisture content in the exterior wall assembly.
