Executive Summary

In response to a number of observed issues and widespread concerns regarding the dimensional stability of polyisocyanurate (polyiso) roofing insulation, a long-term monitoring study was conducted of a conventional roof assembly in New Westminster, BC. This study was set-up to evaluate in-situ conditions which may impact the long-term dimensional stability and thermal performance of two types of polyiso roofing insulation.

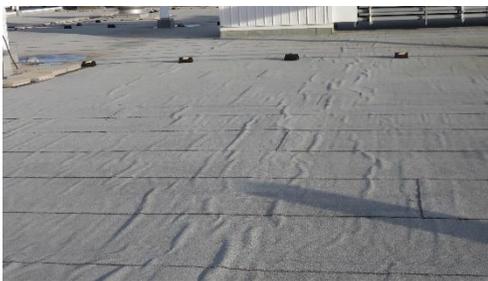
Figure 2.1 Wrinkling and distortion of 2-ply SBS roofing membrane in a conventional roof assembly with polyiso insulation.

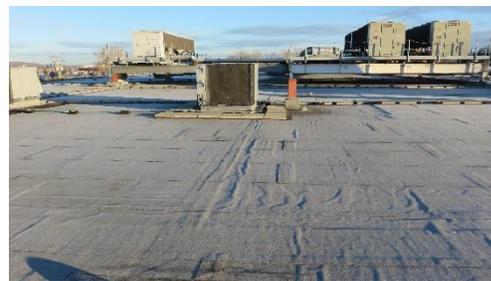
Figure 2.2 Distortion of 2-ply SBS roofing membrane in a conventional roof assembly with polyiso insulation.

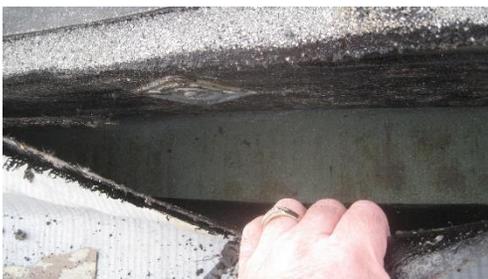
Figure 2.3 Observed 3"+ Gap between parapet and insulation likely due to dimensional movement and shrinkage of polyiso insulation.

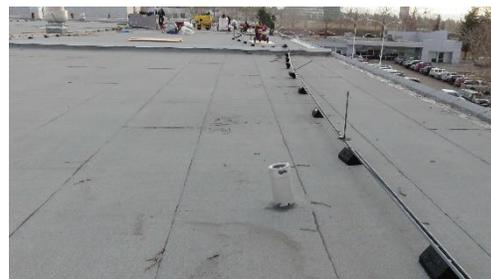
Figure 2.4 Damage to roof stack vent likely due to movement of underlying polyiso insulation.

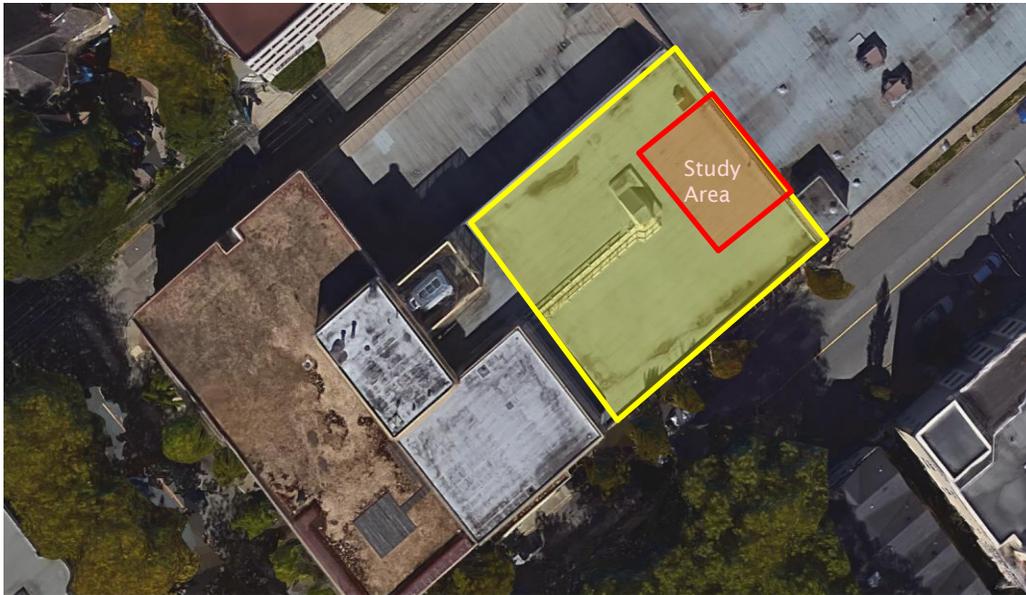
Figure 3.1 Aerial view of roof of study building in New Westminster, BC. Roof is outlined in yellow, study area is outlined in red.

The study building is a five-storey reinforced concrete office building located in New Westminster, BC that was constructed in the early 1980s. The original roof assembly for the building had exceeded its useful service life and was being replaced which provided a good opportunity to integrate monitoring equipment into the new roof assembly. An aerial image of the roof of the study building and the study area is provided in Figure 3.1.

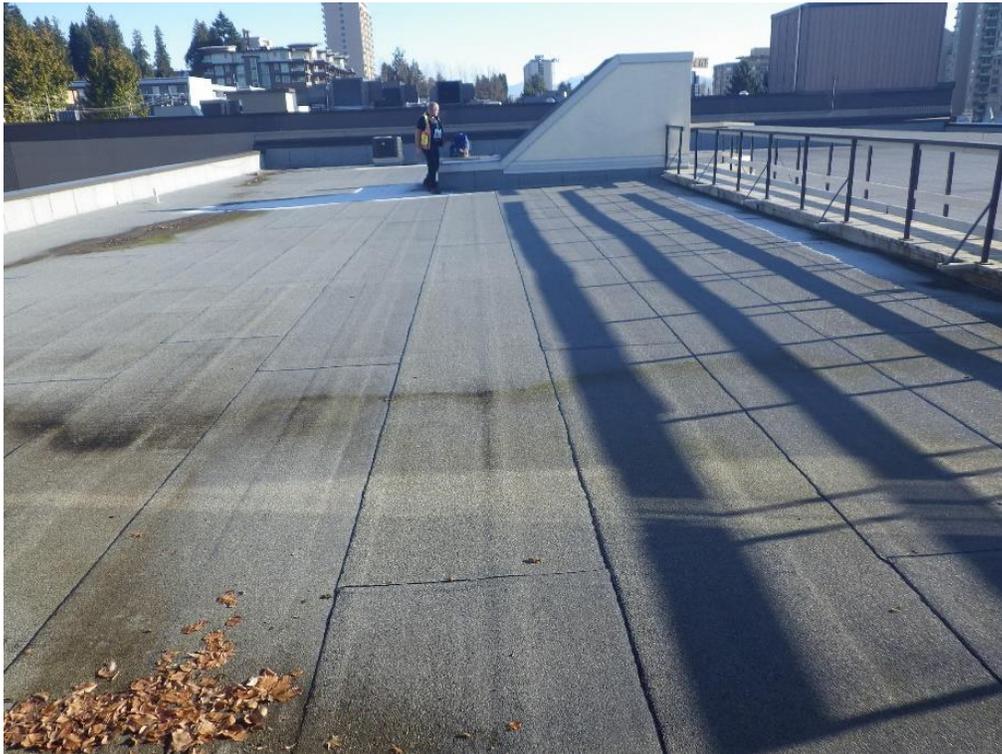
Figure 3.3 Overview of test area at the study building located in New Westminister, BC.

An image of the test site is shown in Figure 3.3. Note that the test site is largely unshaded by surrounding buildings and other objects.

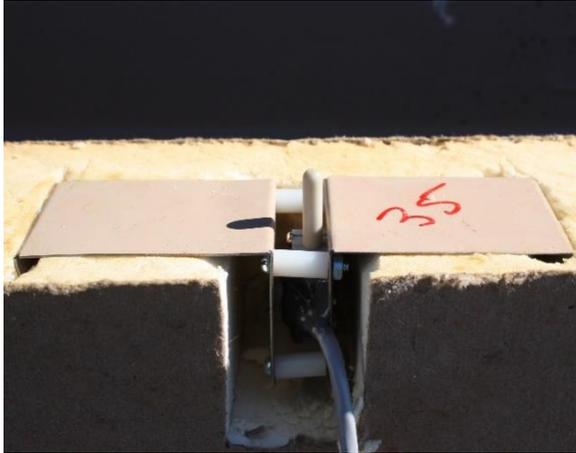
Figure 3.6 Displacement sensor Installed into the edge of a polyiso insulation board with the plunger fully extended. The plunger will contact the contact plate on the adjacent insulation board once installed.

The displacement sensors were embedded into a factory edge of the polyiso insulation and epoxied in place as shown in Figure 3.6. A rigid metal plate was permanently glued to the face of a factory edge of the polyiso insulation board immediately adjacent to the displacement sensor (Figure 3.7) to act as a solid contact for the plunger of the displacement sensor.

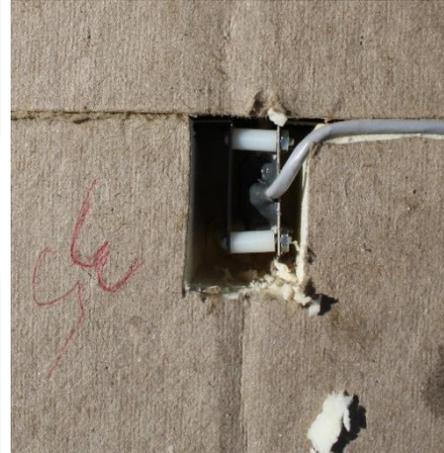
Figure 3.7 Displacement sensor installed at joint between adjacent polyiso insulation boards. The plunger is now depressed and in contact with the plate on the adjacent board.

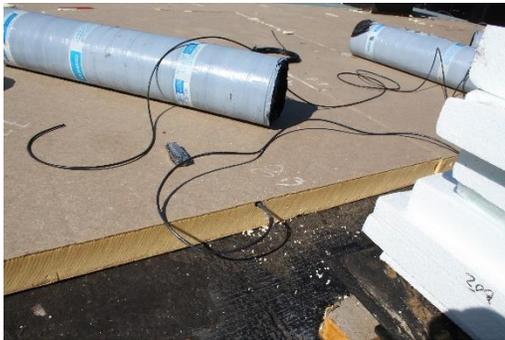
Figure 3.8 RH and temperature sensor during installation, installed into top surface of polyiso insulation. Typical of all RH/Temp sensors.

Temperature, relative humidity, and moisture content sensors were also installed into the insulation boards to monitor the potential impact that these parameters have on dimensional movement of the polyiso. Photographs of these sensors are shown in Figure 3.8 and Figure 3.9.

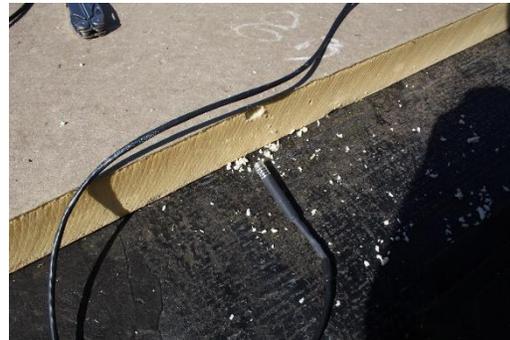
Figure 3.9 Closeup of RH and temperature sensor that was installed into top surface of polyiso insulation.

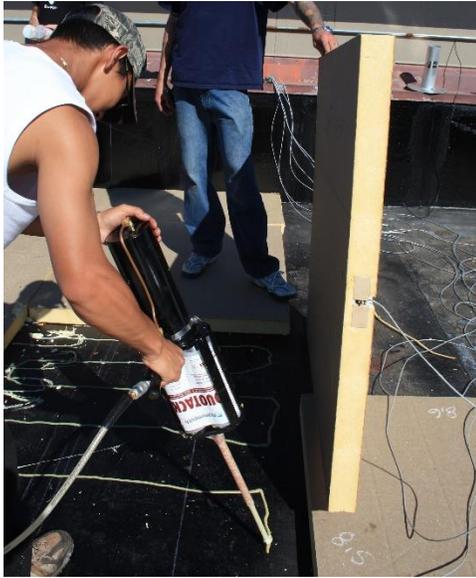
Figure 3.10 Study insulation board immediately prior to being adhered to air and vapour barrier on top of roof deck.

Installation of this monitoring equipment was performed on between September 10th and 14th, 2009 by representatives of SMT Research, RDH, and Wells Klein. Images of this installation are shown in Figure 3.10 and Figure 3.11.

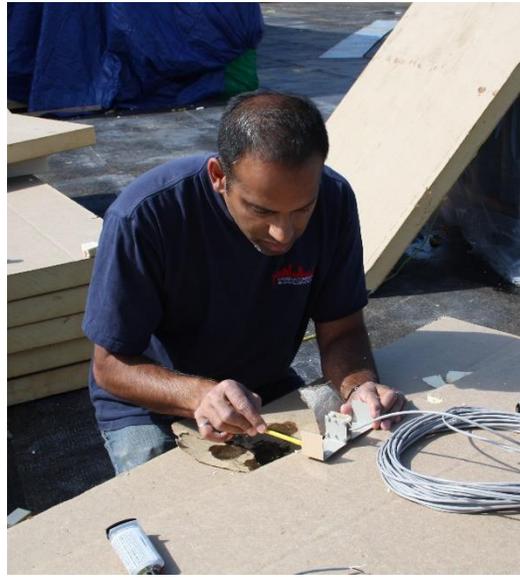
Figure 3.11 Installation of monitoring equipment by SMT Research.

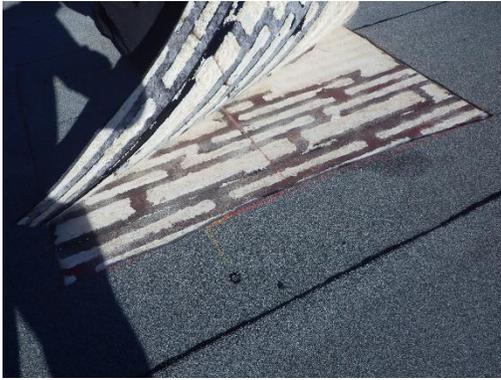
Figure 3.21 SBS roofing membrane being removed in order to visually inspect polyiso insulation

After five and a half years of monitoring, exploratory openings were made in the roofs in order to confirm the shrinkage recorded by the displacement sensors and observe the physical condition of the insulation and roof assembly components. Roof openings were made on February 23, 2015 by representatives of RDH, Wells Klein, and RCABC. At the time of the openings, the roof surface was dry, and no liquid water was observed within the roof assembly. The monitoring data measured gaps between insulation boards of approximately 5 mm when the review was conducted, and exploratory openings were generally consistent with these measurements as gaps between the boards ranged from 1 to 6 mm. Photos of these exploratory roof openings are provided in Figure 3.21 to Figure 3.24. Supplementary photos are provided in the Appendix.

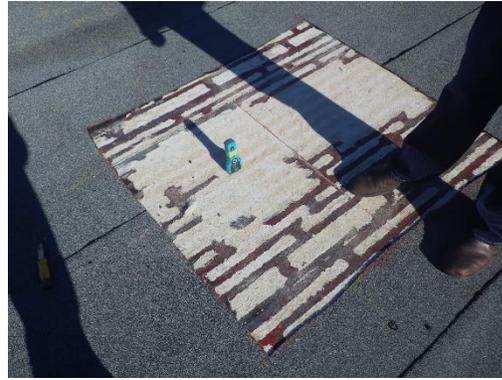
Figure 3.22 Overall shot of 4'x4' exploratory roof opening.

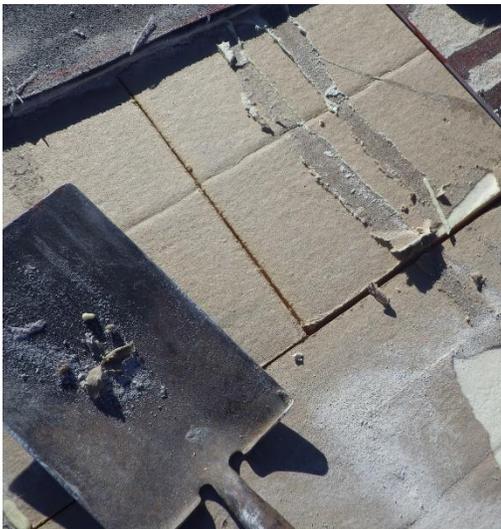
Figure 3.23 Polyiso insulation board exposed during exploratory roof openings.

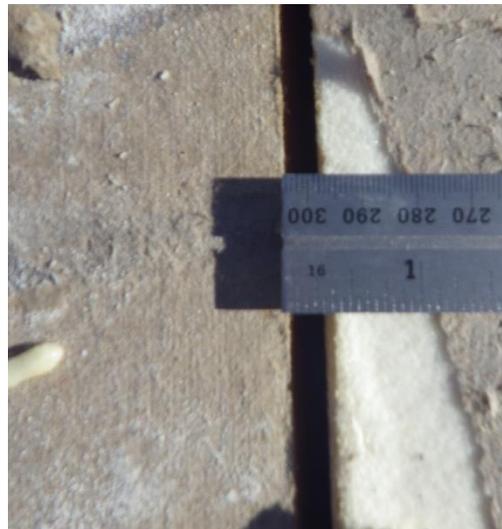
Figure 3.24 ~5mm gap observed between edges of polyiso insulation boards.

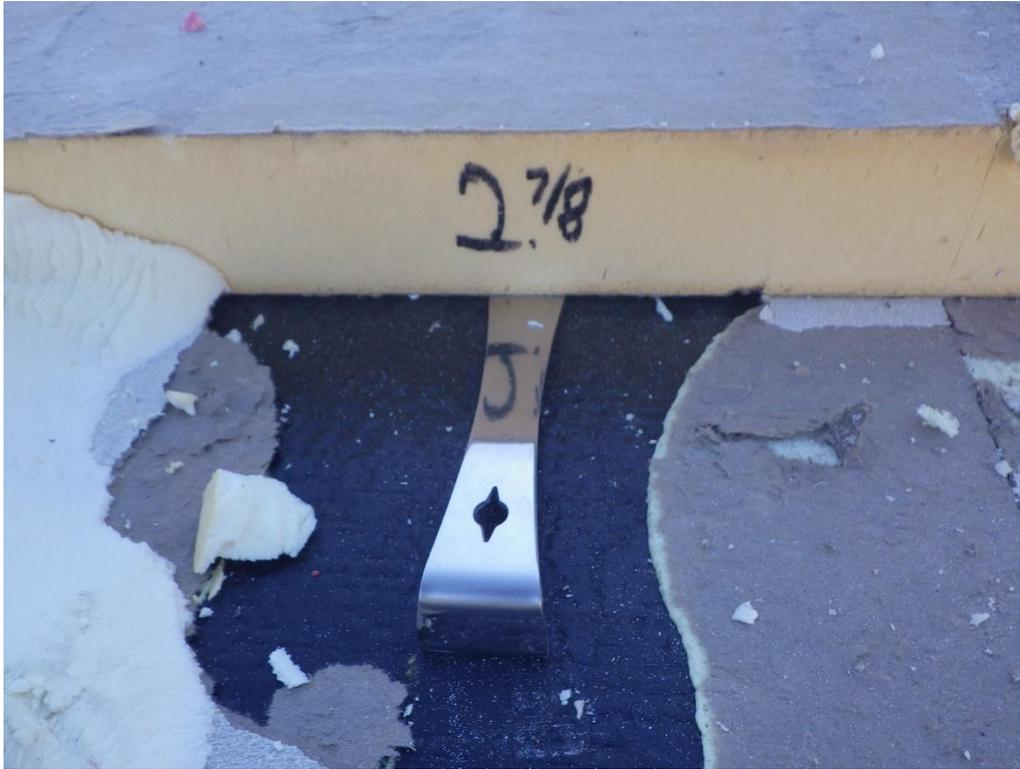
Figure 3.25 Polyiso insulation board thickness, measured at factory edge. Several of the exposed insulation boards appear to have shrunk in thickness during the course of the monitoring study, from 3" initial as purchased to 2 7/8" in-service.

In addition to the confirmed increase in gap size between insulation boards, measurements taken of the polyiso insulation boards exposed in the exploratory openings also revealed that the majority of both brands of insulation had shrunk by approximately 1/8" (3mm) in thickness from 3" to 2 7/8" (76 to 73 mm), as shown in Figure 3.25.

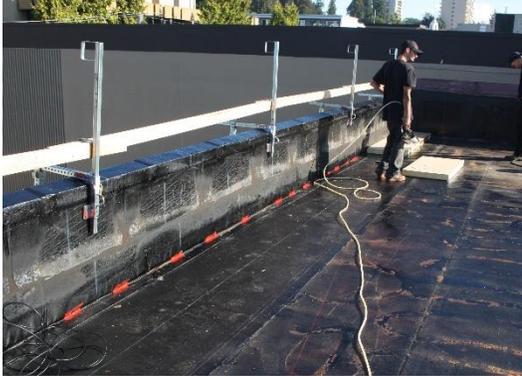
Roof assembly constructed up to vapour barrier. Wiring for sensors during installation.

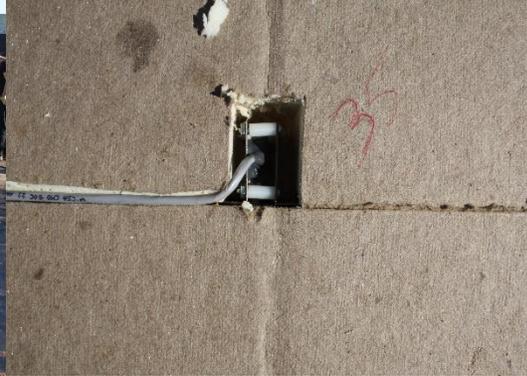
Displacement sensor installed with metal contact plate in polyiso roof insulation. This is typical of how all displacement sensors were installed.

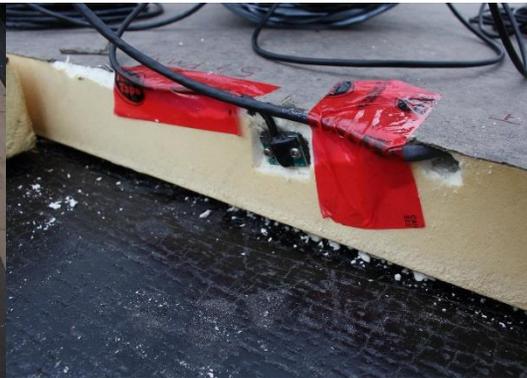
RH, temperature and moisture sensors installed into polyiso insulation.

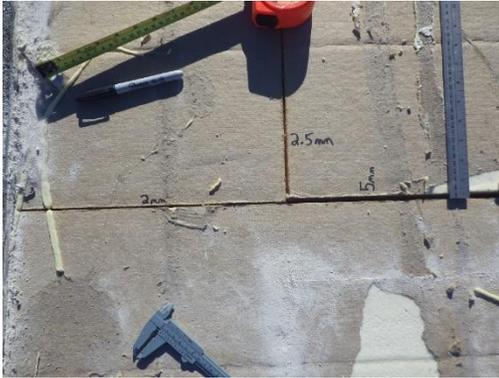
Gaps between polyiso insulation boards, ranging from 2mm - 5mm. These measurements generally confirmed the accuracy of displacement sensor readings.

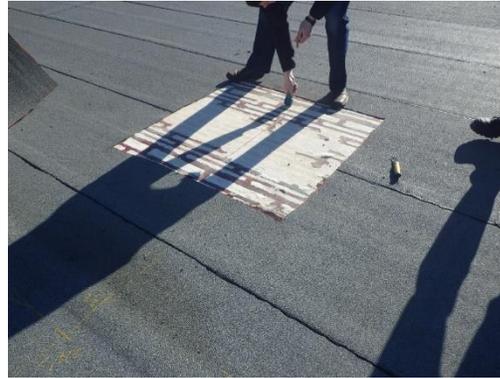
SBS membrane removed in order to observe dimensional change in polyiso as well as its overall condition.

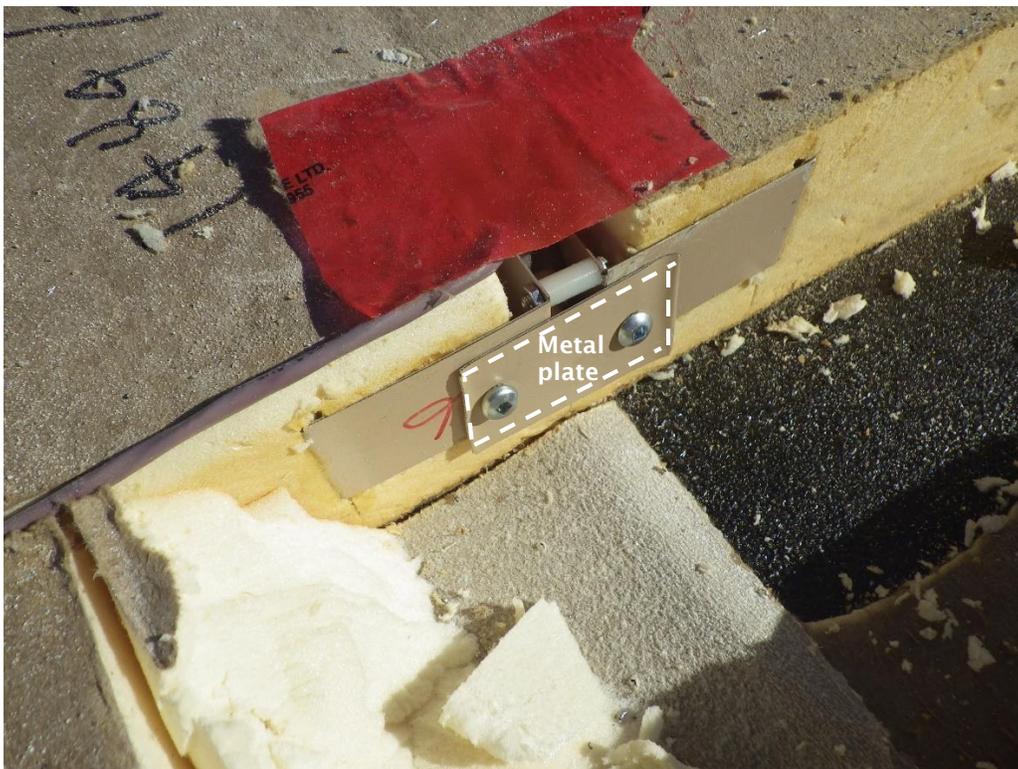
Displacement sensor with plunger restrained by rigid metal plate at consistent position in order to determine the temperature sensitivity of its readings.

A control displacement sensor with its plunger fixed by a metal plate was also installed within the roof assembly to confirm that the sensor itself is not adversely affected by changes in temperature.
