AIR LEAKAGE WITHIN MULTI-UNIT RESIDENTIAL BUILDINGS: TESTING AND IMPLICATIONS FOR BUILDING PERFORMANCE

Graham Finch, MAsc

RDH Building Engineering Ltd. Vancouver, BC

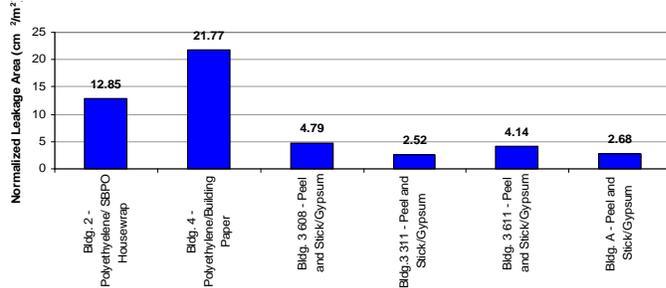
Figure 1: Normalized Leakage Area by Exterior Wall Type

The two wood-frame exterior walls tested here had the highest normalized leakage area - consistently higher than the steel stud and gypsum walls, with peel and stick air barrier membrane.

Data from these six suites is summarized and compared to determine if any consistencies can be determined between wall or floor assemblies, from this limited data set. While statistically insignificant, the results confirm predicted differences between assembly types. Figure 1 compares the air leakage between the tested exterior wall assemblies.

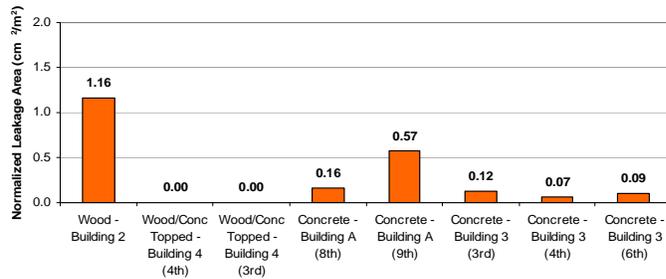
Figure 2: Normalized Leakage Area by Floor Type

The tightest floor systems tested were the concrete-topped wood frame floor, followed by the concrete slab floor. The wood frame floor showed the highest air leakage. Air leakage through a floor slab largely depends on how well the penetrations were fire/smoke sealed. It appears that in Building A one or more of these penetrations was poorly sealed, contributing to the higher-than-average leakage measured through this solid concrete slab. The wood frame floor had a higher leakage area, as could be expected, due to penetrations, gaps, or shrinkage of the plywood and wood joist floor.

The differences in air leakage through the different floor assemblies are compared in Figure 2.

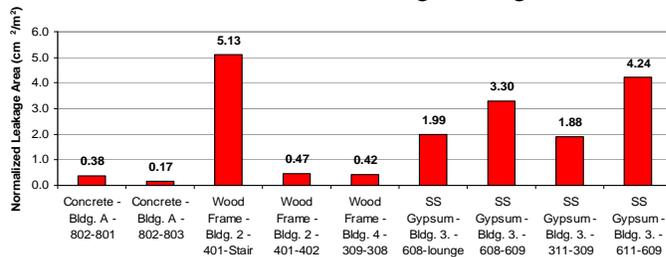
Figure 3: Normalized Leakage Area by Interior Wall Type

The solid concrete walls tested were found to be tightest, followed by the wood frame walls (except one location), and finally the steel-stud and gypsum demising walls. Air leakage differences between solid concrete and framed walls are evident, and it appears that these wood-framed walls were constructed

The differences of air leakage through the interior suite demising walls are compared in Figure 3.

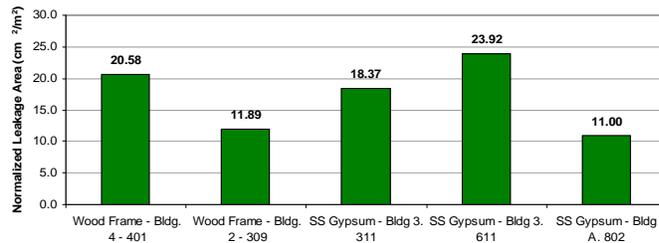
Figure 4: Normalized Leakage Area through Hallway Walls

Hallway door air leakage is excluded from these tests, having an intentional leakage area in the order of 50 cm²/m² for a standard entrance door (including a 1 cm door undercut, normalized over the total area of the door frame). The measured hallway leakage shown here is through unintentional openings such as plumbing penetrations, cracks, gaps, or electrical boxes/switches.

Hallway demising walls were shown to be significantly leakier than the suite demising walls tested, possibly because openings were more frequent or poorly sealed. While this leakage area is unintentional (i.e. not through passive vents or door undercuts), it may be beneficial in cases where suite owners have intentionally blocked the door undercut, inhibiting suite supply air.

tighter than the steel-stud and gypsum framed walls. Figure 4 compares air leakage for walls between test suites and hallways.

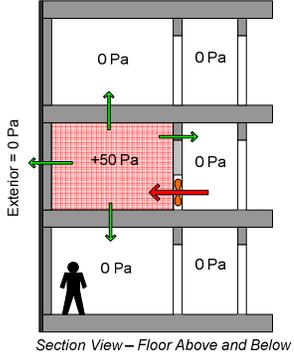
Test # 1 – Pressurize Suite (Adjacent Suites Open to Exterior)

This differential procedure is performed in steps to isolate and eliminate each surface until the leakage through the exterior enclosure can be isolated. A six step test procedure to incrementally determine air leakage between suites is illustrated in the Appendix. Large red arrows indicate fan flow direction and small green arrows indicate air leakage paths. The pressurized suites are highlighted in red, and when two pressurized suites are adjacent, the leakage is neutralized between those spaces. The de-pressurization tests are run with the fans turned around to face the opposite direction; however the door-fan setup remains the same.

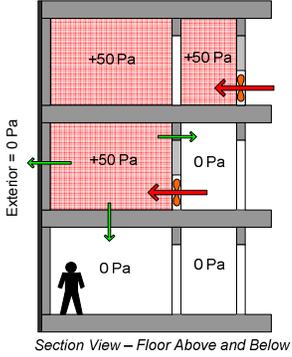
Test # 2 – Pressurize Suite and Floor Above

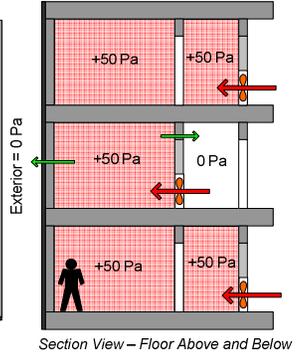
Test # 3 – Pressurize Suite, Floors Above and Below

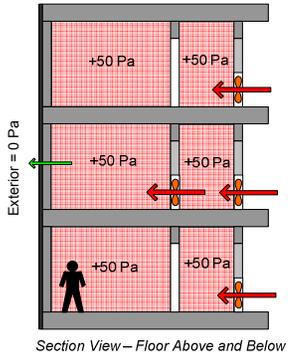
Test # 4 – Pressurize Suite, Floors Above and Below, and Hallway

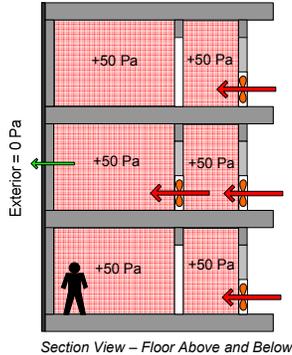
Test # 5 – Pressurize Suite, Floor Above and Below, Hallway and Left Suite

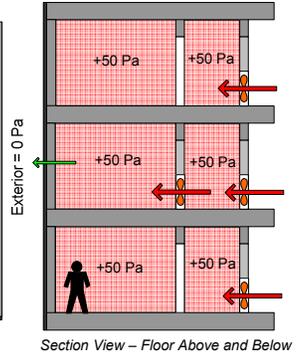
Test # 6 – Pressurize Suite and All Adjacent Interior Surfaces

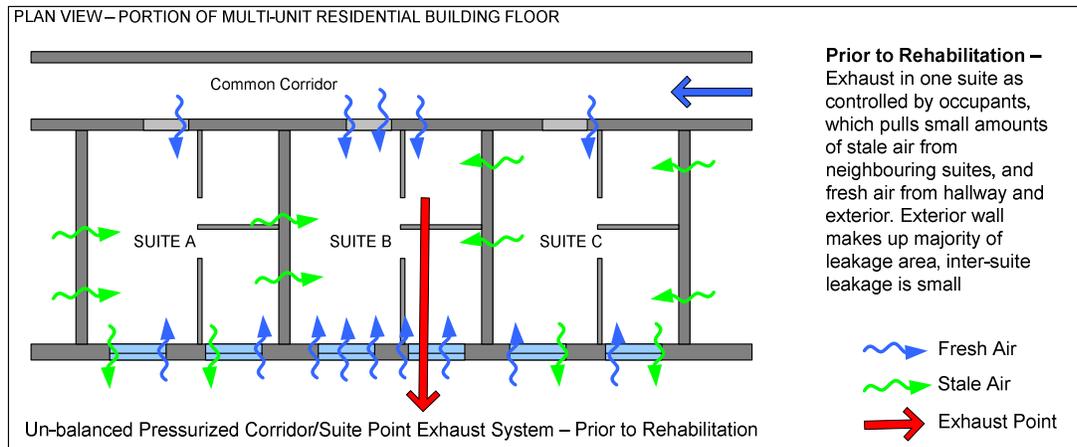
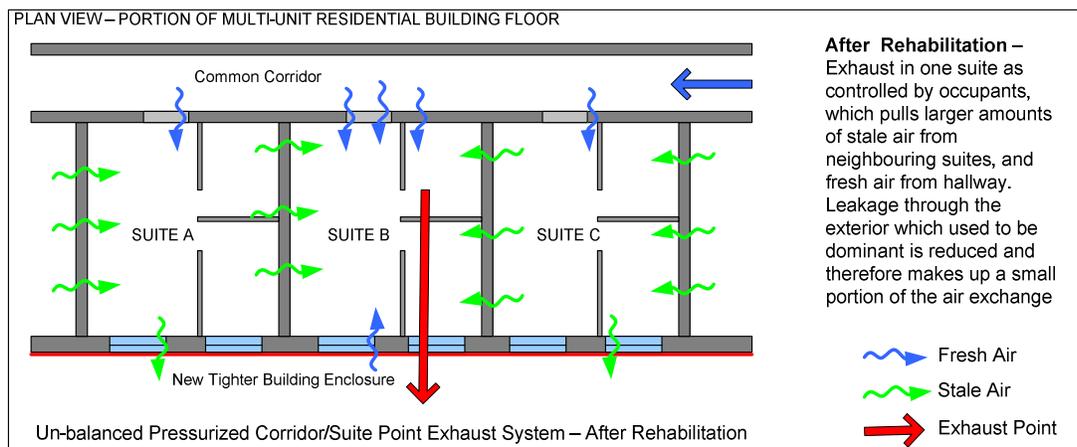
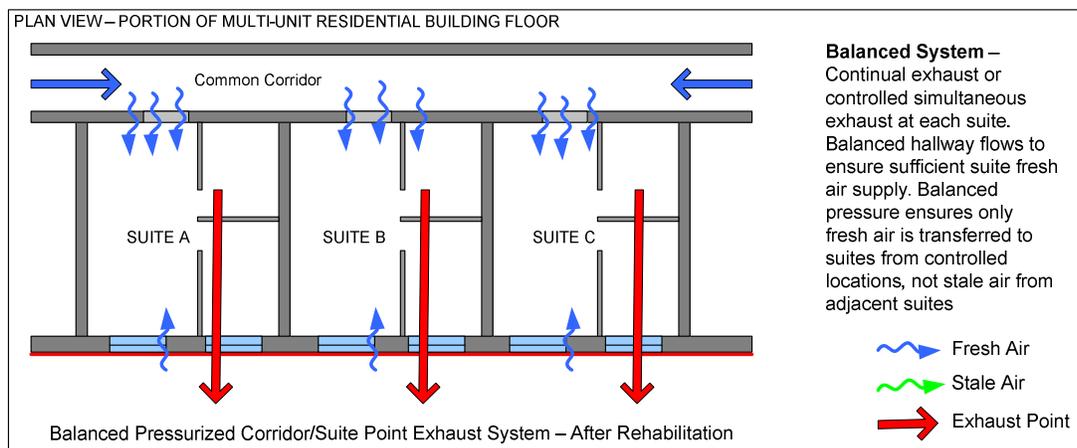
Rehabilitation Strategy Schematic for Suite Ventilation in Multi-Unit Residential Buildings
