ICF Wall Testing and Modeling

LAB TESTING REPORT

ICF Wall Testing and Modelling RDH Building Engineering Ltd. PAGE 7 OF 11

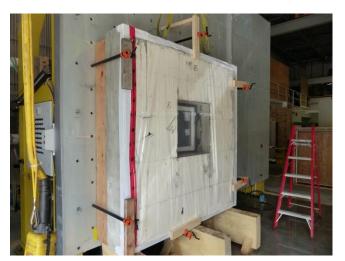
Fig. 3.1.2 Air Leakage Testing

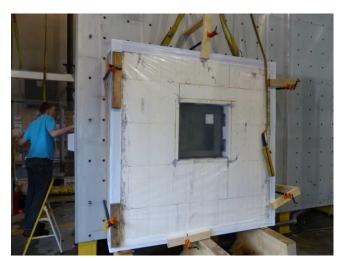
Fig. 3.1.1 Air Leakage Testing

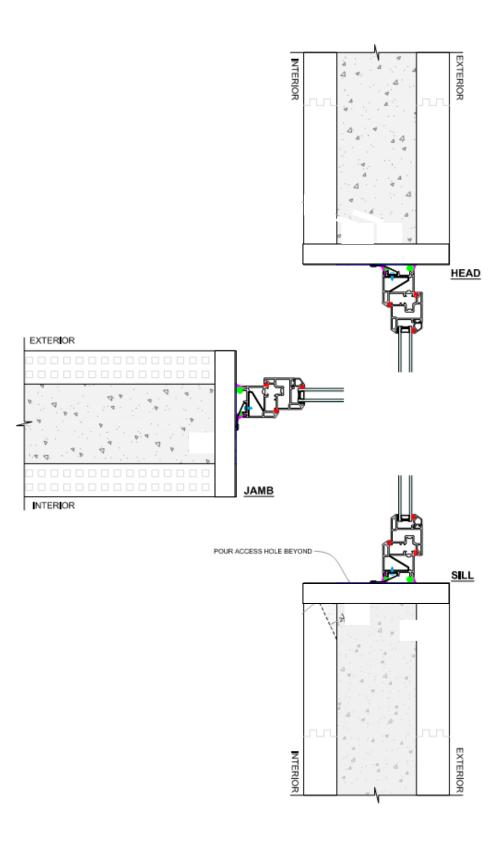
The Gorilla Buck ICF wall was constructed in a similar manner as Module 1B; the only change is that the wooden buck is replaced with a Gorilla Buck around the window.

The Gorilla Buck is a proprietary system constructed from expanded polystyrene (EPS) for window and doors openings in ICG construction.
