Real Energy Savings from Windows Upgrades

By Graham Finch, Dipl.T, MASC, P.Eng

This bulletin presents the thermal improvements, improved airtightness, and measured energy savings resulting from the upgrading of windows in two 1970's vintage residential concrete towers.

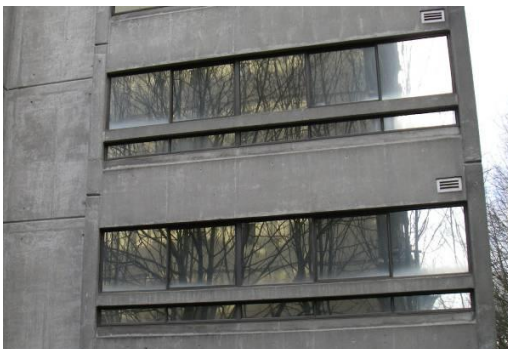
BEFORE: The original windows.

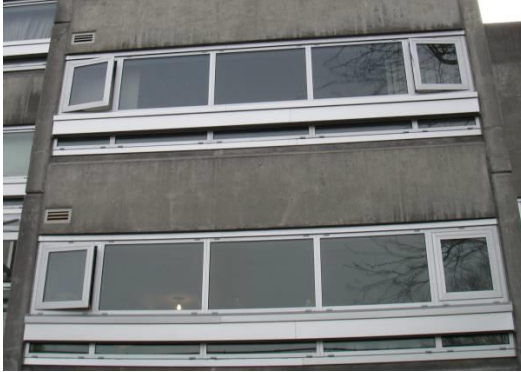
AFTER: New windows installed.

Thermally broken aluminum Kawneer series 5500 fixed frames, AA900 casement vents and AA3900 sliding doors were selected for the replacement program. Insulating glazing units within the frames utilized a high quality low-e coating on surface #2 (interior side of exterior pane), argon gas fill, and thermally improved stainless steel edge spacers. The overall R-value of the building wall enclosure was improved by approximately 90% to R-2.7.
