Technical Bulletin

No. 007

Glass and Glazing on Our Tall Towers: Is It All It's Cracked Up To Be?

By Brian Hubbs, P.Eng.

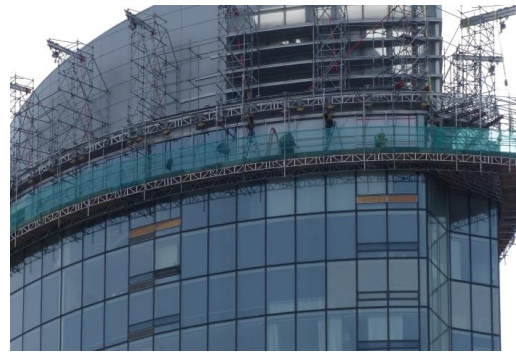
Figure 2: Glazing replacement project at a 45 storey high-rise building utilizing a large suspended stage hung from the building

glazing a modern curtain wall typically needs to be done from the exterior off suspended stages and the cost of replacement can approach the cost of the original glazing system for complicated buildings. Due to the high cost of replacing glazing units on an existing building, it is critical for owners and managers of older buildings to have an understanding of when replacement will be required and if anything can be done to extend the life of the existing glazing units.

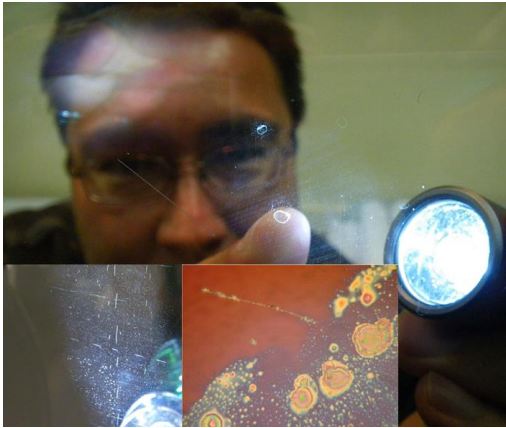
Figure 5: The author examining hazing that could not be cleaned from the glass (corrosion of silver low-e coating inside the IGU).

When investigating IGU problems, a visual review is first conducted to look for fogging, hazing caused by corrosion of coatings, or spacer bar displacement.

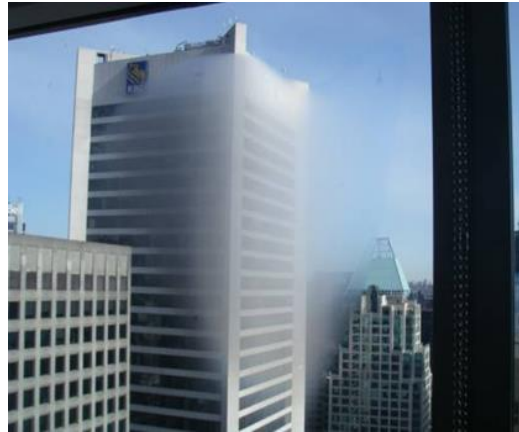
Figure 6: Volatile fogging between panes of glass occurring during periods of warm weather in direct sunlight.

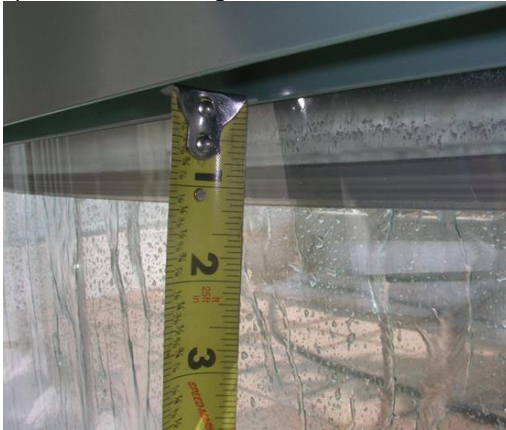
Figure 7: Spacer bar displacement into glazing unit obstructing view and resulting in fogging.

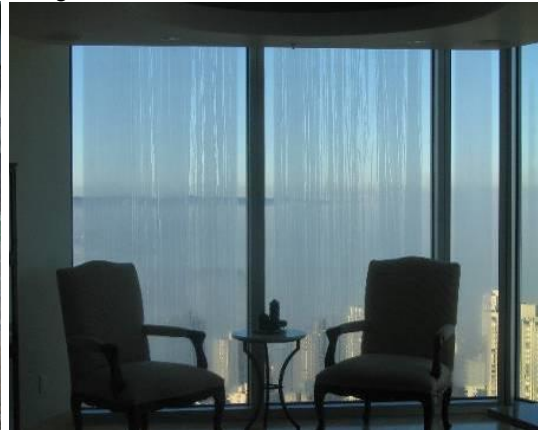
Figure 8: Severe condensation and frost inside glazing unit during cold weather.

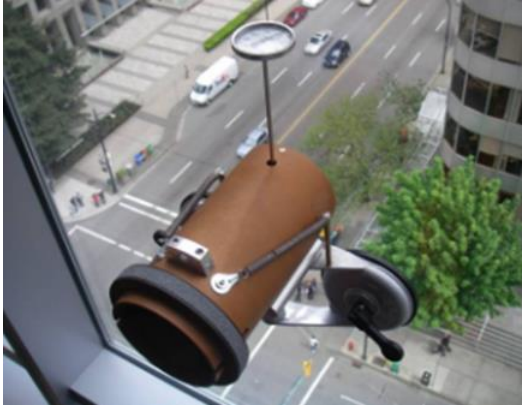
Figure 9: Performing a Frost Point test on a suspect unit.

If there is a concern regarding moisture (water vapour) within the IGU, a sampling of units is typically tested using a device called a frost point tester to measure the amount of water inside the glazing unit. Once the amount of water is known, a mathematical model is used to predict the remaining life and the expected replacement costs over the next decade.

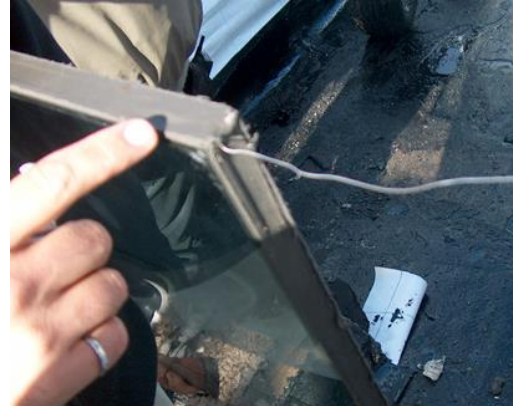
Figure 10: The culprit: unsealed vent tubes. The solution: crimp and seal them.

Most importantly, if there is evidence of excessive water vapour within the IGU, the construction and installation of the IGU must be investigated further to try and develop an economical method of extending the remaining service life of the units that have not yet failed. On older buildings, cleaning weep holes in the aluminum framing members or installing exterior sealants to reduce the amount of water contacting the glazing unit edge seal are methods sometimes used to prolong the service life of an IGU.
