30th RCI International Convention and Trade Show

THE PROBLEMS WITH AND SOLUTIONS FOR VENTILATED ATTICS

RDH BUILDING ENGINEERING LTD.

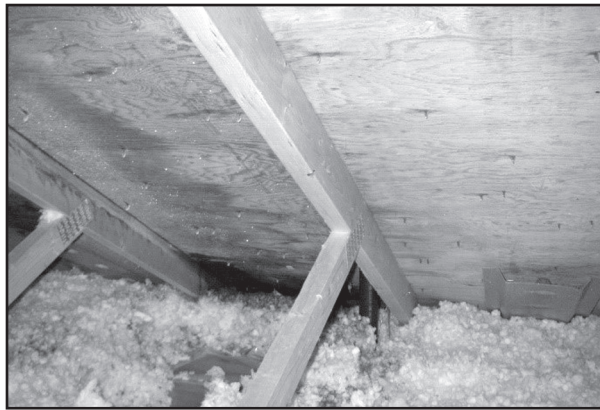
Figure 1 – Locally stained and wet sheathing and frost due to condensation of humid air leaking from a poorly sealed bathroom exhaust fan and duct.

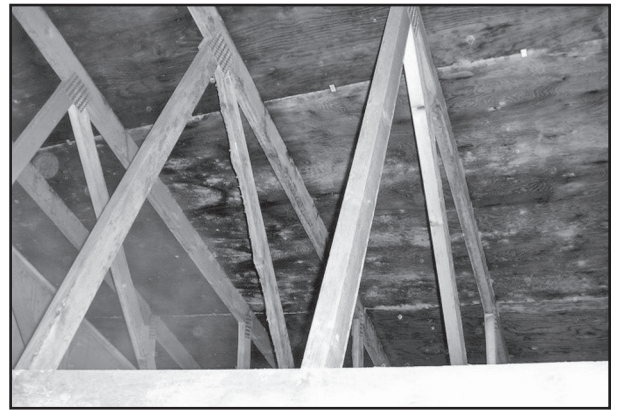
Figure 2 – A wood-frame attic with widespread stained, wet, and deteriorated sheathing from persistent indoor and exhaust duct air leakage and poor attic ventilation.

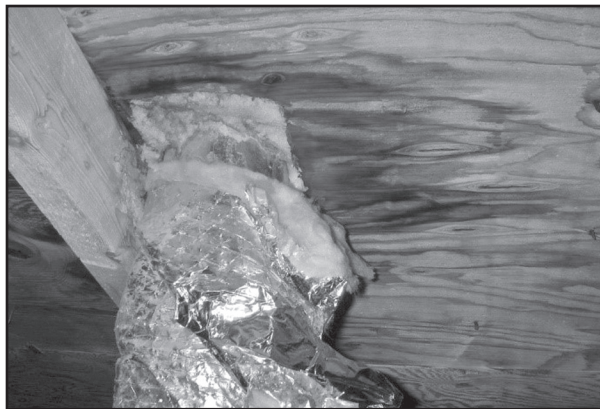
Figure 3 – Locally stained, wet, and deteriorated sheathing from water ingress around a plugged dryer exhaust duct boot.

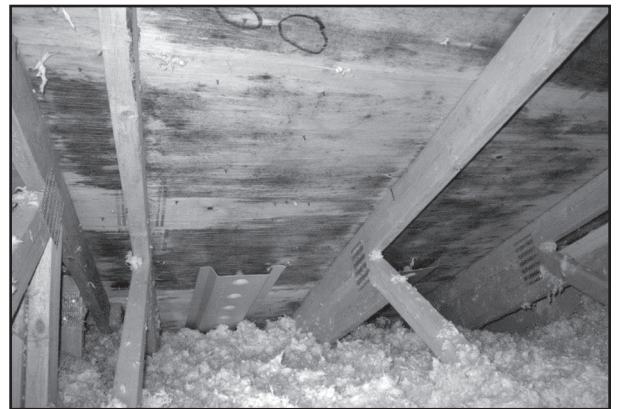
Figure 4 – Stained and damp sheathing only on the north slope of a very well-ventilated wood-frame attic not obviously linked to conventional wetting mechanisms and hypothesized to be caused by night sky condensation of outdoor ventilation air. Note that the staining is more apparent on the sapwood than the heartwood.

Detailed investigations and testing of many of these attics have shown that the traditional wetting mechanisms cannot account for the observed mold growth (as shown in *Figure 4*). Moisture-related problems have been found to occur in the absence of rainwater ingress, relatively airtight ceiling planes, and code-required attic ventilation rates or those required by third-party warranties. Consequently, we hypothesize that other mechanisms are affecting the moisture performance of these roof assemblies and, specifically, the roof sheathing.

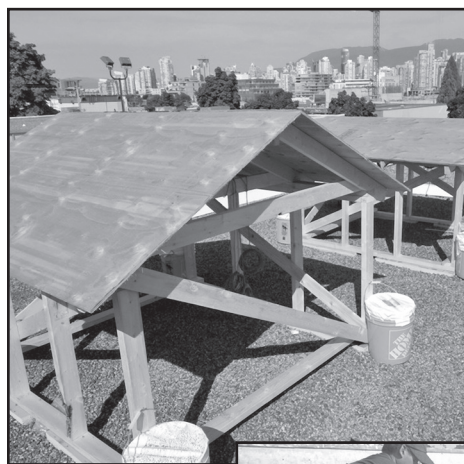
Figure 6 – Roof huts under construction with plywood sheathing installed.

The roof huts were arranged such that one side of the roof slope faces due north and one side faces south to investigate the impact of solar radiation on performance. The different orientations influence how the roof heats up and dries and gets wet and potentially how well the self-sealing stripping of the shingles engages. Photographs showing the construction of the four test huts are shown in Figures 6 through 8.

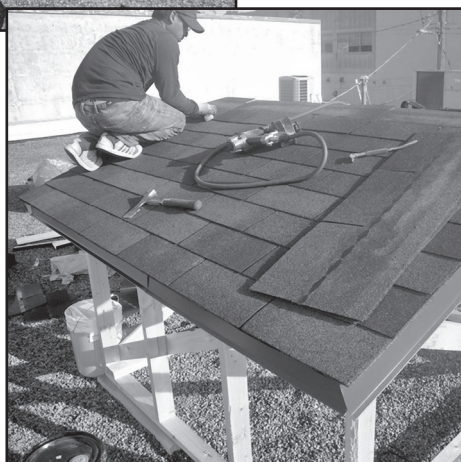
Figure 7 – Three-tab asphalt.

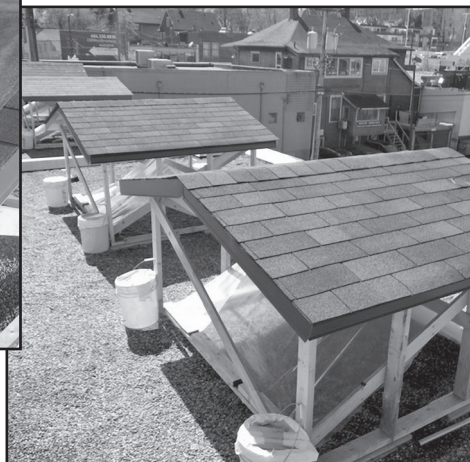
Figure 8 – Completed roof huts in place on low-slope commercial rooftop in Vancouver, BC.

The four roof huts were placed on the open low-slope roof of a two-story commercial building in Vancouver, BC, in order to expose them to exterior conditions while also decoupling them from the potential impact of a heated attic, indoor air leakage, duct leakage, or poor attic ventilation. Additionally, the installation of the self-adhered vapor-impermeable membrane on the control roof was intended to eliminate the potential for all wetting of the sheathing from the top of the roofs, including rainwater ingress and inward vapor diffusion. This controlled test hut approach allowed for evaluation of the field performance of these assemblies under unrestricted ventilation conditions (i.e., very well ventilated), while eliminating many of the conventional wetting mechanisms. The roof huts were constructed in late August 2012, and were roofed by mid-September 2012, under seasonally dry conditions.

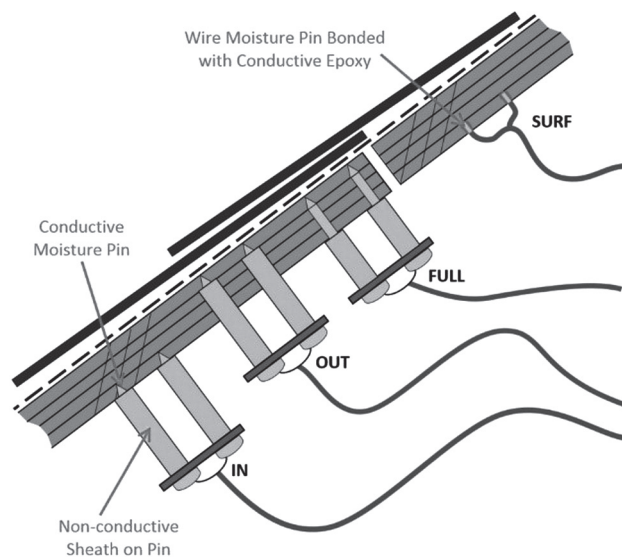
Figure 9 – Schematic and coding of moisture pin installation at inner 1/8 in. (In), outer 1/8 in. (Out), and whole depth (Full) of the plywood, and inner 1/8 in. of the plywood using pins installed with conductive epoxy (Surf).

Moisture pins were installed to monitor the moisture content of the plywood sheathing. Placement of moisture pins is critical in observing how wetting occurs; therefore, three sets of moisture pins were installed on each orientation of each test roof. The first set of moisture pins penetrated through all layers of the plywood in order to detect the worst-case moisture content in the sheathing. The second set of moisture pins was insulated and only exposed at the upper layers (outer 1/8 in.) of the plywood to measure wetting from the exterior side. The third set of moisture pins penetrated only the bottom layers (inner 1/8 in.) of plywood to measure wetting from the underside (e.g., night sky condensation). This arrangement of various moisture pin depths allows for monitoring moisture movement through the plywood sheathing. The sensors were placed near the center of the panels to eliminate edge effects. A standard 1/8-in. gap in the roof sheathing was included as part of the roof assembly near the sensors. A temperature sensor for moisture content calibration was installed within a small hole drilled into mid-depth of the plywood. Moisture content pins are referred to as MC

Figure 9 shows a schematic of the moisture pin installation into the plywood, and Figure 10 shows the initially installed moisture content and temperature sensors.

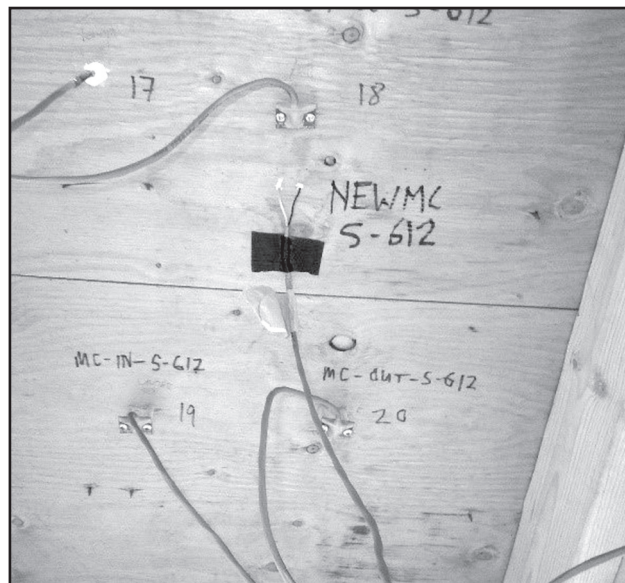
Figure 10 – View of underside of south side of 6:12 roof hut showing placement of moisture pins and sheathing temperature sensors.

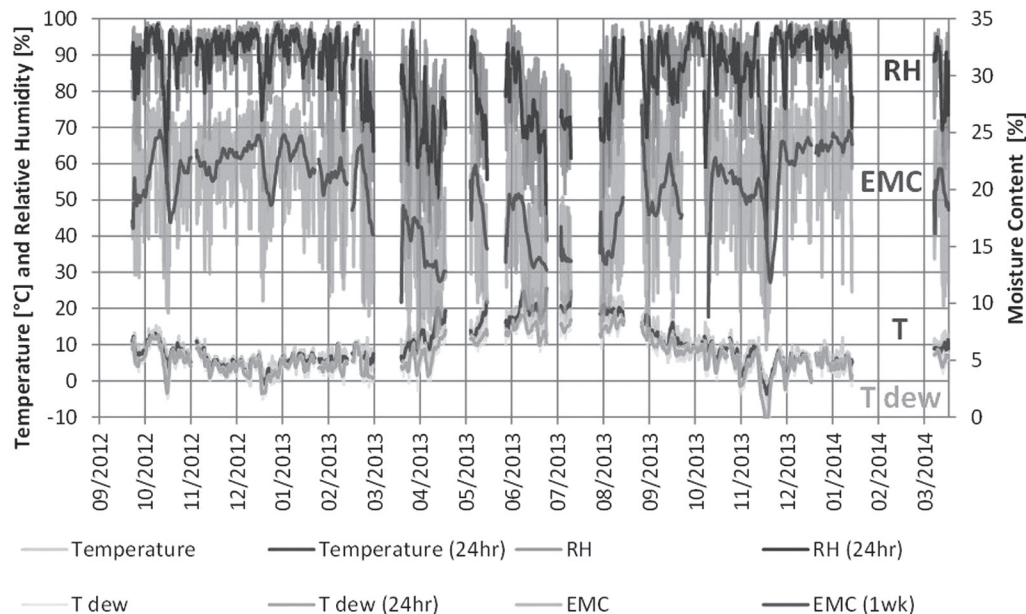
Figure 11 - Temperature, RH, equivalent moisture content, and hourly and 24 hr./weekly averages for the monitoring period.

The temperature and RH were measured throughout the duration of the monitoring period (Figure 11). Even

Reviewing the climatic data shows that the EMC exceeds 20% MC throughout the winter due to natural exterior temperature and RH levels, even in the absence of wetting or drying forces. Wetting and drying mechanisms, however, have the ability to both increase and decrease the moisture content of the wood relative to EMC levels. These potential wetting and drying mechanisms include precipitation, condensation from night sky cooling, and solar radiation.

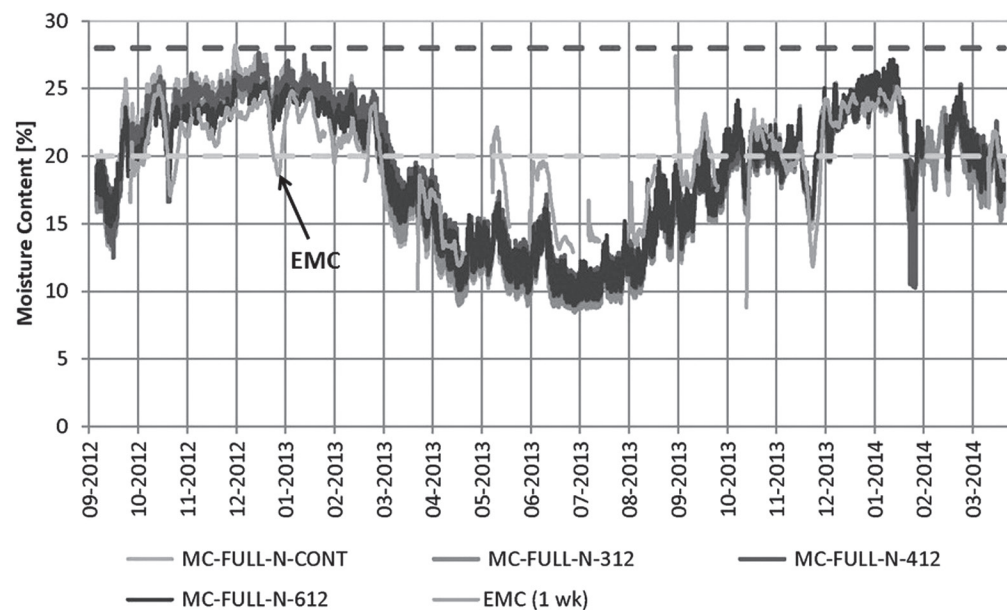
Figure 12 - Moisture content of plywood sheathing and calculated EMC - north, full-depth MC pins (full) - 2-year data for the four roof huts.

below the calculated EMC, it is likely that additional drying is occurring from solar radiation heating. The monitored values for the full-depth moisture content pins for each of the three roof slopes and the control at the north orientation are presented in Figure 12. The south orientation shows very similar, albeit slightly drier results. Some gaps are present due to intermittent sensor malfunctions, and error readings were omitted from the plots.

The general seasonal trends show summer drying and winter wetting consistent with the hourly trends shown previously in Figure 12. In addition, the north exposure is generally wetter than the south exposure, with a more pronounced difference for the steep-sloped roofs. Importantly, all three roof pitches exhibited the elevated moisture contents at certain times of the year, and the variation of the moisture content between roof pitches is not large enough to impact this more general trend.

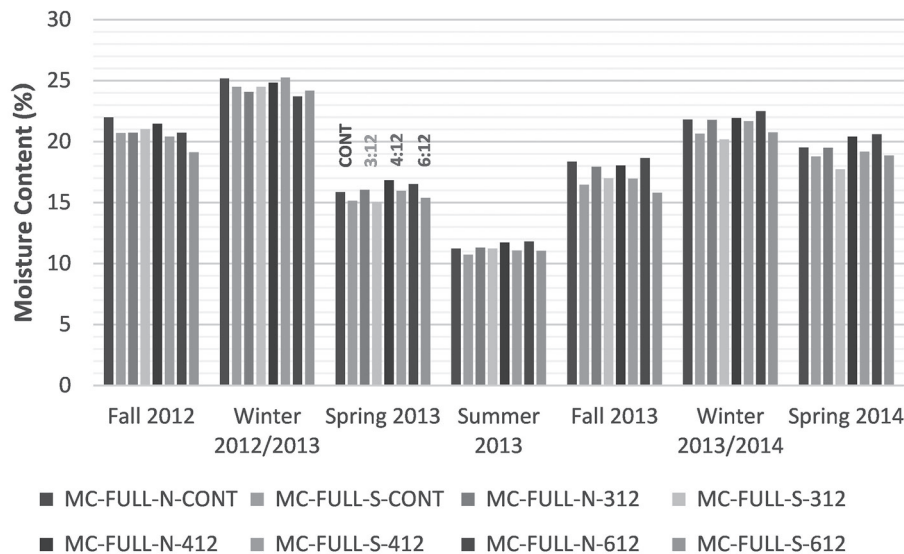
Figure 13 – Seasonal average sheathing moisture content for north and south elevations – full depth for the four roof huts.

Figure 13 provides the average seasonal moisture contents of the sheathing for each of the roof huts for the full-depth moisture content sensors at the north and south orientations. Average moisture contents for the inner and outer 1/8-in. depth of plywood are very similar, though they show more daily fluctuations.

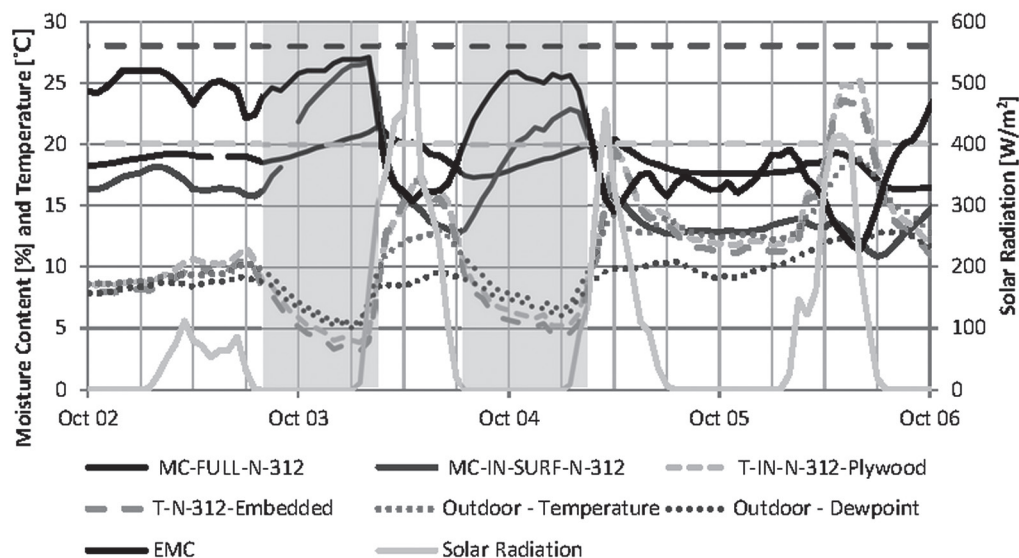
Figure 14 – Diurnal temperature and moisture content variation in the north control roof from October 2 to 5, 2013.

Figure 14 shows the diurnal temperature variations for three nights, with October 3 and 4, 2014, experiencing condensation for the north orientation of the 3:12 roof slope. The moisture content is also included to demonstrate the effects of the condensation on the sheathing. Condensation occurs when the sheathing interior surface temperature is lower than the ambient air dew point temperature.

The figure shows a cyclical wetting and drying of the plywood sheathing. While the full-depth moisture content of the sheathing does not vary appreciably, the surface moisture content (which measures the out-

ermost fibers of the plywood) does exhibit significant diurnal variations. It can be seen that incident solar radiation, even in the north orientation, causes the surface moisture content to drop by 10%. However, nighttime condensation increases the surface moisture content by nearly an equivalent amount.

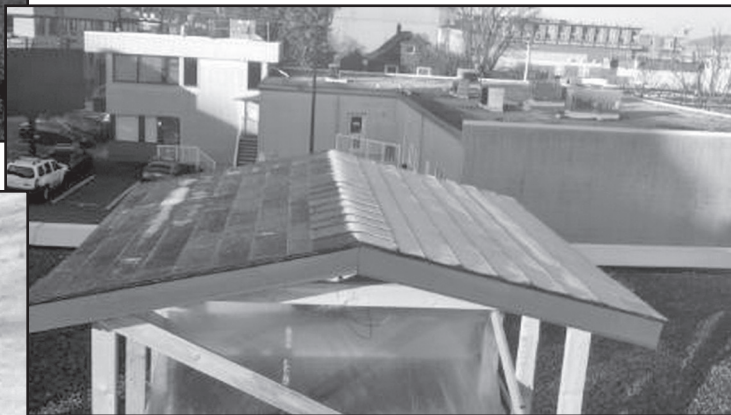
Figure 16 – Frost on exterior of shingles and impact of rising sun during the morning of January 2, 2013.

The night sky cooling and subsequent condensation and frost formation were confirmed visually at multiple periods during the study. Photos showing the condensation and frost observed on January 2, 2013, are provided in *Figures 15 through 18*.

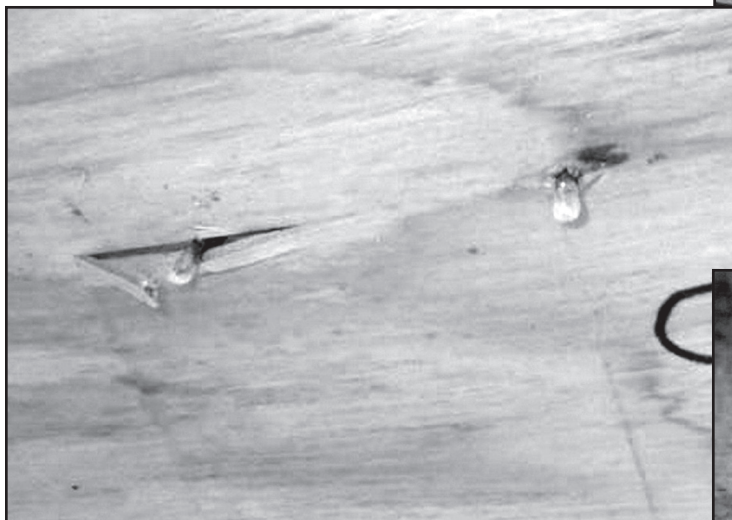
Figure 17 – Frost on nail heads of south-facing roof slope on the morning of January 2, 2013.

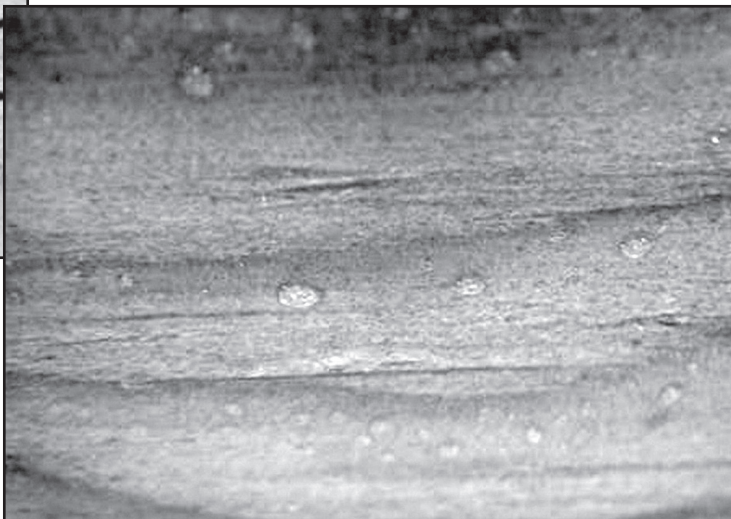
Figure 18 – Condensation on underside of plywood sheathing on the morning of January 2, 2013. Note that surface condensation at this time only occurred on certain areas of the plywood and was affected by wood grain.

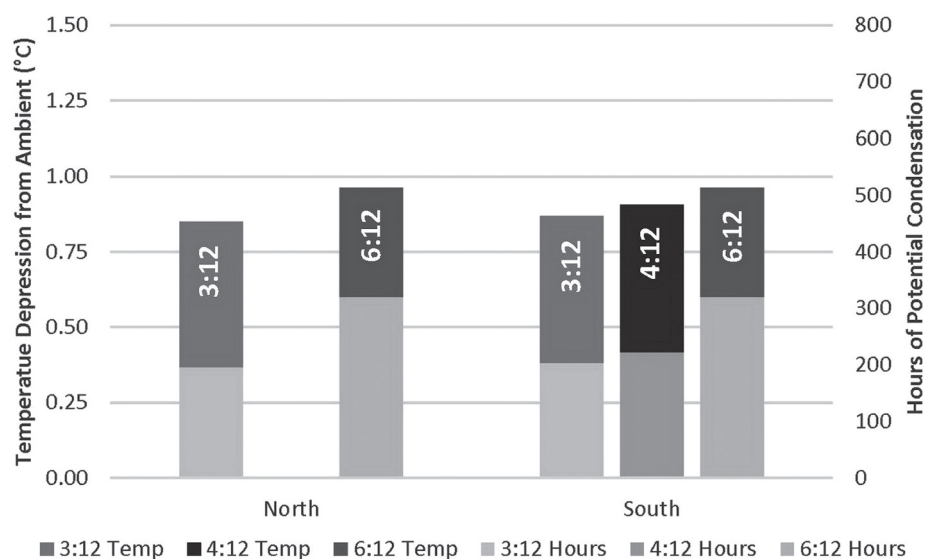
Figure 19 – Number of hours of potential condensation and average night-time sheathing temperature depression from ambient for north- and south-oriented roofs for 3:12, 4:12, and 6:12 roofs from December 1, 2013, to January 31, 2014.

The nighttime average temperature depressions for each of the roof huts was calculated and compared. A statistically significant difference was observed between the roof shingle temperatures on the 3:12/4:12 roof and the 6:12 roof, with the 6:12 typically experiencing less cooling than the other two

To further assess the effects of night sky cooling, an analysis of the total number of hours of potential condensation is shown in *Table 1* for the wet winter period from December 2013 through January 2014. A histogram of the number of potential hours of condensation is also shown in *Figure 19*, with the darker-colored bar representing the sheathing temperature depression relative to ambient conditions and the lighter-colored bars representing the number of hours of potential condensation based on ambient dew point temperatures.

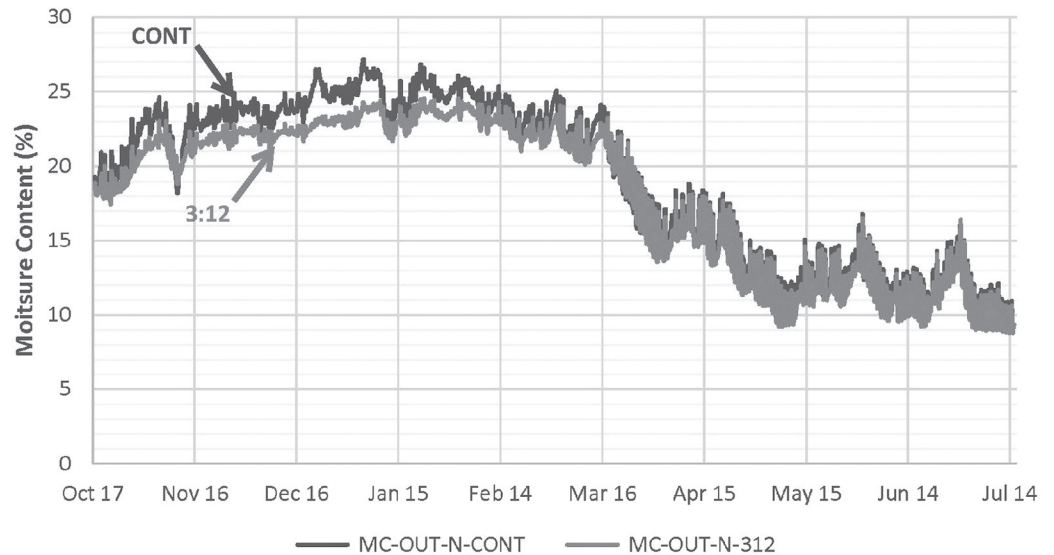
Figure 20 – Moisture content of outer 1/8 in. of sheathing for impermeable and permeable underlayment, including moisture content gradient, north elevation, 2012/2013.

The moisture content of the outer sheathing layer for the impermeable and permeable roof assemblies for the north orientation are shown in *Figure 20*. Data for the south orientation is similar, though

The figure indicates that the outer moisture content in the vapor-impermeable assembly is consistently wetter than the permeable assembly. The increased moisture content of the sheathing in the control roof is likely a result of the inability of the sheathing to dry to the exterior. This finding suggests that exterior wetting from saturated shingles is not a significant cause of wetting of the exterior of the assembly and that instead, the reduced outward drying increases the moisture content of the sheathing. However, this finding is for small, well-constructed, new roofs with no

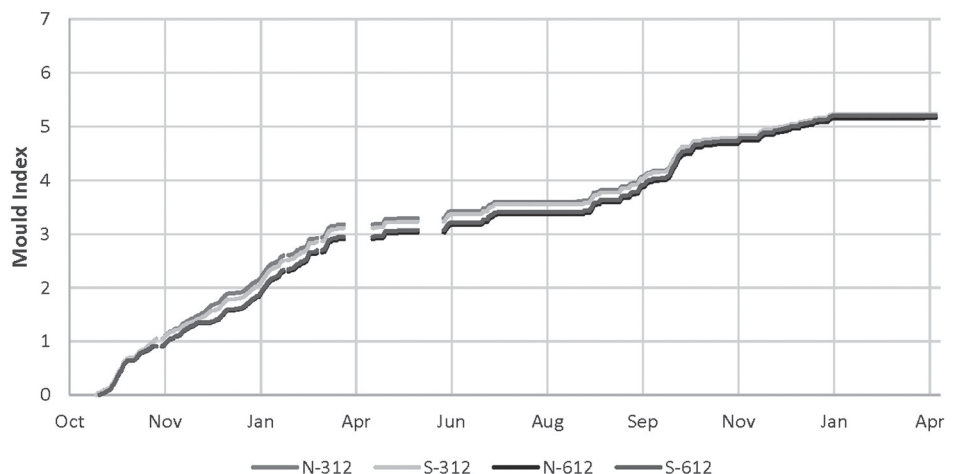
Figure 21 – Mold growth index for 3:12 and 6:12 roof pitch for north and south orientation.

The model assumes that a certain amount of germination time is required prior to macroscopic mold growth. This is accounted for in the 0 to 1 mold index, whereby only microscopic observations could confirm the presence of mold. Subsequent indices from 2 to 5 cover the range of mold growth from less than 10% of the surface area to near complete mycelia matting. Note that based on environmental conditions, a maximum degree of mold can be supported; the calculations indicate a maximum mold index of approximately 5. The results of the predicted mold growth are shown in Figure 21.

The results of the mold modeling suggest that the 3:12 roof pitch would exhibit slightly higher occurrences of mold compared to the 6:12 roof pitches. Similarly,

mold growth was calculated to occur faster on the north orientation than on the south. Despite the predicted faster initial mold growth on the lower sloped and north facing roofs, after a period of two years, mold

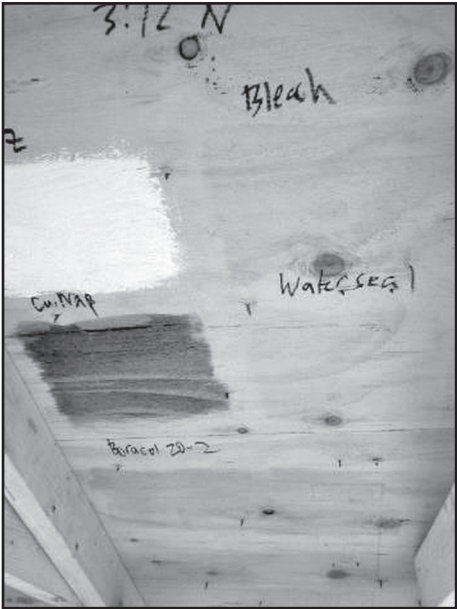
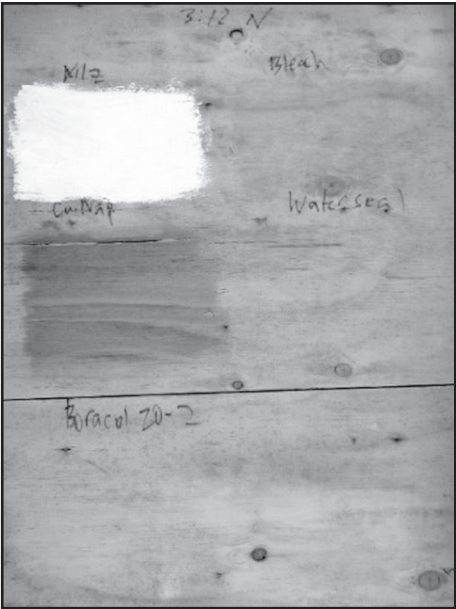
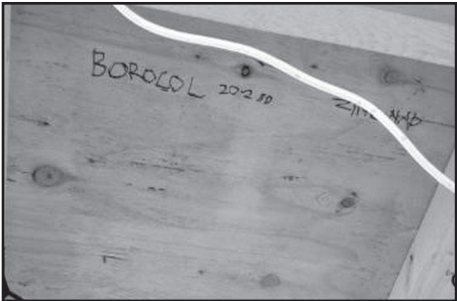
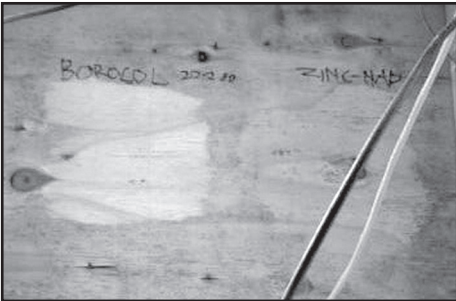
Table 3 – 3:12 roof, as-new and 1.5-year condition.

North - Treatment Phase 1	2012/10/15

2014/04/07: 1.5 Years

2013/04/11: After first winter

2014/04/07: 1 Year

The impacts of surface treatments were visually analyzed. Comparative photographs of the as-new and 1.5-year-old sheathing conditions for the different treatments are shown in *Table 3* for the north orientation of the 3:12 slope roof. Additional photos can be found in the full study report, though they show similar levels of final mold contamination.

Consistent with calculated prediction, the north orientation exhibited the greatest degree of fungal growth on all three roof pitches, with the 6:12 roof showing the least amount of growth. The south-facing slopes were in generally better condition, with the 6:12 pitch similarly showing the least fungal growth. This is somewhat in contrast to the previously stated findings, which indicated lower moisture contents and fewer hours of condensation for the 6:12 roofs. Further investigation into the discrepancy

In regard to the efficacy of the fungal treatments, in general, the bleach and Thompson's WaterSeal® have to this point been inadequate in preventing fungal growth. In some cases, it appears as if the antifungal properties of bleach have primed the surface for a new wave of fungal colonization by eliminating the established fungi, resulting in more severe fungal growth than the adjacent areas. The Boracol 20-2BD, Kilz® paint, copper naphthenate, and zinc naphthenate seem to provide good resistance to fungal growth at this early stage. It is also obvious that products with moldicides (e.g., Boracol 20-2BD and Kilz® paint) perform better than wood preservatives primarily designed to stop fungal growth (copper and zinc naphthenate). Nonetheless, longer-term field studies are required to ascertain whether repeated application is required to maintain the level of fungal resistance. A
