## Previous Wind Washing Research

## RDH Measured Thermal Impact of Wind Washing

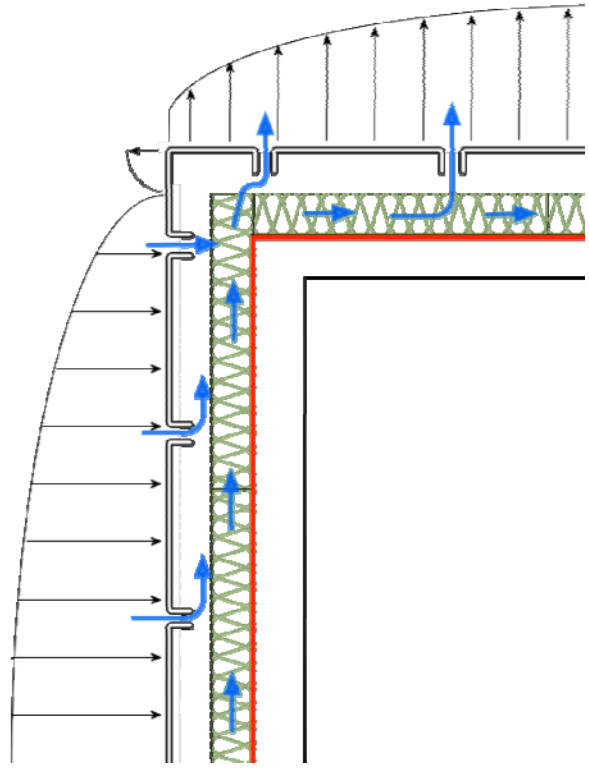
*Figure 6: Wind washing - airflow passing through air permeable insulation*

*Figure 7: Wind washing - airflow passing behind and around insulation*
