# Literature Review and Research Summary on Wind Washing of Air Permeable Insulation

John Straube | Ph.D., P.Eng.  
Principal, Senior Building Science Specialist

*This summary report explains the building science physics of wind washing, including some previous laboratory testing on the air permeance of stone wool insulation. Information about research conducted for ROCKWOOL is used with permission. All contents © RDH Building Science.*

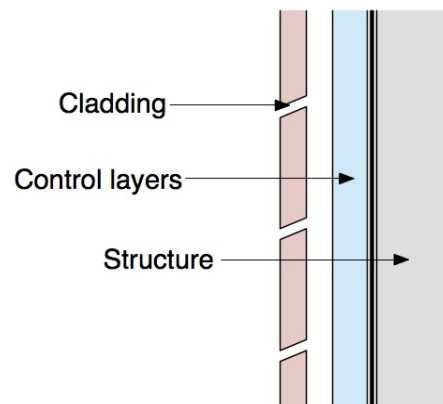
Figure 1: The “perfect wall” concept (Lstiburek 2007)

Modern enclosure design favors the use of exterior continuous insulation (ci) over the supporting structure. This approach has long been favored by building science research because of its excellent thermal performance, condensation resistance, and enhanced durability provided to the materials installed inside of the insulation (Hutcheon 1964). More recently, this design concept has been championed as the “perfect wall” (Lstiburek 2007) shown in Figure 1.

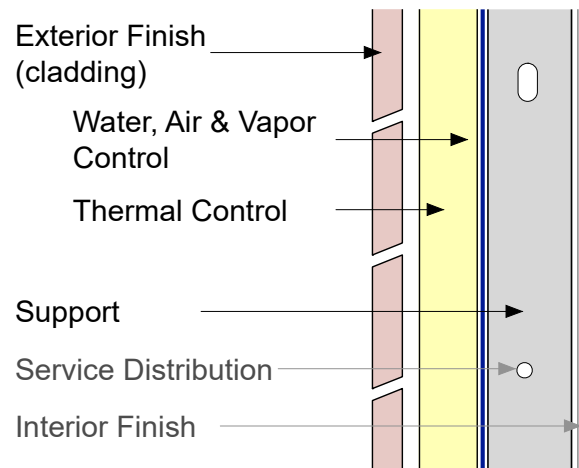
*Figure 2: Modern enclosure wall with continuous insulation and exterior air and water barrier*

In a typical well-designed ci assembly, the air and water control (air barrier and water-resistant barrier) is a single membrane placed over the support structure and protected by a layer of continuous exterior insulation (Figure 2). In many enclosure walls, well-vented and even open-jointed cladding is installed over an air gap of ½” to 2” (12 to 50 mm) depth to provide a ventilated space behind the cladding and outside the continuous insulation. The flow of outside air through the gaps into the space behind the cladding – i.e., ventilation – is beneficial for encouraging drying of the back of the cladding and any undrained rainwater or condensation retained on or within the cavity.

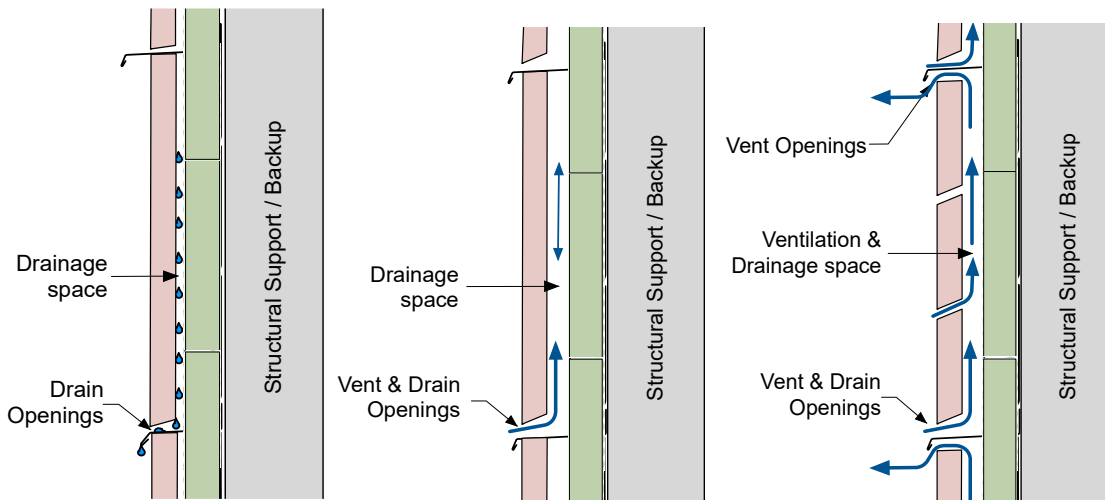
Figure 3: Drained (left), vented (middle), and ventilated (right) cladding systems

A **drained cladding system** employs a specific rain control strategy: the cladding is assumed to allow water to pass, and a drainage layer (water-resistant barrier) and drainage gap (as small as a fraction of a millimeter) collect and drain the water back to the outside.

A **vented cladding system** is one which has openings that allow some degree of connection between the outdoors and the gap behind the cladding, but whose vent area and distribution is such that little to no airflow occurs, although diffusion is encouraged.

A **ventilated cladding system** uses relatively large vent openings to connect the outdoors to an unobstructed air gap behind the cladding in such a manner that air flows in one vent and out another via the air gap.

Figure 3 illustrates the differences between these three systems.

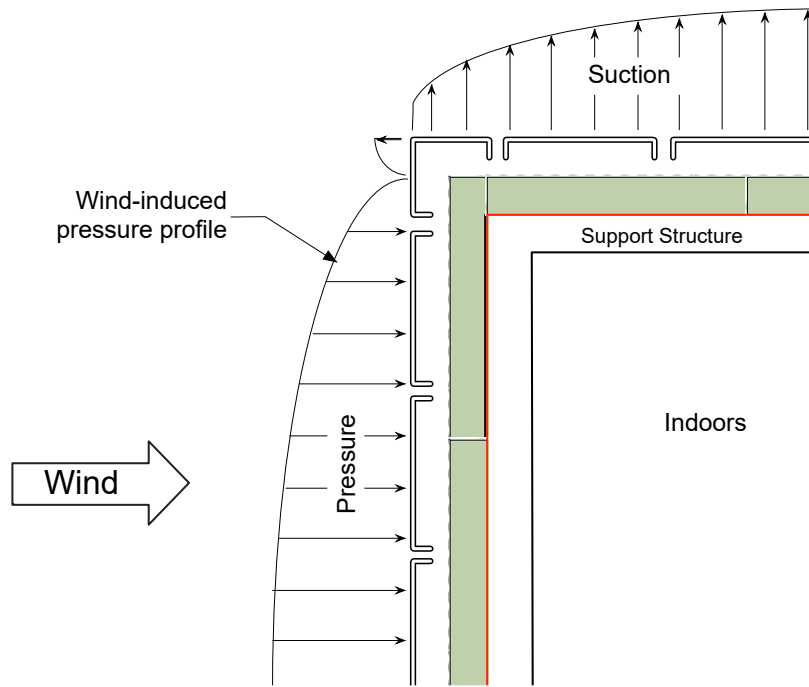
Figure 4: Typical pressure profile by wind action at a building's exterior corner

Wind washing airflows are driven by wind-induced air pressure differences which form over the face of a building (pressure gradients). Tall buildings and exposed sites experience the highest wind speeds. Wind pressures and gradients increase with the square of wind speed. The wind pressure gradients that drive wind washing are largest near building corners and parapets. Hence, wind washing is a serious concern at the corners of a building, where wind pressure gradients are large, although it can be a problem in the field of the wall as well. Figure 4 presents the typical shape of the pressure profile that forms around the corner of a building when the wind blows on one face.

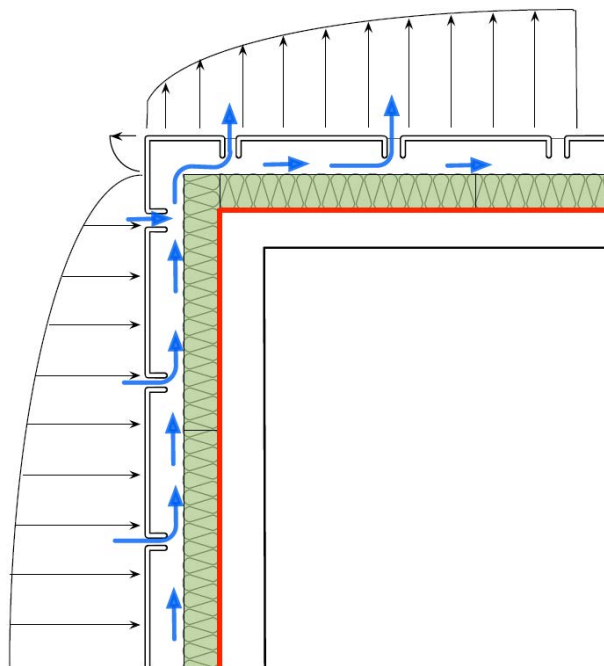
Figure 5: Airflow path through vented cladding and air gap

In walls with vented cladding over air gaps, airflow will occur behind the cladding through the air gaps (Figure 5). This is desirable as it supports the drying objective of the air gap. However, if the airflow velocity rises too high, or if the material properties or assembly are improper, the airflow can pass through or behind the insulation and result in much more heat loss than assumed in design.

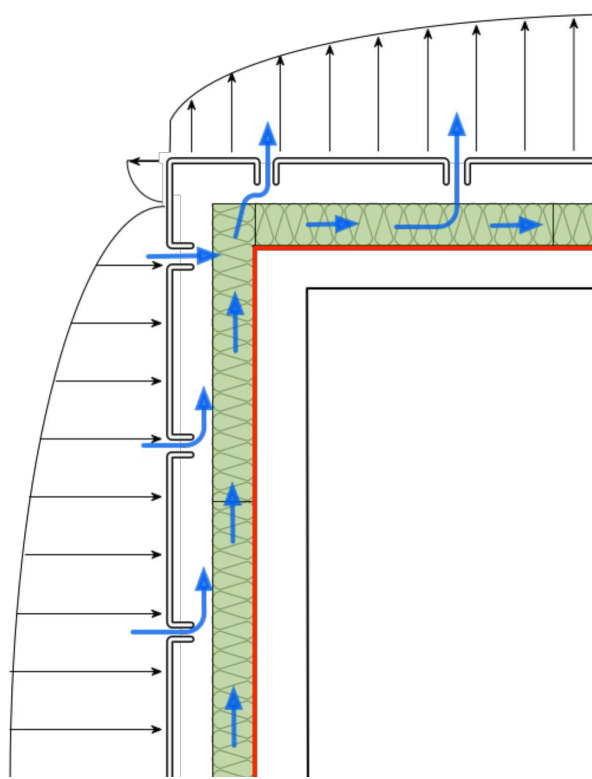
Figure 6: Wind washing - airflow passing through air permeable insulation

Two very different types of wind washing can occur: wind-driven airflow over and through air permeable (fibrous) insulation (Figure 6) and airflow behind insulation of all types (Figure 7). For air to flow behind the insulation, gaps must exist both behind the board and between joints to form a complete flow path.

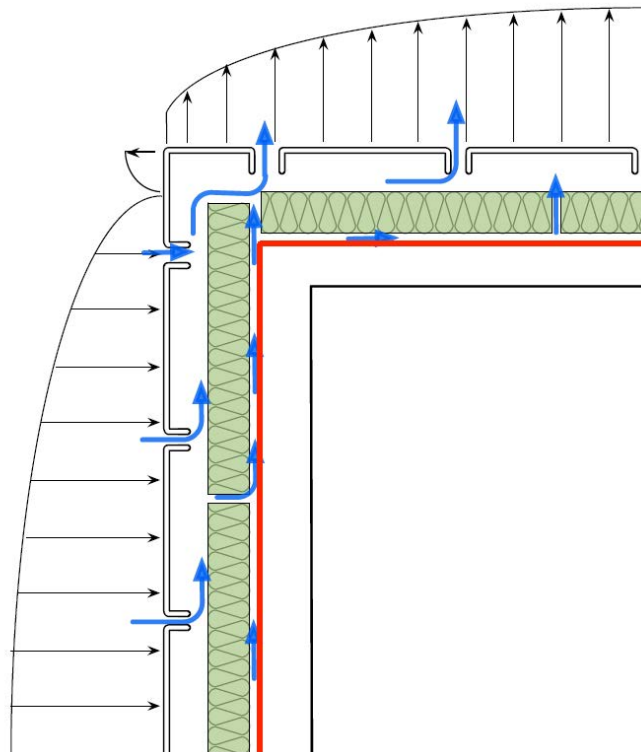
Figure 7: Wind washing - airflow passing behind and around insulation

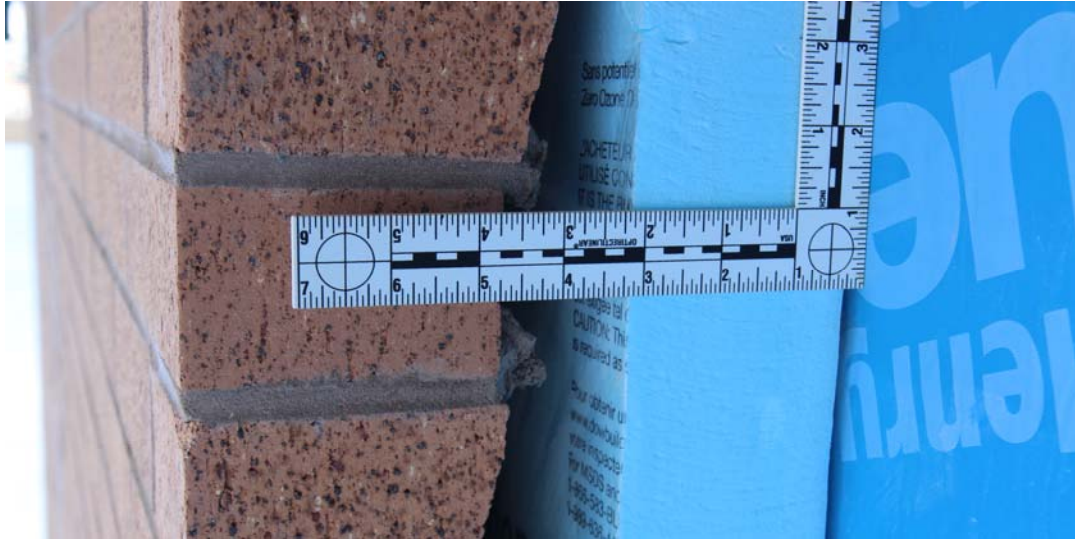
*Figure 8: Actual air gap (1/4" or 6 mm) measured behind insulation on a school enclosure*

The most common problem experienced in the field is airflow passing behind or around layers of insulation. Rarely is this a problem with materials or design: the insulation boards must be butted tight together and be pressed tight to the air barrier behind them on the warm side. Figure 8 is a photograph of a school under construction which was built with a ¼" (6 mm) gap behind the insulation for a significant proportion of the enclosure. This building did not experience in-service problems because the joints were butted tight and the cladding was vented sparingly (it was a vented and drained system).

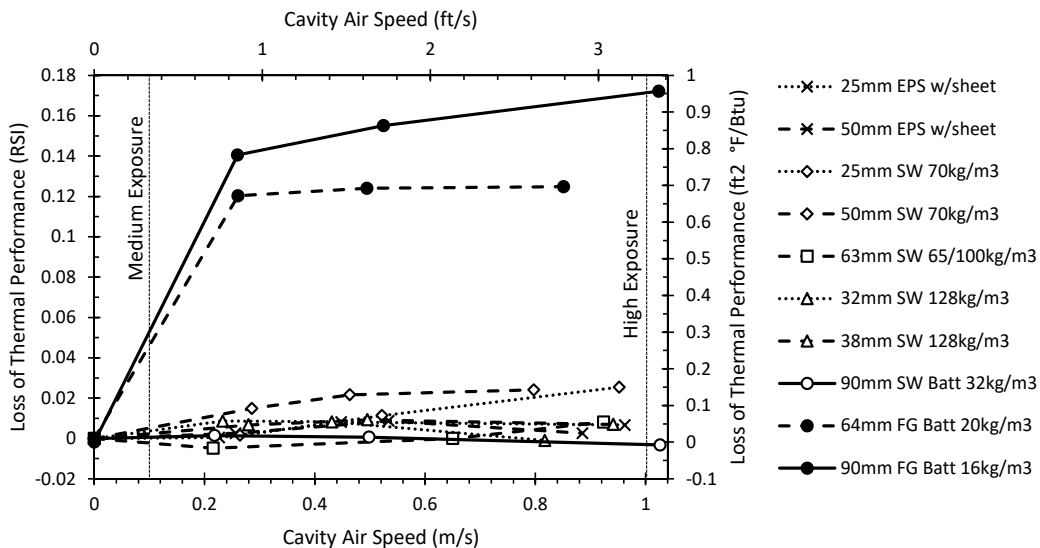
Figure 11: Measured impact of wind washing from laboratory measurements (R-value= RSI\*5.678)

A number of different mineral fiber insulations (both glass fiber and stone wool) with densities from 16 kg/m<sup>3</sup> (1 pcf) to 128 kg/m<sup>3</sup> (8 pcf) were tested. As a comparison an expanded polystyrene (EPS) foam board with an airtight laminated plastic film was tested.

The loss in thermal resistance (in RSI) is plotted for each sample in Figure 11 as a function of air gap air speed between zero and 1 m/s (near the top of the likely range of velocities expected based on the literature review). It can be seen that only the low-density fiberglass batt (FG) products exhibit a measurable impact: about a 5-8% reduction in thermal resistance. The impact on the other stone wool (SW) products is small, close to the range of error of the equipment. Regardless, the reduction is at most RSI0.03 (R-0.2).

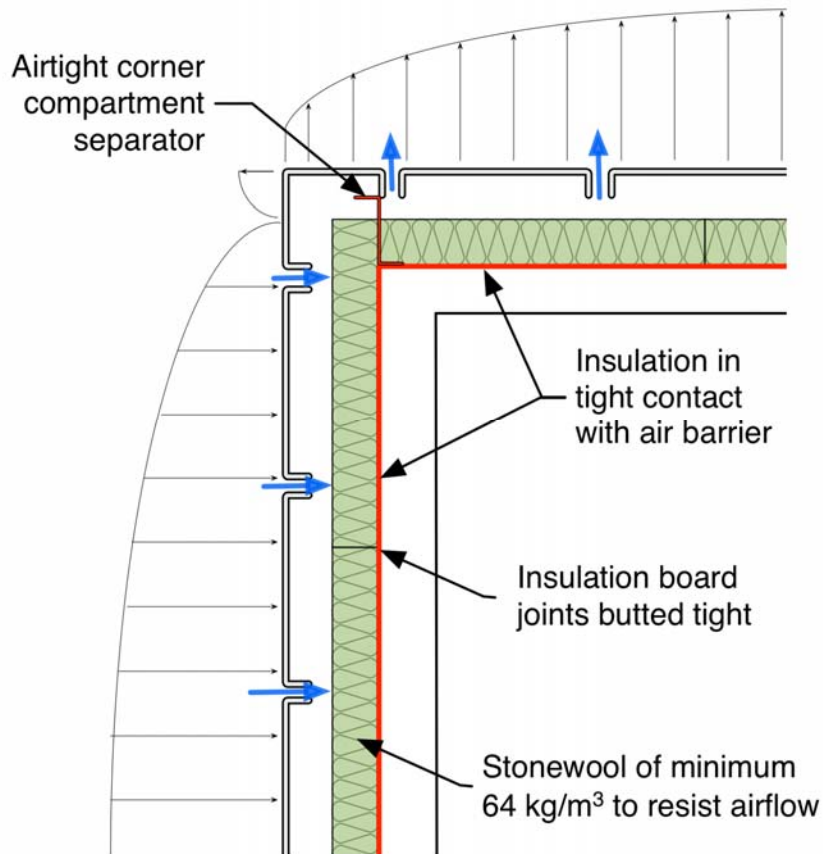
Figure 12: Several strategies to minimize the risk of wind washing are available

The extensive research, spanning many decades, presented above indicates that wind washing can occur, but can also easily be avoided. Poor design choices, inappropriate materials, and bad workmanship can result in poor performance in some situations. Several strategies that can reduce wind washing risk are shown in Figure 12.
