RDH BUILDING SCIENCE LIVE
NOVEMBER 10, 2021

Historic Limestone Masonry Repairs: Intervention for Prevention

Amy Montgomery, MASc, P.Eng.
Associate, Building Science Engineer

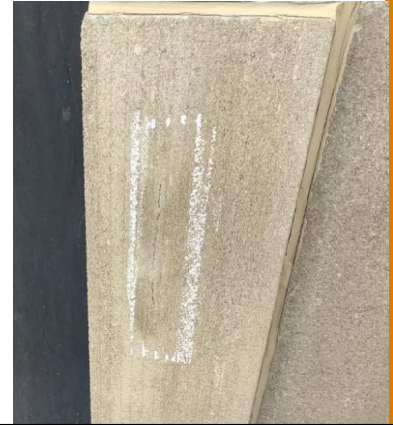
>> **Hot Tip!** Visible weathering can help you identify the orientation of the stone bedding planes

Naturally Bed

Face Bed

Edge Bed

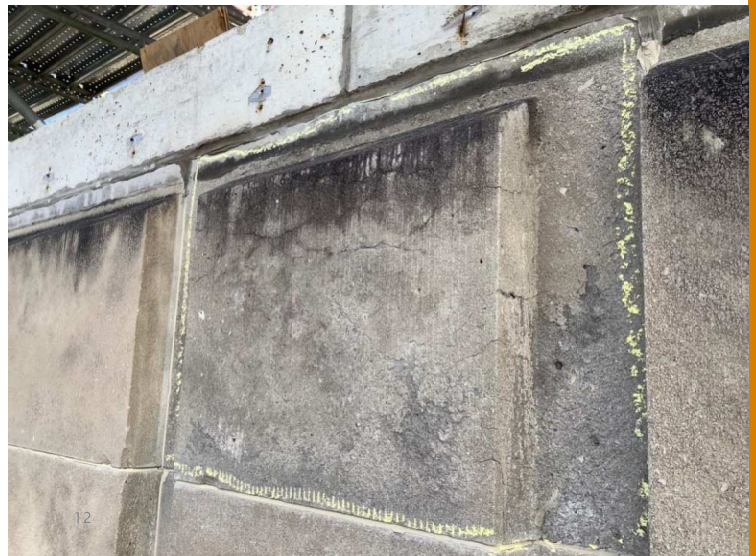
“Enhanced” Wear & Tear

- Higher exposure (e.g., parapet)
- Skyward-facing surfaces
- Receiving runoff from adjacent surfaces

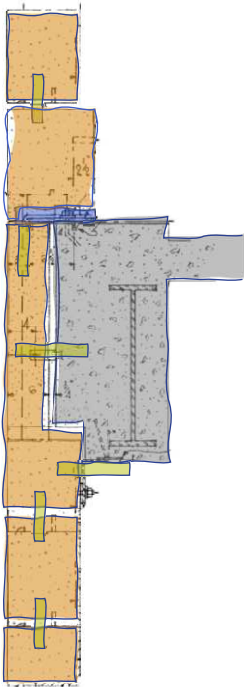
Deterioration at Stone Supports

Assuming limestone as masonry cladding, supported by building structure

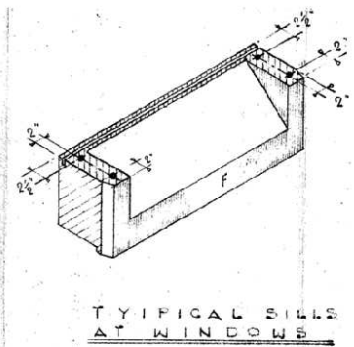
Deterioration at Attached Components

→ Typical culprits: window anchors,
parapet flashing anchors

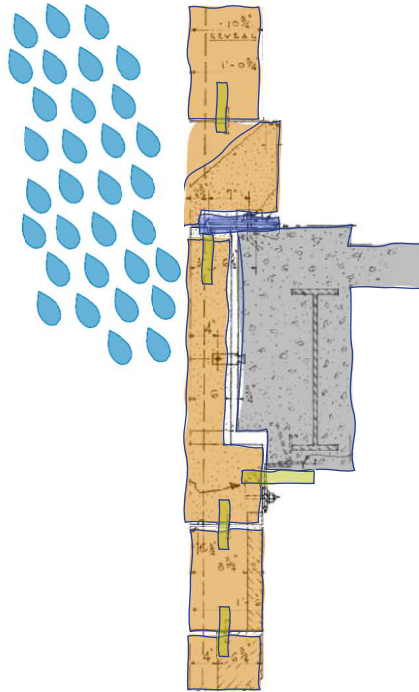
From Inside → Outside

- Stone structural gravity support repairs
- Stone structural lateral anchorage repairs
- Limestone body repairs
- Preventative strategies

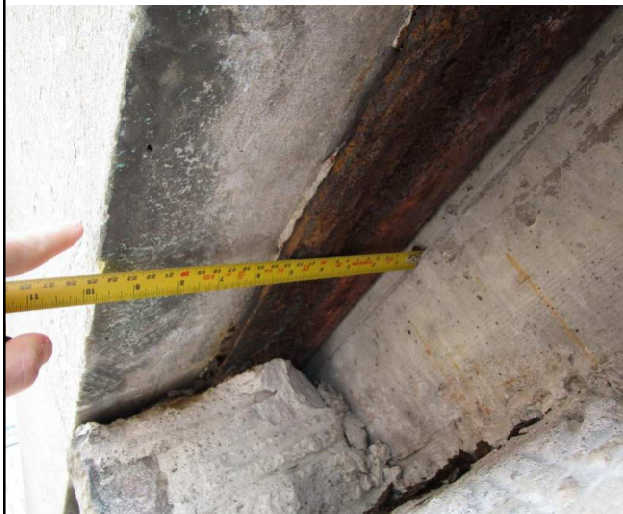
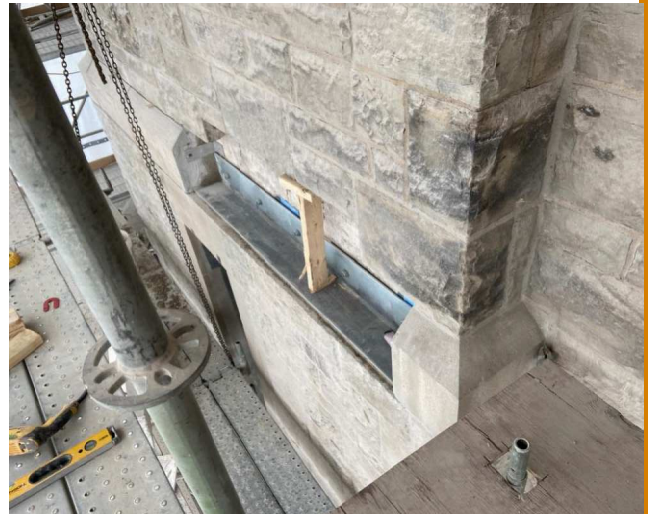
Gravity Support Replacement

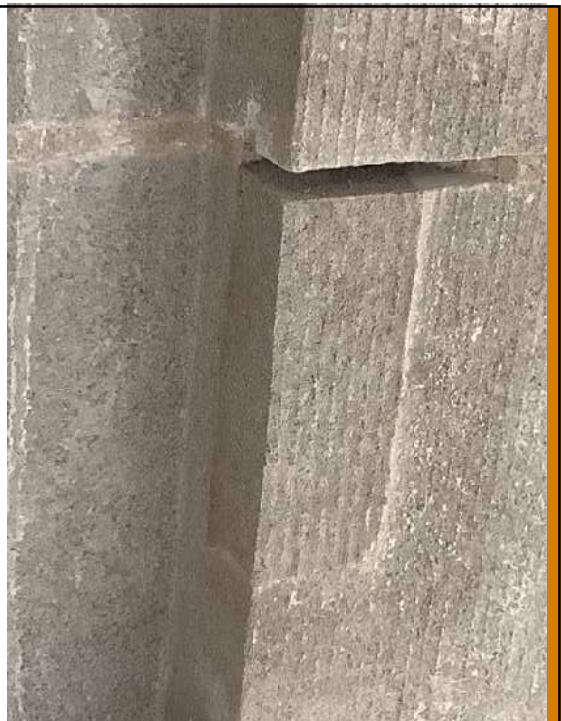
Repair Mortar Patch

Appropriate for:	Not appropriate for:
<ul style="list-style-type: none">• Patching deteriorated or damaged stone that is at risk of holding water• Rebuilding damaged carved stone to recreate the carved detail• Repairs 12-50mm (0.5-2 inch) deep	<ul style="list-style-type: none">• Repairs where continued movement is anticipated• High exposure surfaces such as parapets and sills (skyward facing surfaces)

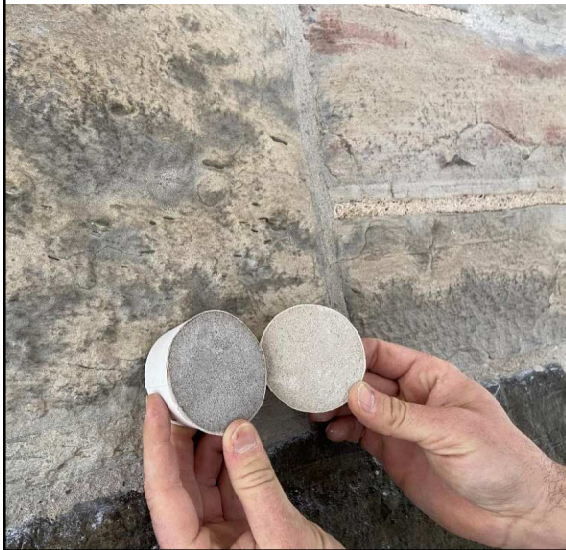
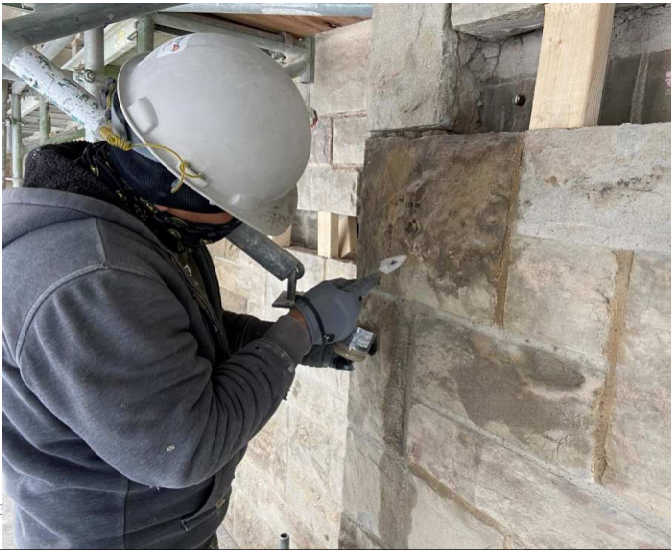
Repair Mortar Patch

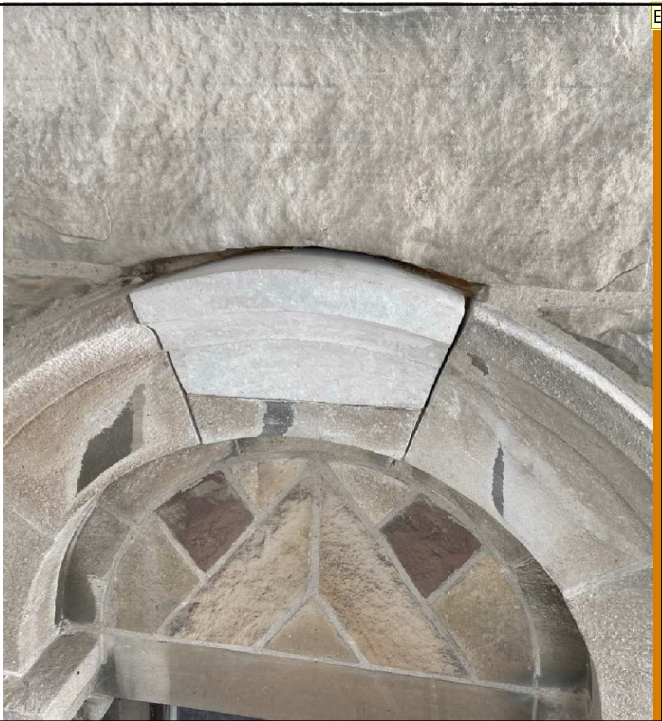
Stone Dutchman

- Limestone shop or site cut to fit the volume of deteriorated stone removed
- Appropriate for larger repair areas and skyward facing surfaces

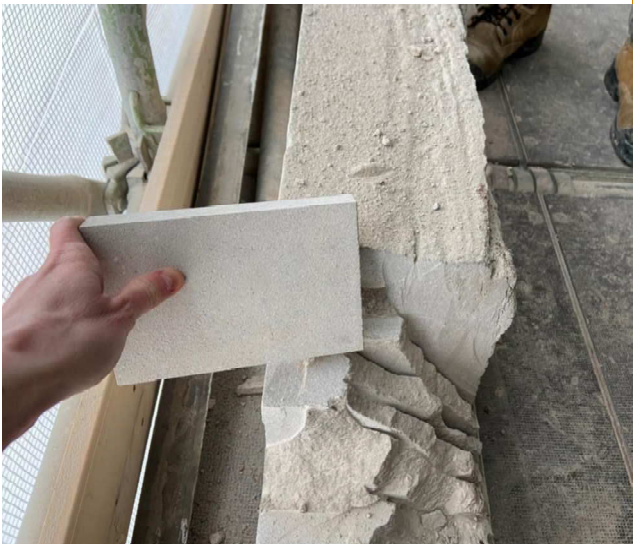
Full Stone Replacement

→ Appropriate where there is extensive and/or significant deterioration, and deteriorated stone is in a high-risk or difficult to access area

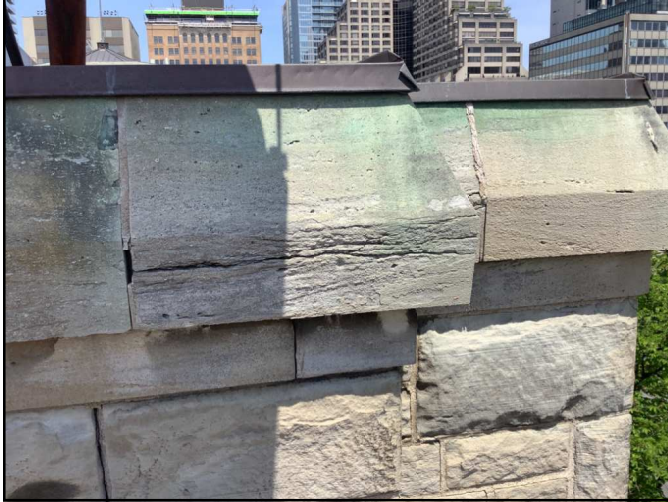
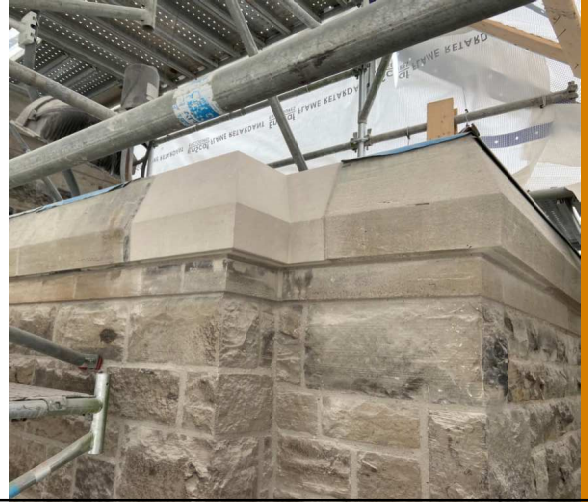
Full Stone Replacement

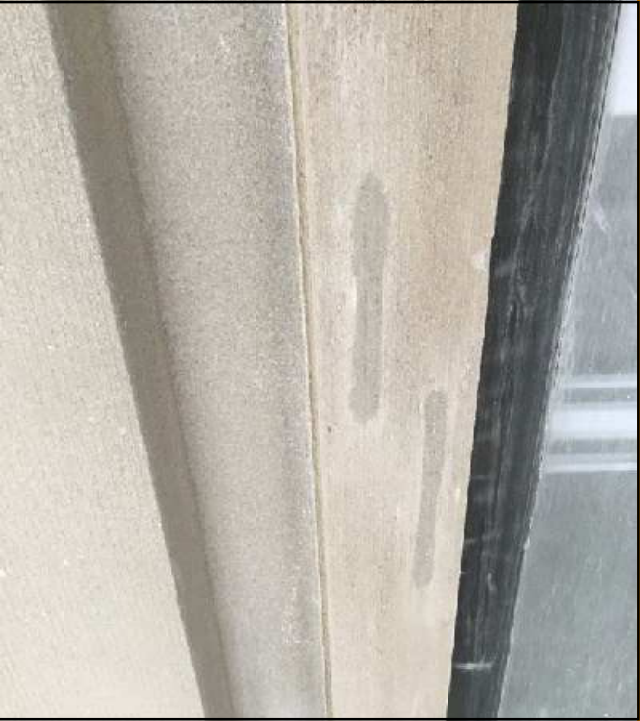
INTERVENTION STRATEGY

- Rout along lines of erosion and fill void with repair mortar
- Rationale is to prevent water entry along lines of existing erosion

- Erosion is occurring along the stone bedding plane of an edge-bed stones at window jambs
- 1960s office tower, 24-storeys
- Climate Zone 6
- Owner's project requirements are for 40-year service life

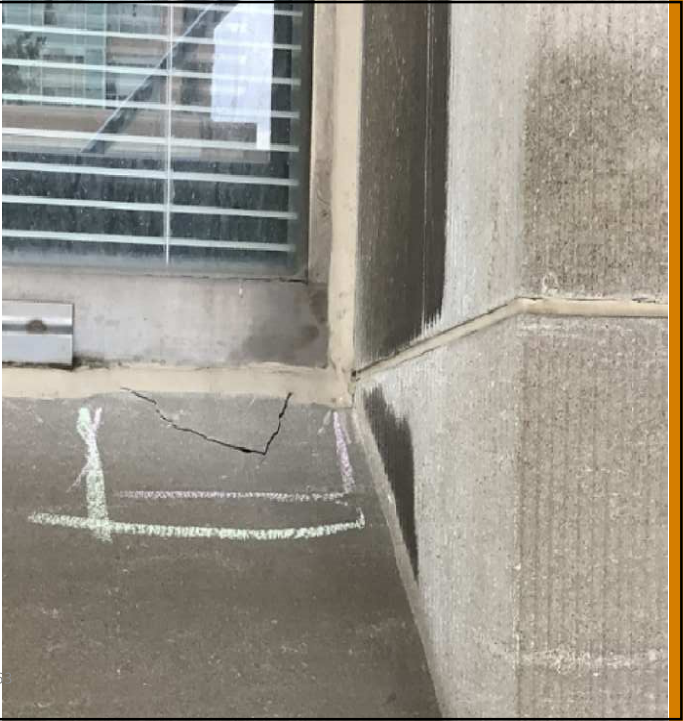
OBSERVATIONS + CONTEXT

- Cracking and spalling at location of existing window anchor
- 25% of window sills affected, concentrated at upper storeys
- Window removal and replacement is included in the project scope; all existing anchors will be removed

- Remove existing anchors
- Localized stone Dutchman repairs
- Anchor new windows with alternate strategy
- Rationale is to have highly durable repair material at openings and skyward-facing surfaces

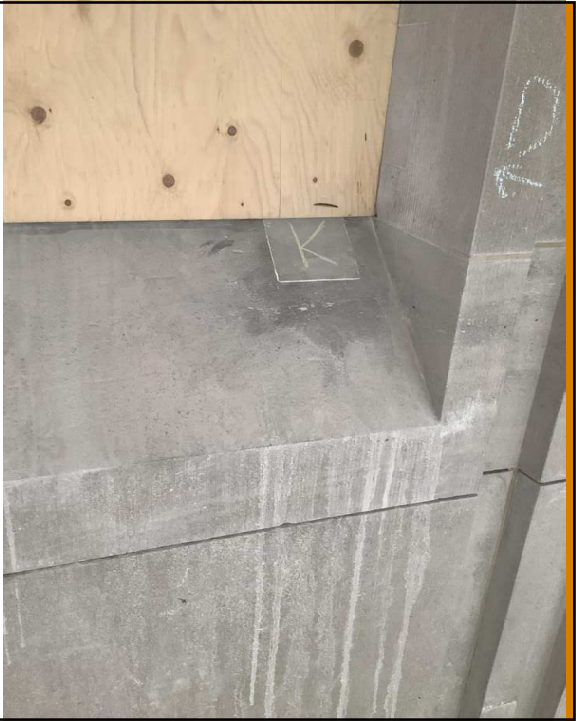
INTERVENTION STRATEGY

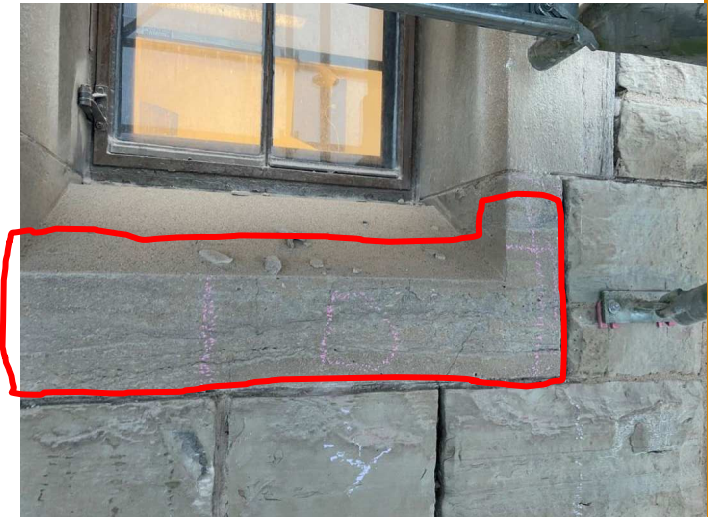
OBSERVATIONS + CONTEXT

- Cut back stone 6-inches
- Deterioration extends further than expected
- Window frame removal not included in the scope
- Adjacent office occupied

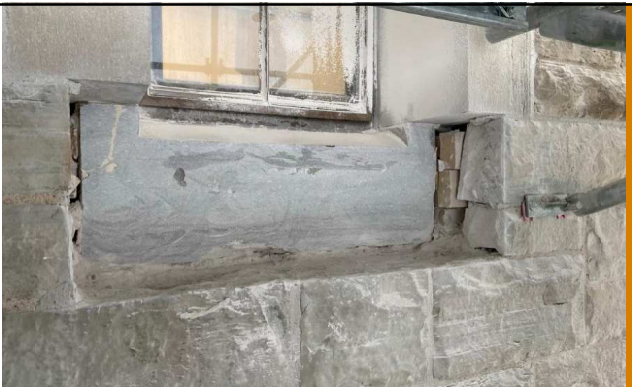
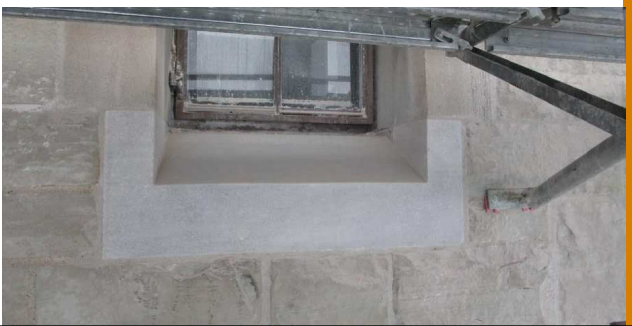
INTERVENTION STRATEGY

- Cut back stone for the full depth of deterioration
- Keep window frame in place
- Install large stone dutchman
- Rationale is to repair the deteriorated stone on this high exposure sill but not disrupt the building operations and the stone surrounding the window frame

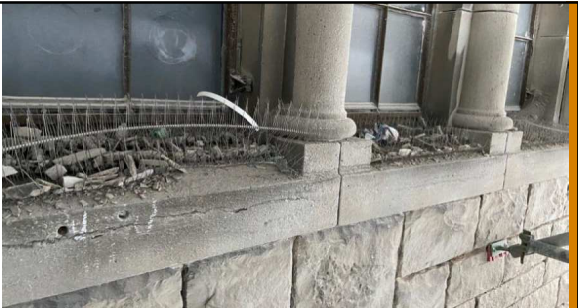
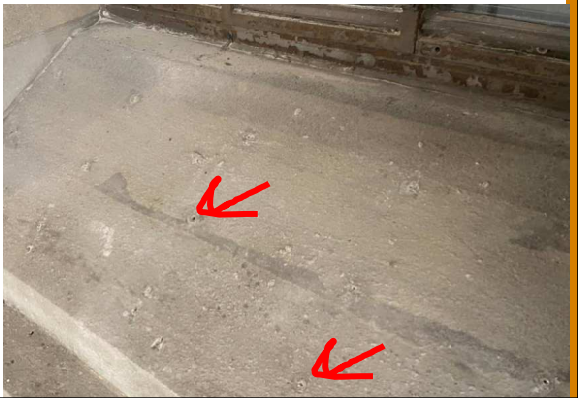
OBSERVATIONS + CONTEXT

- Existing bird spikes were fastened into the stone sills
- The stone sills were exhibiting signs of increased deterioration, including cracking and scaling
- Removal of the bird spikes and fasteners and replacement with an electric bird wire is included in the scope

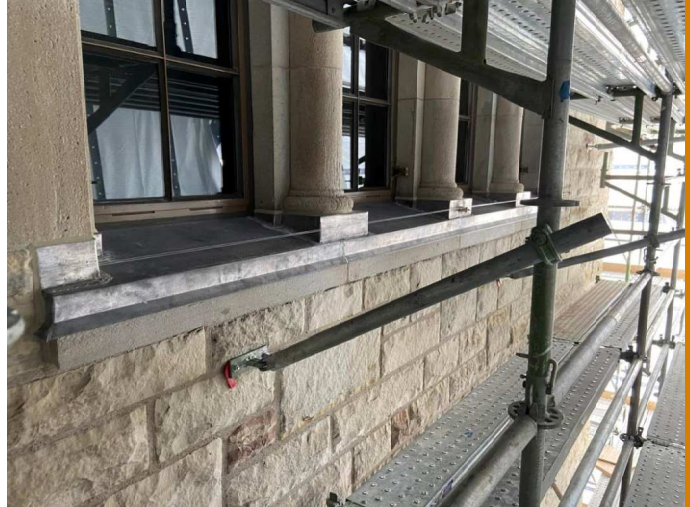
INTERVENTION STRATEGY

- Fill the fastener holes with repair mortar
- Repair the significantly deteriorated stone with a stone dutchman
- Protect the sill surfaces with sheet metal flashing
- Rationale is the stone body is repaired, high exposure surfaces are protected, and the original heritage fabric is retained.

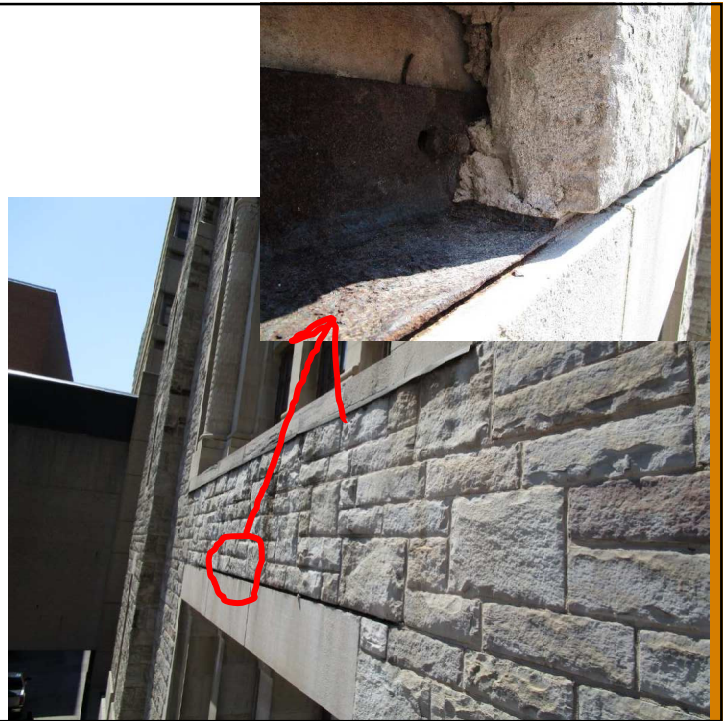
OBSERVATIONS + CONTEXT

- The stone masonry panel is out of plane (bowing)
- From an exploratory opening, the shelf angle below the panel is significantly corroded
- The sheet metal flashing at the window sill above is bent and directing runoff water onto the panel.

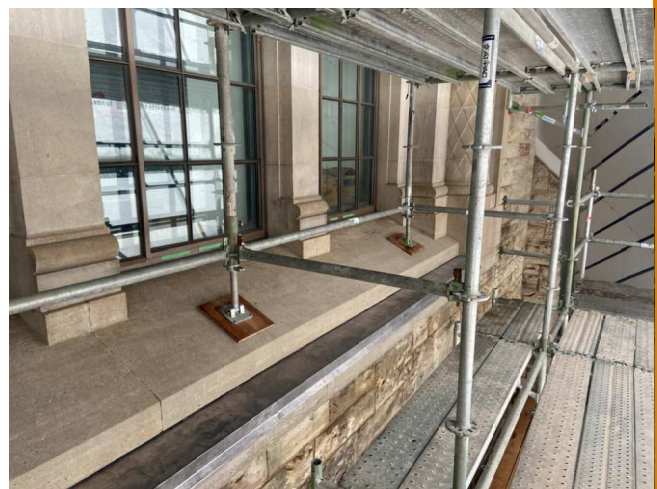
INTERVENTION STRATEGY

- Remove the stone panel
 - Replace the shelf angle
 - Reinstall the stone panel with new lateral anchorage
 - Install new sheet metal flashing with drip edge at top of panel
- Rationale is to reset the stone panel and protect the stone and shelf angle from excess water run off

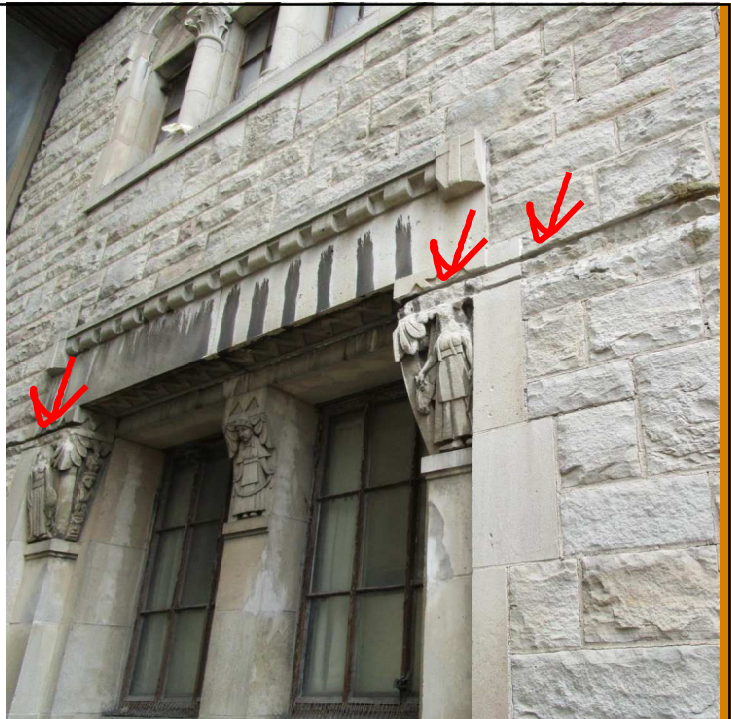
- Stone previously cut to form reglet for canopy
- There is no evidence of increased stone deterioration within the cut area
- The elevation is protected from wind driven rain and is not easily visible from grade

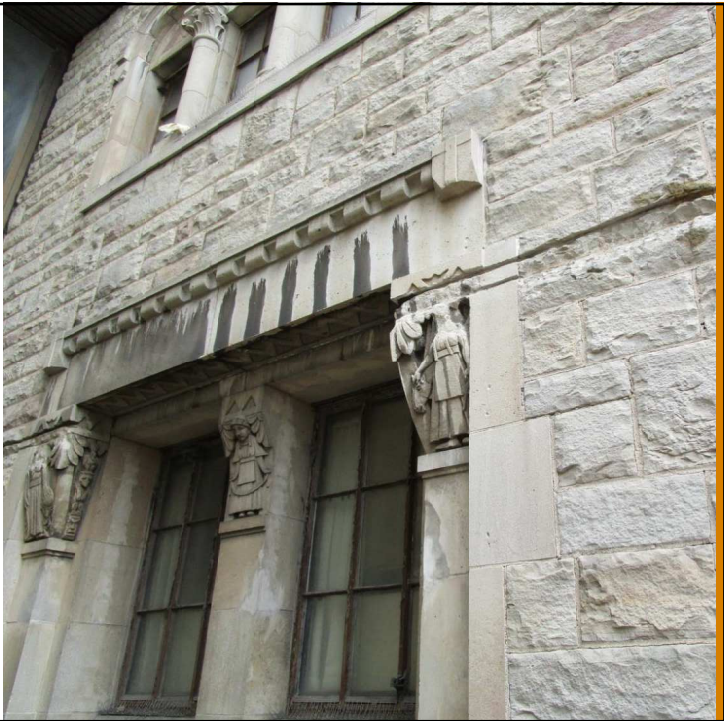
- Do nothing to stone body
- Rationale is that the cut stone surface is not at high risk of holding water and the area has low visibility

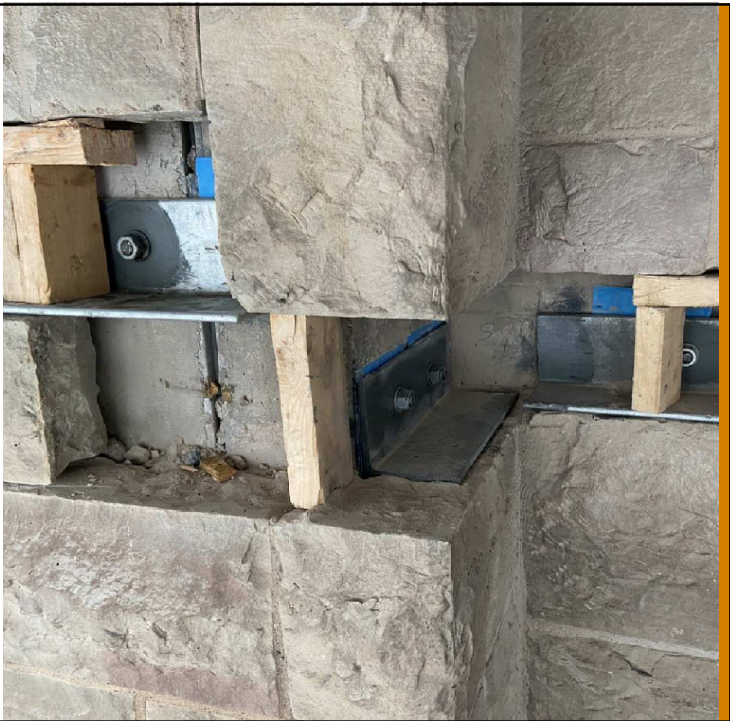
Stone Gravity and Lateral Support

- Gravity support replacement
- Lateral anchorage replacement
- Gravity and lateral support repairs

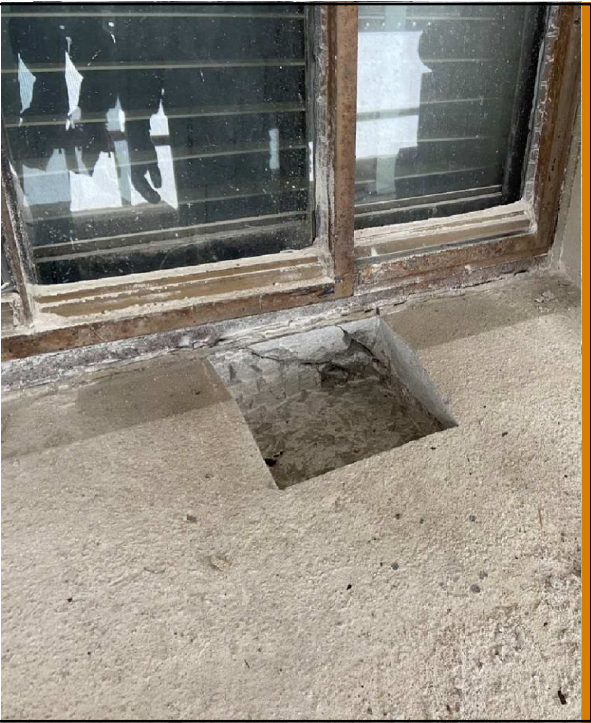
OBSERVATIONS + CONTEXT

- Crack propagating from the existing window frame anchor
- Stone removal completed for a depth of ~3-inch and crack continues
- Remainder of stone is in good condition
- Window frame removal is not included in the scope but corroded window anchor is accessible following window sash removal

- Remove corroded window anchor
 - Pin across crack
 - Install stone dutchman
- Rationale is to remove the source of deterioration, stabilize the stone, and protect the exposed stone surface

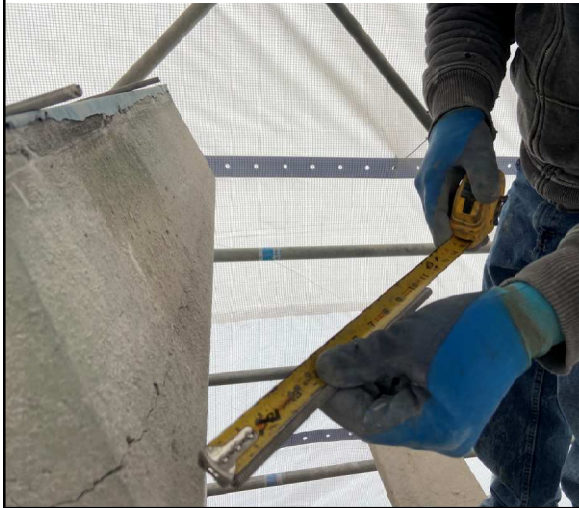
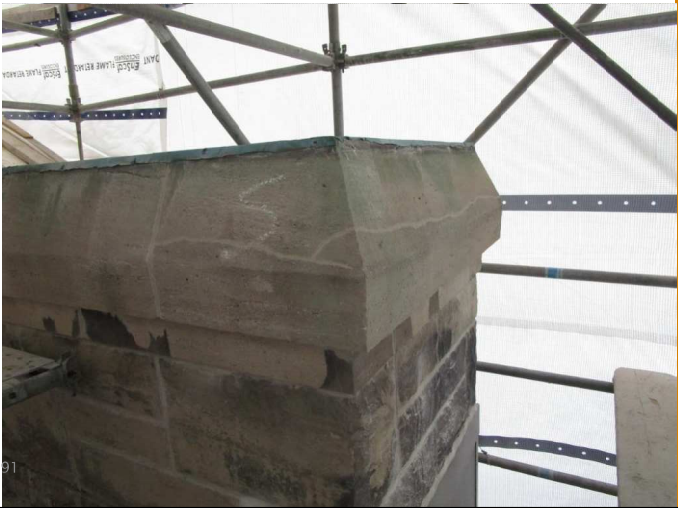
In-Situ Cracked Stone Stitching
