Indoor Environmental Quality of Social Housing Buildings in British Columbia

On behalf of BC Housing, RDH Building Science Inc. conducted a monitoring study to understand the indoor environmental quality (IEQ) of existing multi-unit social housing buildings in the Metro Vancouver area. The study identified trends in monitored temperature, humidity, and carbon dioxide (CO₂) concentrations as well as analyzed the IEQ impact of building retrofits and upgrades.

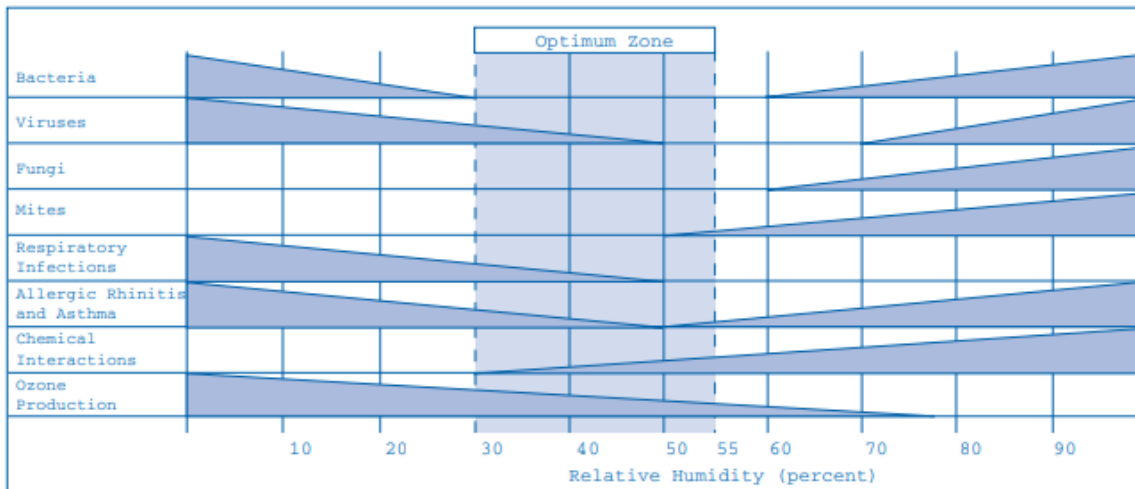
Figure 1.1 – Health range of indoor RH according to Health Canada.

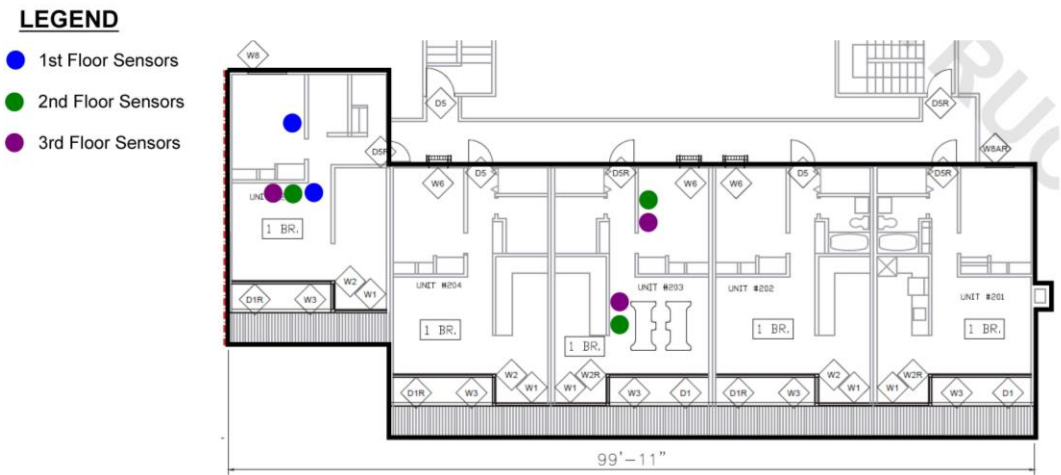
Figure 3.1 – Location of sensor installations at Building A

Five suites of the original proposed six had CO₂ sensors installed during the site visit. The sixth suite did not wish to participate in the study. Additionally, two other suites indicated that they did not want sensors installed in bedrooms. The final sensor locations are shown in *Figure 3.1*. The suites layout is identical on all floors of the building.

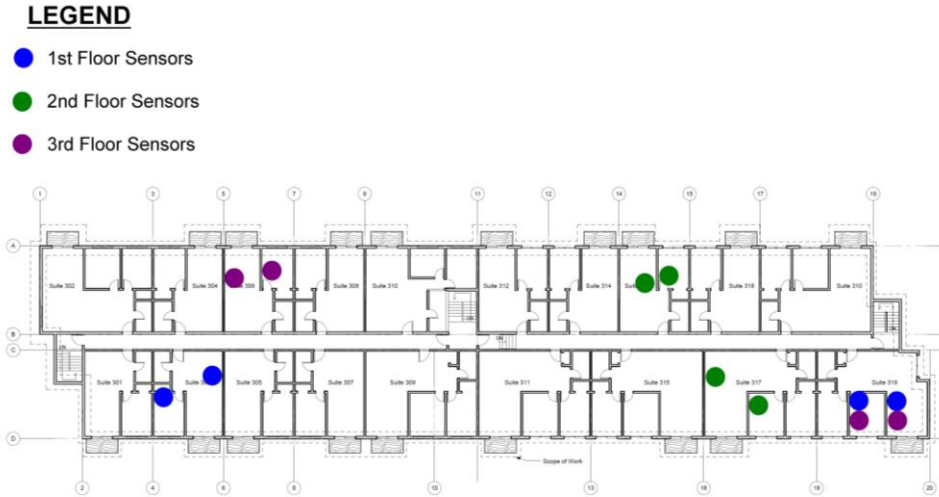
Figure 3.2 – Location of sensor installations at Building B

Two suites on each floor of the building had sensors installed. Two CO₂ sensors were installed in the participating suites. The sensor locations within the building are shown on the floor plan in Figure 3.2. The suites layout is identical on floors one through three.

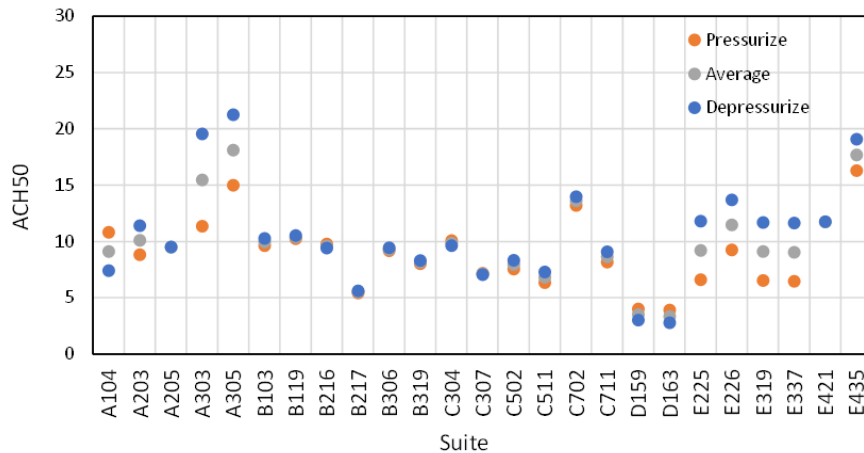
Figure 4.2 – Summary of suite air change rates at 50 Pa (ACH50) from pre-retrofit blower door testing

The suite level airtightness results, expressed as an air change rate at 50 Pa (ACH50) are presented for pre-retrofit and post-retrofit blower door testing, respectively in *Figure 4.2* and *Figure 4.3*.

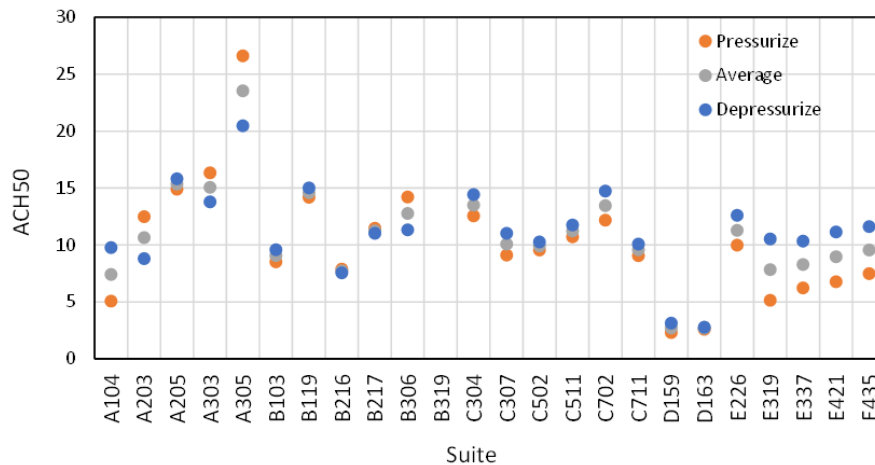
Figure 4.3 – Summary of suite air change rates at 50 Pa (ACH50) from post-retrofit blower door testing

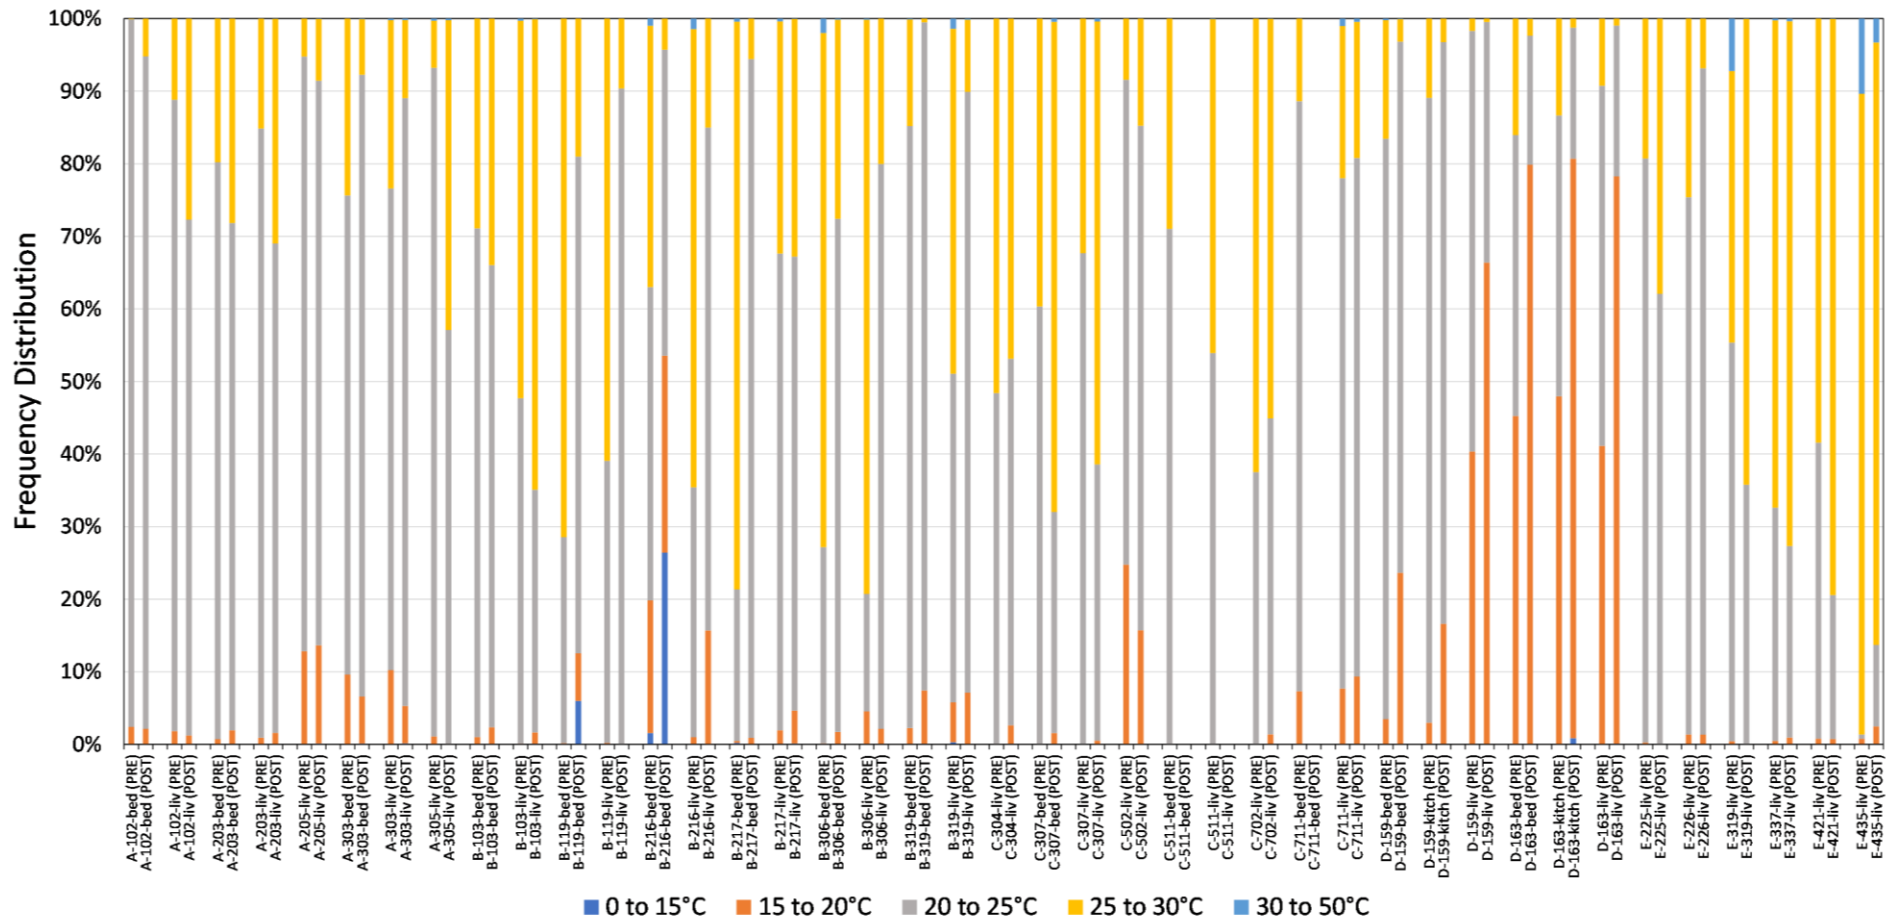
Figure 4.8 – Frequency distribution of air temperature (pre- vs. post-retrofit). Blank columns are the result of no measurements taken during the defined analysis period

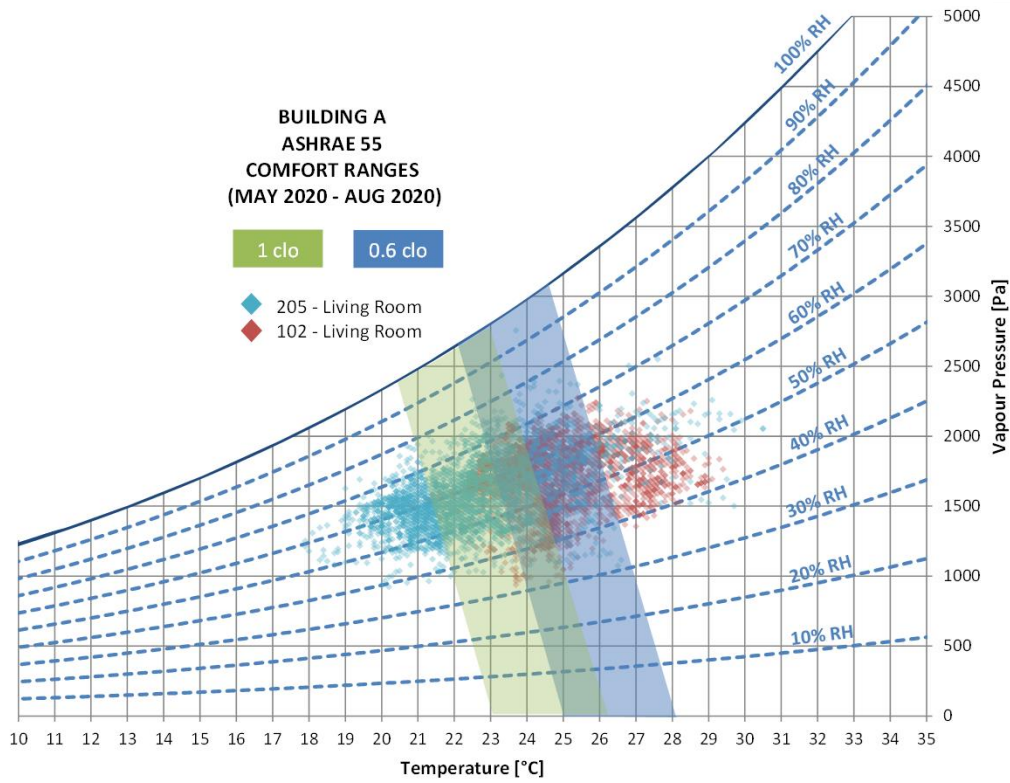
Figure 4.11 - Hourly air temperature measurements of two samples suites from Building A plotted on psychrometric chart (summer)

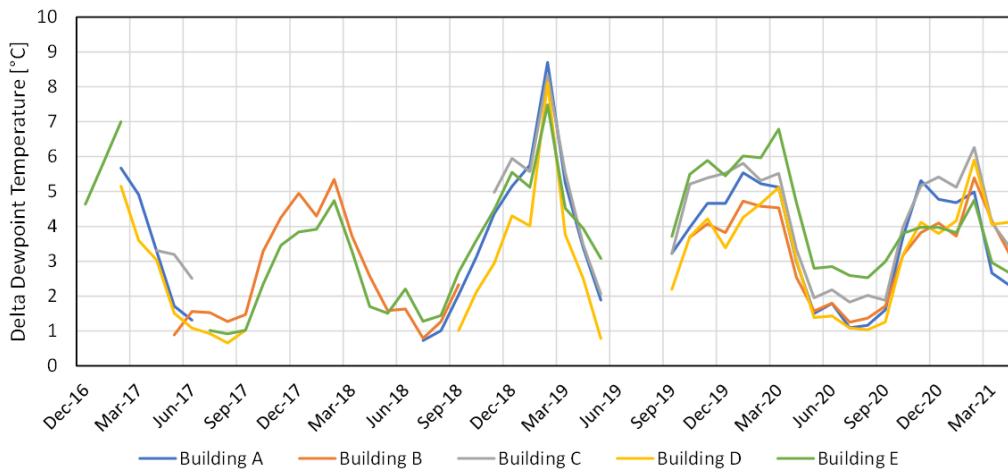
Figure 4.18 – Monthly average delta dew point temperature for each building. Gaps in data are either retrofit periods or missing data.

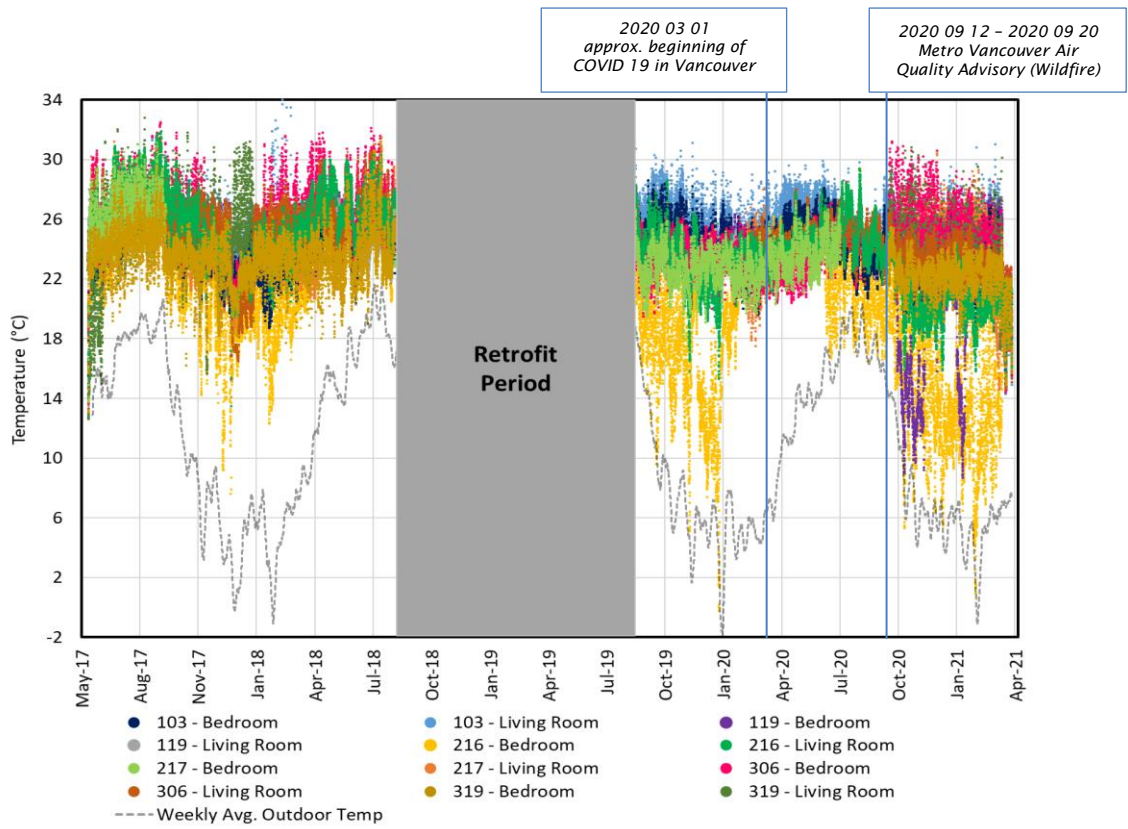
Figure 4.22 – Air temperature measurements throughout monitoring period (Building B)

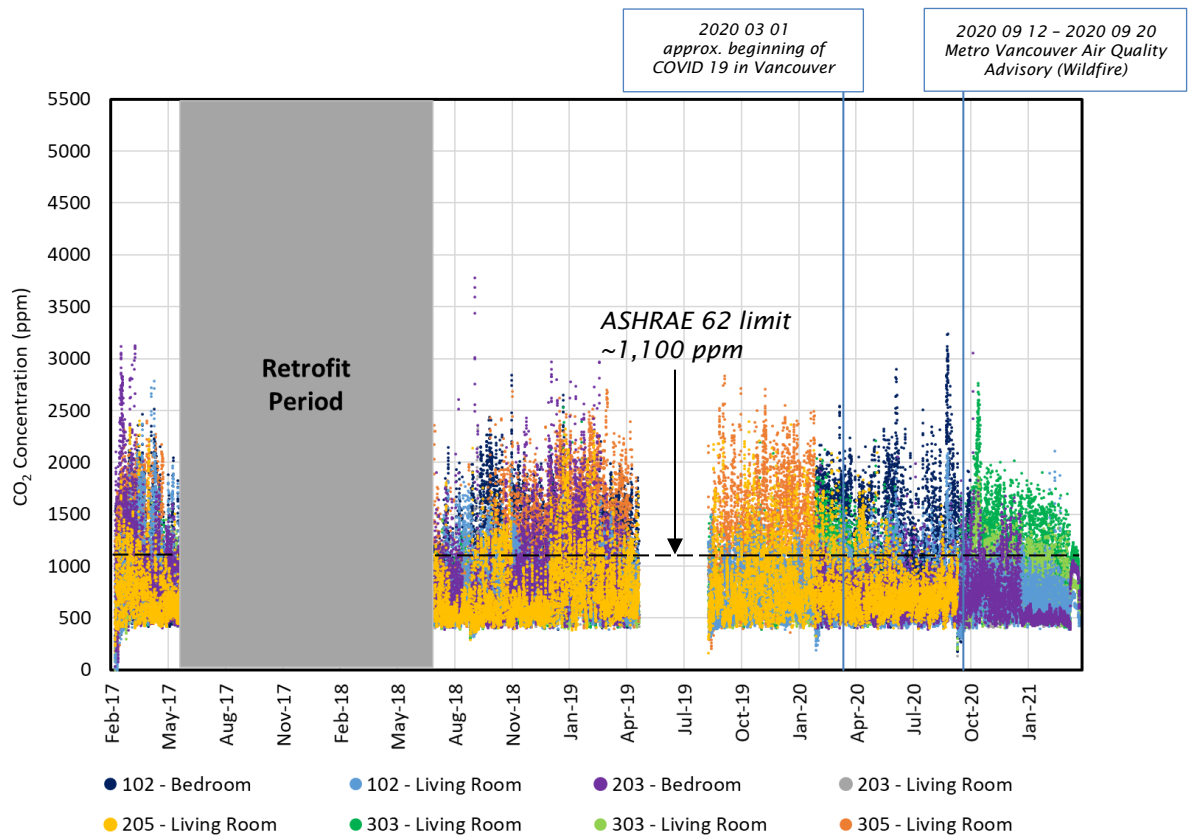
Figure 4.23 – CO₂ concentration measurements throughout monitoring period (Building A)

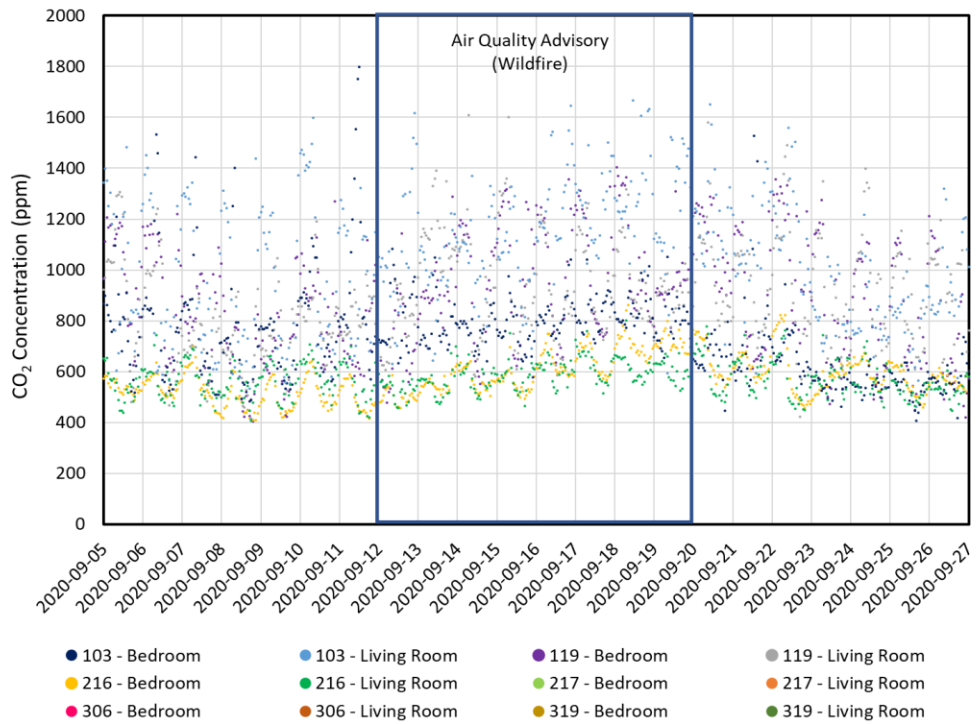
Appendix A.8 – CO₂ concentration one week before, during and after the 2020 wildfire air quality advisory (Building B)

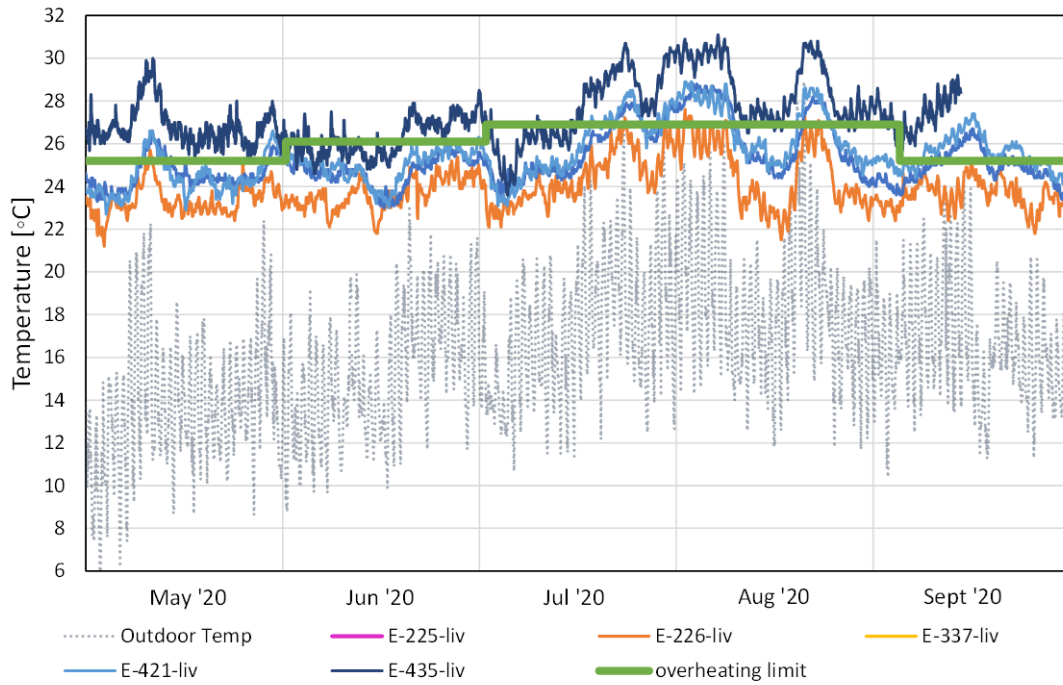
Appendix C.2 – Suite interior air temperature for Building E (2020, post-retrofit) against the summer overheating limit defined by BC Housing Design Guideline and City of Vancouver Energy Modelling Guidelines.

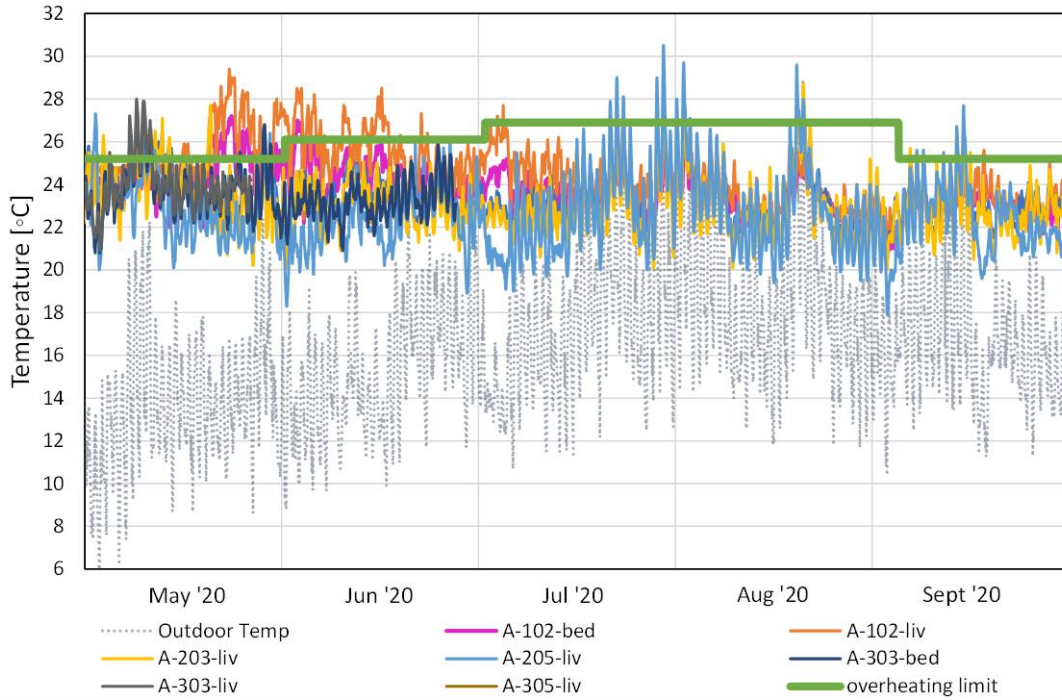
Appendix C.3 – Suite interior air temperature for Building A (2020, post-retrofit) against the summer overheating limit defined by BC Housing Design Guideline and City of Vancouver Energy Modelling Guidelines.

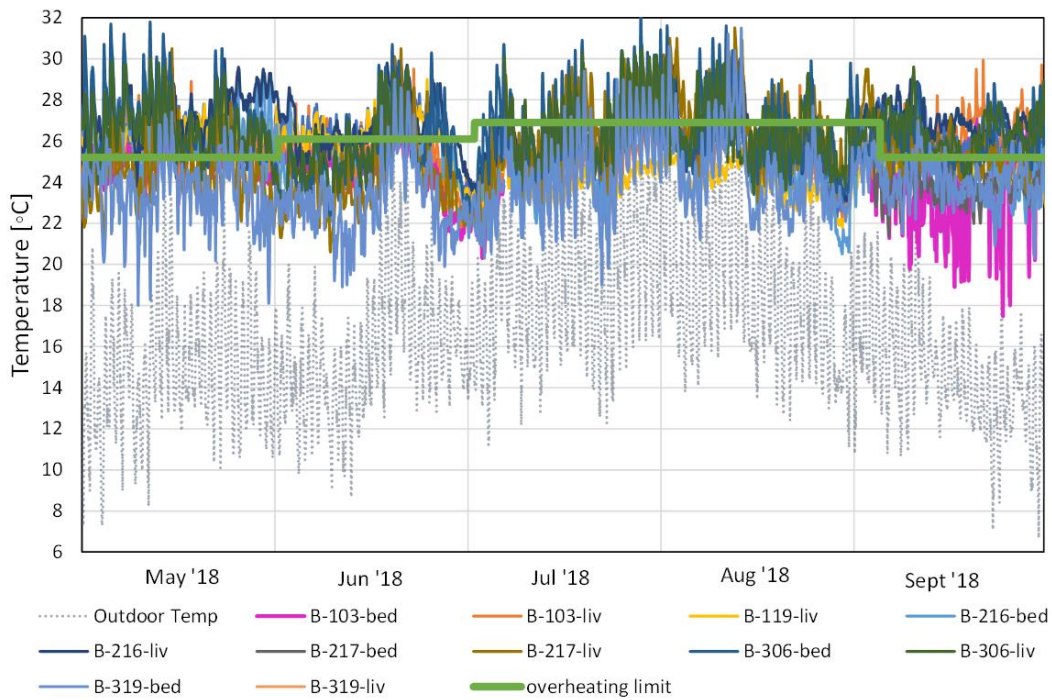
Appendix C.4 – Suite interior air temperature for Building B (2018, pre-retrofit) against the summer overheating limit defined by BC Housing Design Guideline and City of Vancouver Energy Modelling Guidelines.

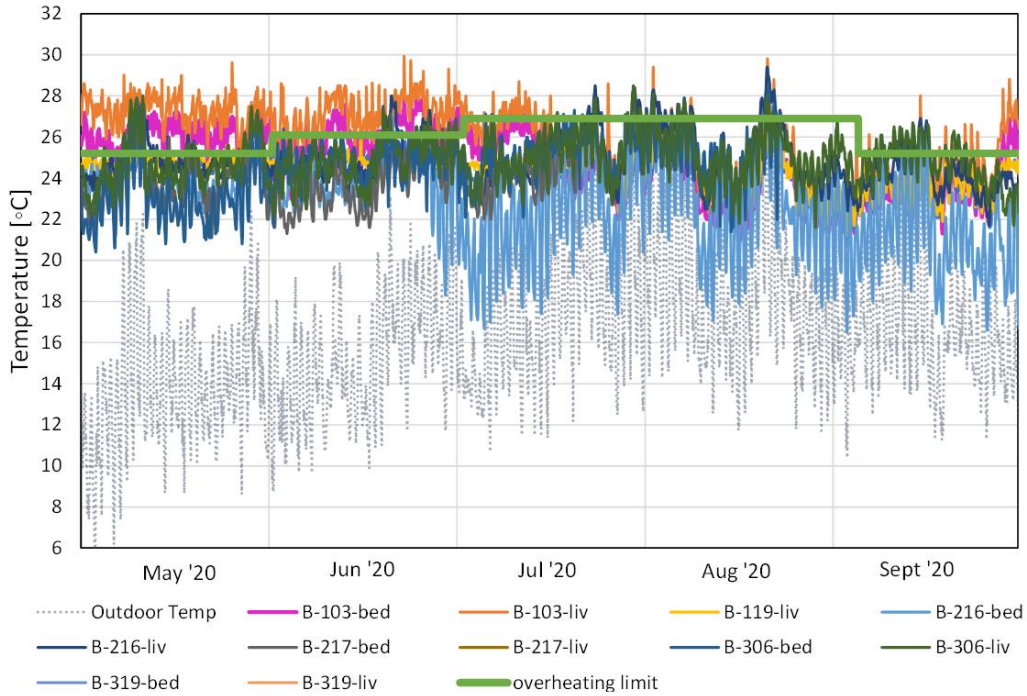
Appendix C.5 – Suite interior air temperature for Building B (2020, post-retrofit) against the summer overheating limit defined by BC Housing Design Guideline and City of Vancouver Energy Modelling Guidelines.

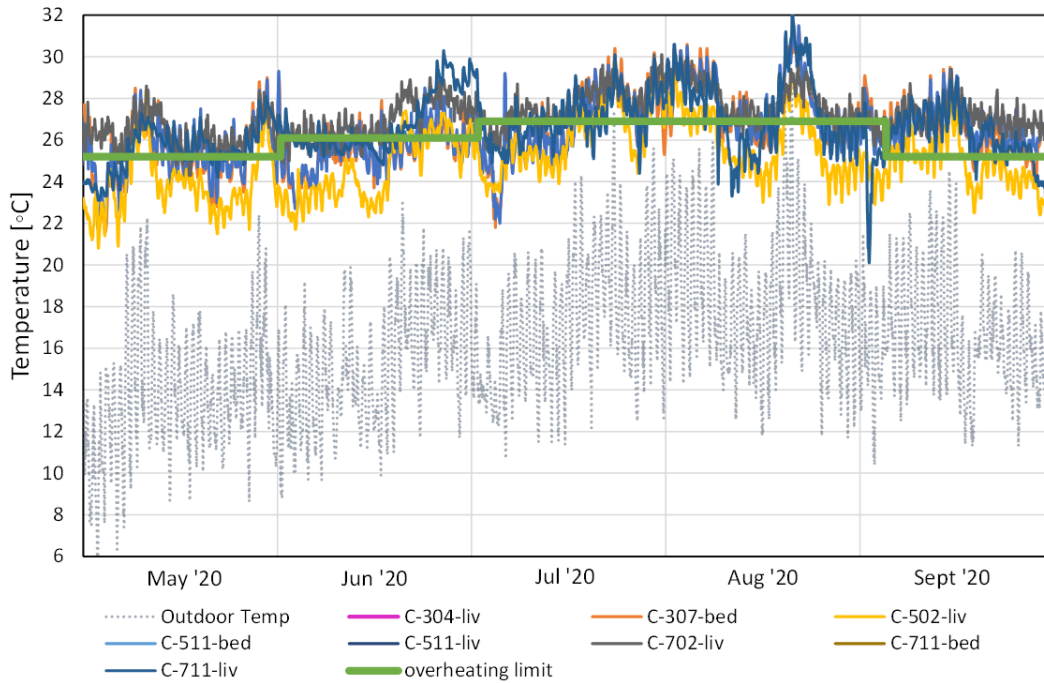
Appendix C.6 – Suite interior air temperature for Building C (2020, post-retrofit) against the summer overheating limit defined by BC Housing Design Guideline and City of Vancouver Energy Modelling Guidelines.

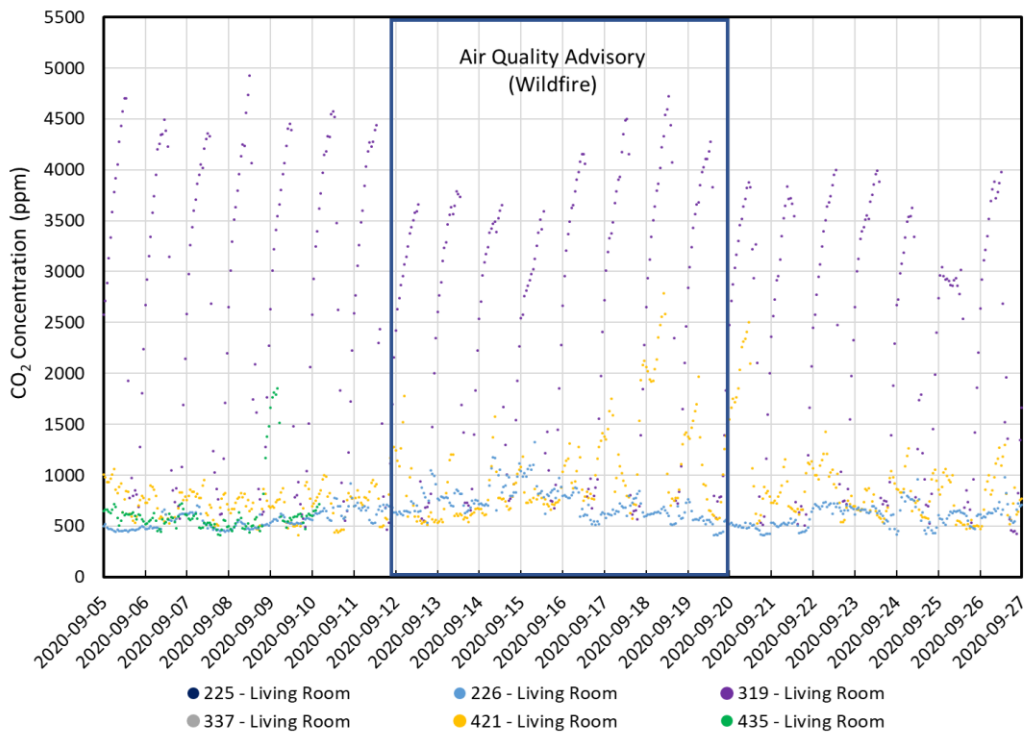
Appendix F.10 – Carbon Dioxide concentrations for three-week period during Air Quality Advisory (Wildfire) for Building E. Note the scale for this graph is significantly higher than the other buildings (3500 vs. 5000 ppm).
