To Ms. Denisa Ionescu  
Homeowner Protection Office  
1701 - 4555 Kingsway  
Burnaby BC V5H 4V8

Submitted March 31, 2022 by  
RDH Building Science Inc.  
4333 Still Creek Drive  
Burnaby, BC V5C 6S6

# Executive Summary

# 0 Introduction

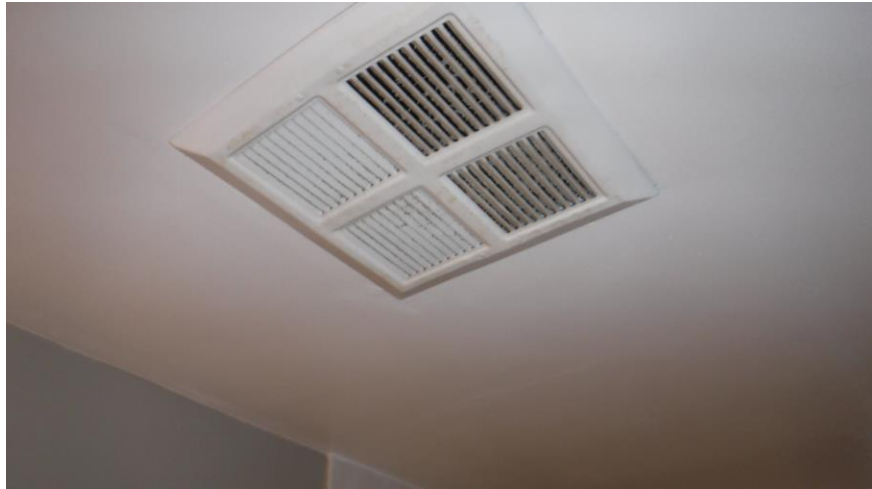
The previous sections primarily focused on how intentionally exhausted air from dryers can cause moisture-related issues within a duct. However, interior air can also leak through an in-slab duct unintentionally due to wind, stack, and mechanically induced pressure differences. To minimize air leakage, airflow dampers are typically provided. Since airflow dampers may not be permitted in all ducts, and vary in effectiveness, investigations of in-slab ducts should also consider air leakage as a potential source of moisture-related issues.

**Figure 1.9:** Bathroom exhaust fan unit. Air from the interior space can enter the exhaust duct due to the combination of wind, stack effect, and mechanical pressures, where it can then cool and condense.

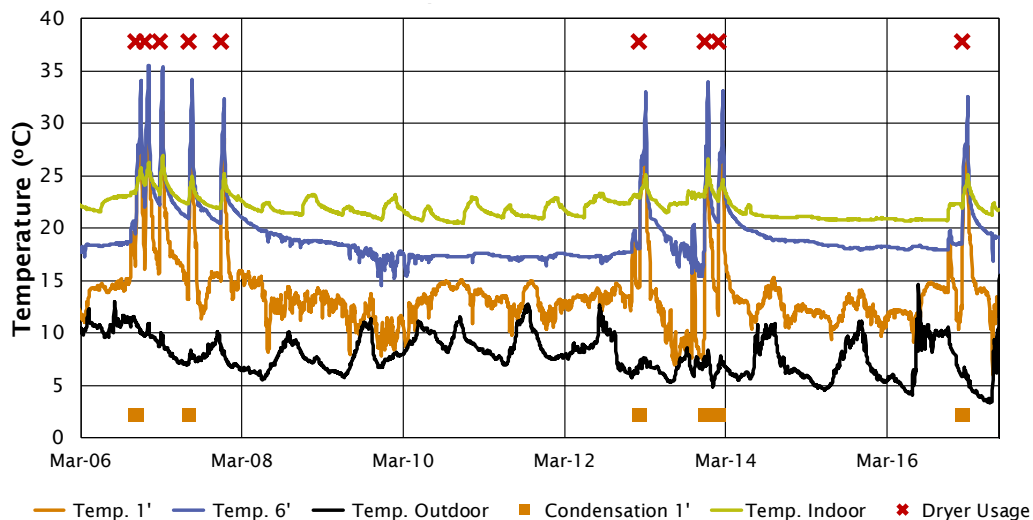
There was no observed moisture buildup at Site A, and in contrast to the other sites there were relatively few periods of predicted condensation. **Figure 2.2** is a graph showing temperature at 1' (0.3m) and 6' (1.8) from the duct outlet. Periods of condensation are shown based on the dew point temperature. When condensation was predicted, the duration was short and coincided with the first 15 minutes of dryer use. Also, condensation was only predicted at the end of the duct (1' or 0.3m from the exterior) and was not measured further within the duct.

**Figure 2.2:** Site A – Graph showing temperature at 1' (0.3 m) and 6' (1.8 m) from the duct outlet. Periods of condensation are shown based on the dew point temperature.

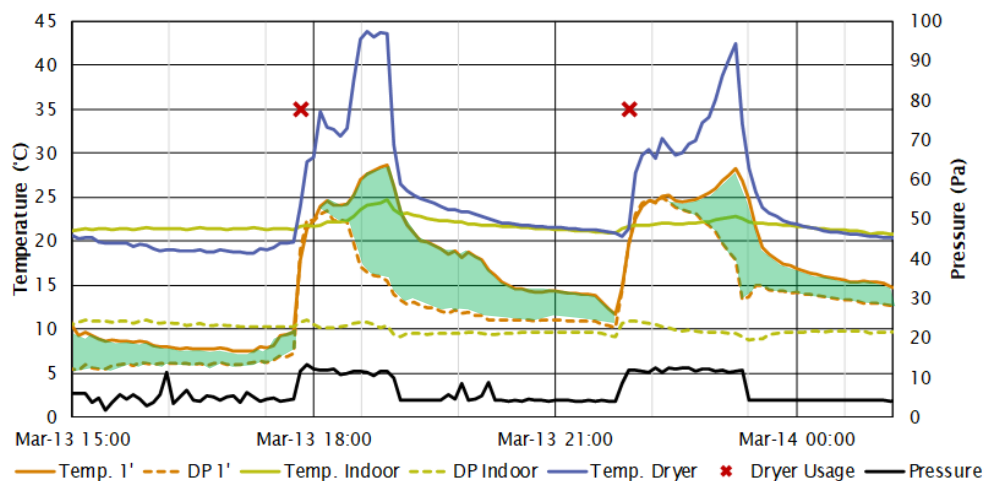
**Figure 2.5** and **Figure 2.6** focus in on typical dryer cycles with and without moisture related issues. At the monitored location with no observable issues (Site A), dryer use coincided with both an increase in pressure and an increase in temperature at the dryer exhaust and within the duct. In each case, the wetting period was followed by a longer period of drying as the cycle continued. The green shaded area in **Figure 2.5** shows the drying period. This pattern of brief wetting followed by an extended period of drying is what would be anticipated from a dryer with no moisture issues.

**Figure 2.5:** Site A - Graph air and dew point temperatures over the course of two dryer cycles. Green area designates when duct temperature is above dew point temperature.

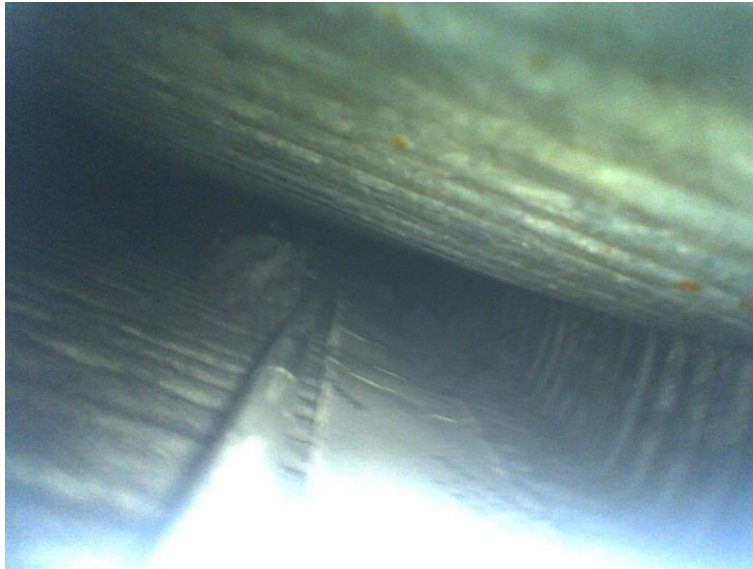
Two-bedroom apartment with no observable moisture issues. Building was constructed in 2006. The dryer exhaust vents under a soffit.

*Figure A.1: Photo of the dryer exhaust duct at site A taken during sensor installation.*

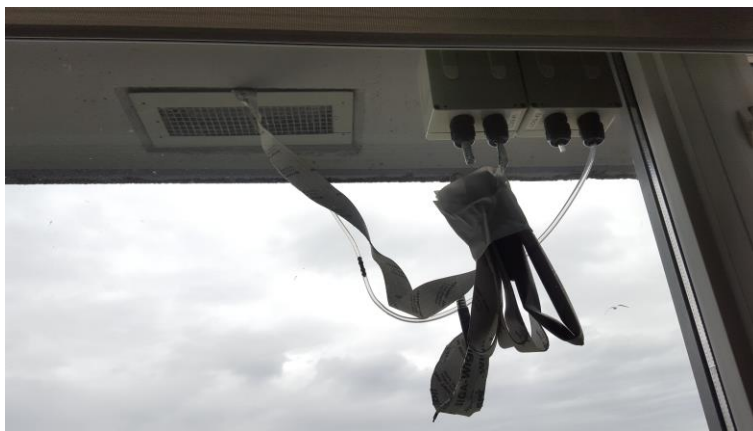
*Figure A.2: Photo of the sensor installation at Site A. Dryer exhaust vents under a soffit.*

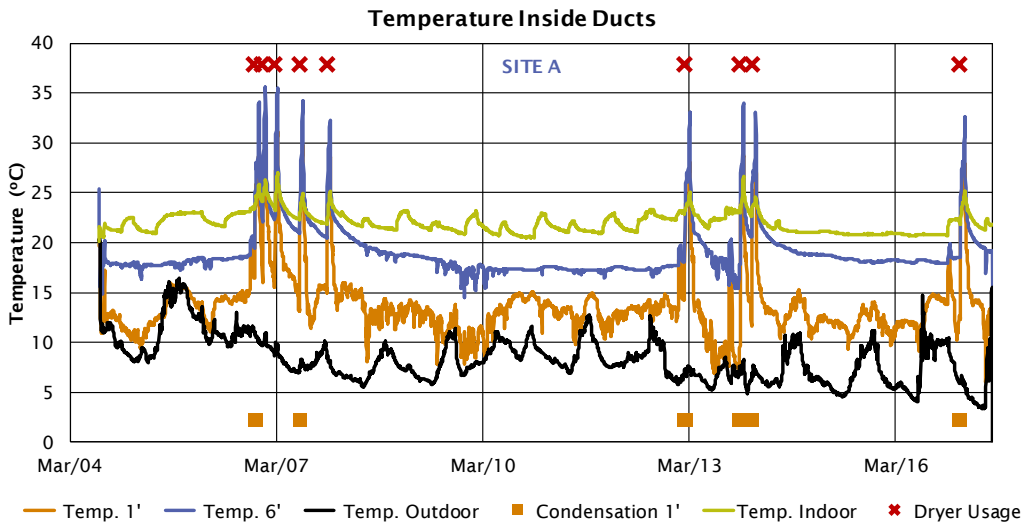
**Figure A.3:** Graph showing air temperature and periods of predicted condensation 1' (0.3 m) and 6' (1.8 m) from the exterior of the duct as well as the outdoor air temperature and duct pressure. Dryer usage, and periods of predicted condensation are also shown.

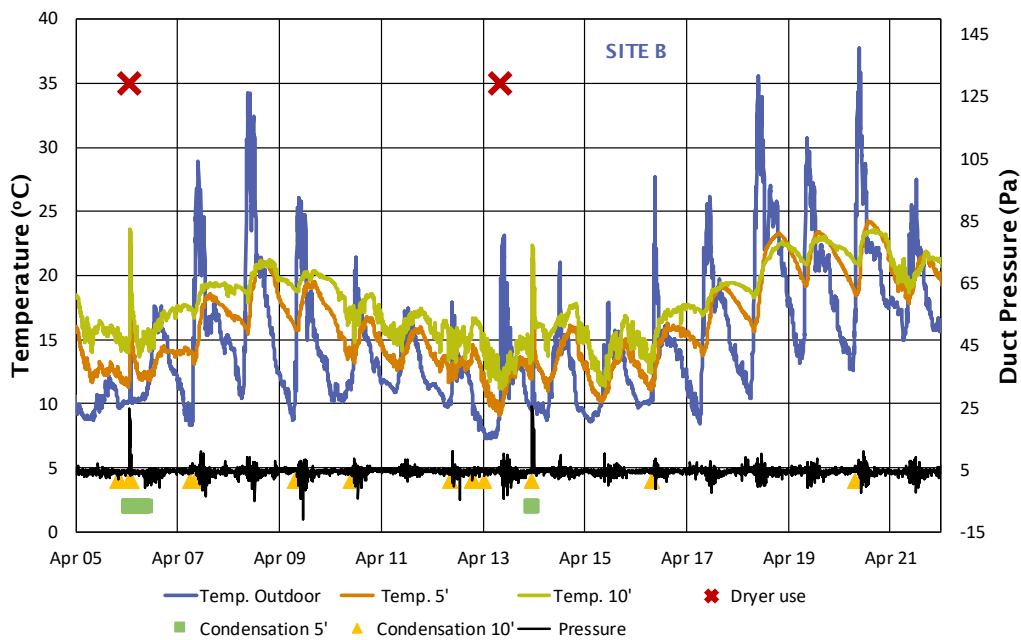
**Figure A.8:** Graph showing air temperature and periods of predicted condensation 5' (1.5 m) and 10' (3 m) from the exterior of the duct as well as the outdoor air temperature and duct pressure. Dryer usage, and periods of predicted condensation are also shown.

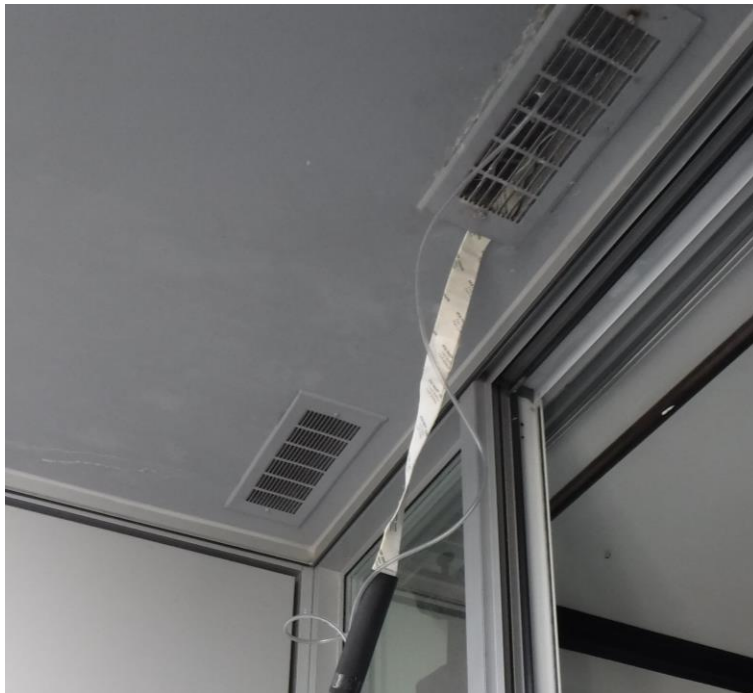
*Figure A.11: Photo of the sensor installation at Site C. Dryer exhaust vents under the exposed concrete balcony of the unit above.*

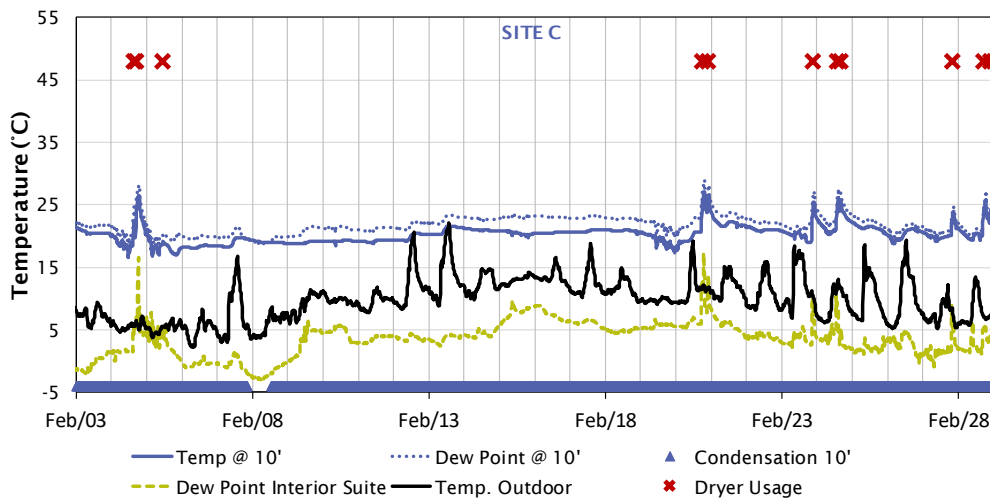
**Figure A.12:** Graph showing temperature and periods of predicted condensation 10' (3 m) from the exterior of the duct. Dryer usage events are also shown.
