# Indoor Environmental Quality of Social Housing Buildings in British Columbia

RDH Building Science Inc. conducted a monitoring study for BC Housing with the goal of understanding the indoor environmental quality (IEQ) of existing multi-unit social housing buildings in the Metro Vancouver area. The project objectives included identifying trends in the monitored temperature, humidity, and carbon dioxide (CO<sub>2</sub>) concentrations as well as analysing the IEQ impact of building retrofits and upgrades.

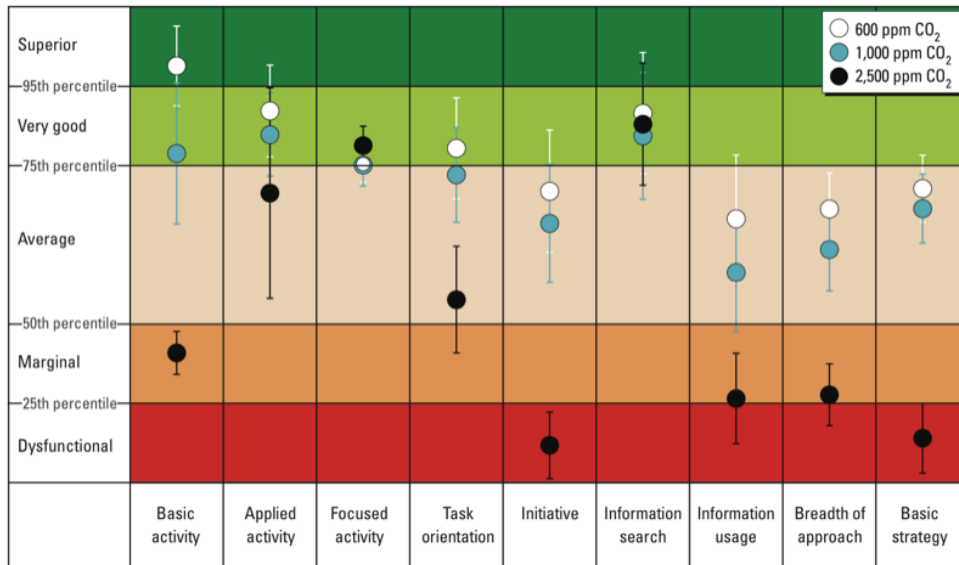
Figure 1.2 – Cognitive function test results for variations in CO<sub>2</sub> exposure (from Satish et al. 2012).

Despite the observed relationships between CO<sub>2</sub> exposure and cognitive performance, the design and operation of many of our buildings expose occupants to elevated CO<sub>2</sub> levels. Numerous indoor CO<sub>2</sub> studies have documented concentrations in excess of 1,000 ppm in schools, daycares, offices, and homes with potentially significant impacts on human performance.<sup>17,18,19,20</sup>

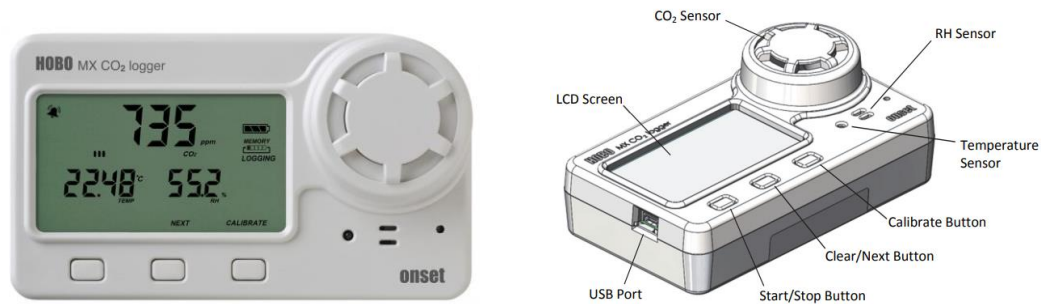
Figure 2.1 – HOBO MX1102 sensors for measuring ambient air temperature, RH and CO<sub>2</sub>.

Monitoring equipment was installed to monitor environmental conditions within each suite. The sensors used were Onset's HOBO MX1102 sensors.<sup>23</sup> These sensors collect measurements of the ambient air temperature, the RH and the CO<sub>2</sub> concentrations at a 15-minute interval. The sensor is shown in Figure 2.1. Outdoor weather data from a local weather station was used for analytical purposes. To avoid skewing the results, sensor locations were carefully chosen to minimize impact of localized variations in the suite, such as proximity to local heat sources or direct exposure to solar radiation.

<sup>23</sup> Carbon dioxide measurement accuracy is  $\pm 50$  ppm  $\pm 5\%$  of reading at 25°C (77°F), less than 70% RH and 1,013 mbar. Temperature measurement accuracy is  $\pm 0.21$ °C from 0° to 50°C ( $\pm 0.38$ °F from 32° to 122°F). RH reading accuracy is  $\pm 2.5\%$  from 10% to 90% RH (typical), to a maximum of  $\pm 3.5\%$ .

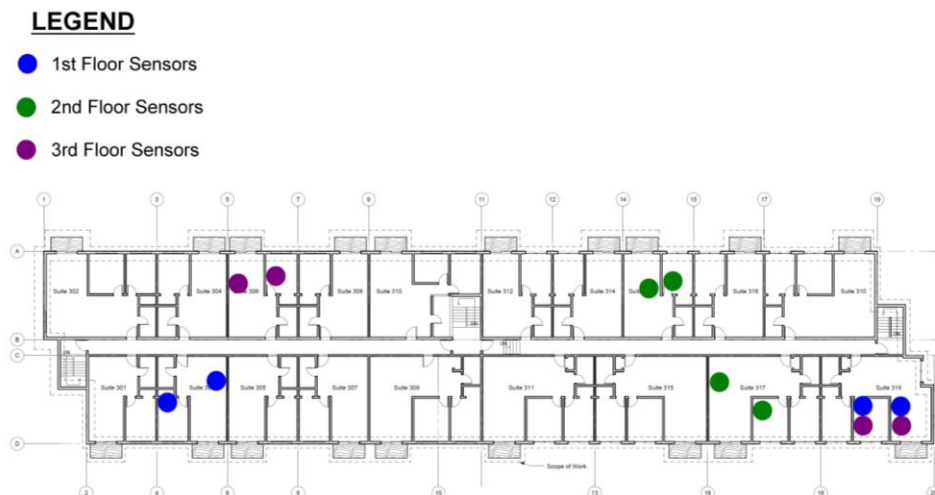
Figure 3.2 – Location of sensor installations at Building B

Two suites on each floor of the building had sensors installed. Two CO<sub>2</sub> sensors were installed in the participating suites. The sensor locations within the building are shown on the floor plan in Figure 3.2. The suites layout is identical on floors one through three.

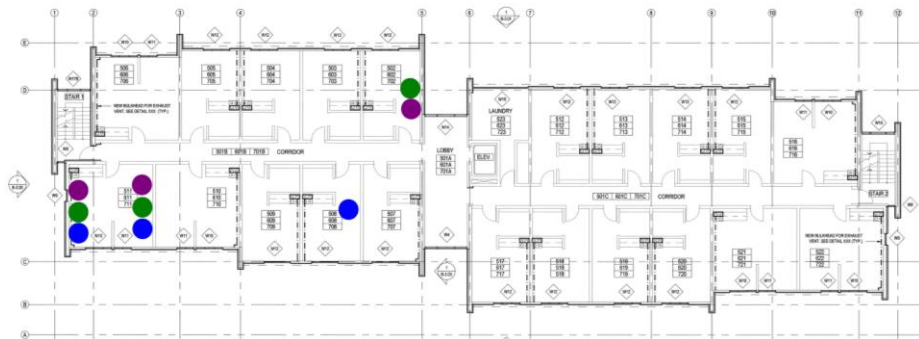
Figure 3.3 – Location of sensor installations at Building C

Six suites, one SRO and a one-bedroom unit on each of levels 3, 5, and 7, agreed to participate in the study. One CO<sub>2</sub> sensor was installed in each of the three SRO units and two sensors in each of the one-bedroom units along with an additional sensor in the 5<sup>th</sup> floor corridor to capture common air background conditions. The sensor locations within the building are shown on the floor plan in Figure 3.3. The suites layout is identical on level 3 to level 7.

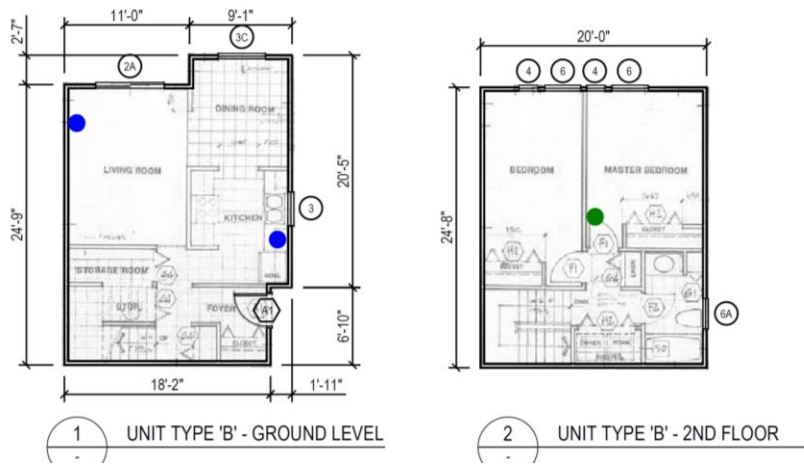
Figure 3.4 – Location of sensor installations at the Building D

Two units in the townhouse complex agreed to participate in the study. The townhouses were significantly larger than the suites at the other locations in the study and therefore warranted additional sensor coverage to determine a proper distribution. Three CO<sub>2</sub> sensors was installed in each of the suites to capture conditions in the living room, the bedroom and the kitchen. Locations of the sensors are indicated in Figure 3.4.

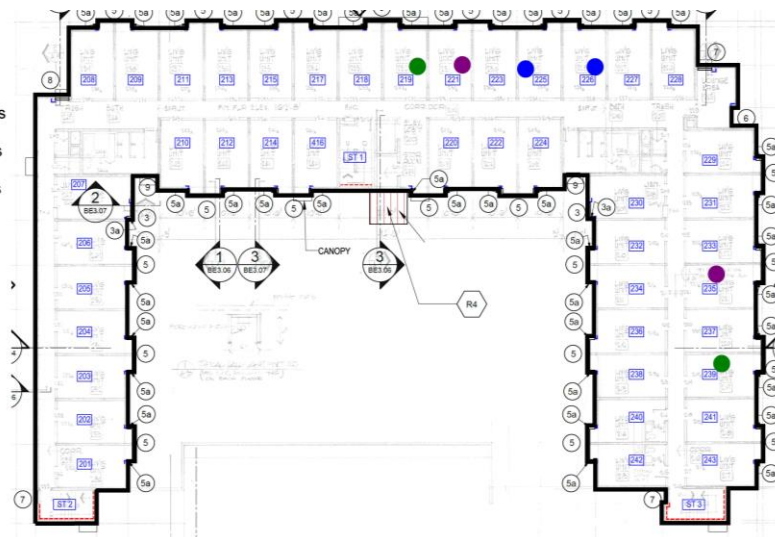
Figure 3.5 – Location of sensor installations at Building E

Building E is a four-storey concrete low-rise apartment. The building consists of two wings (West and East) off a central corridor (North). All suites in the building are SRO containing a living/sleeping area and a washroom. The building ventilation is provided by a rooftop make-up air unit that supplies in to the North and East wings and exhausts from the West wing. The suites do not have direct ventilation but are equipped with intermittent exhaust fans in the washroom. The building renewal included replacement of the windows in suites and common areas, replacement of exterior doors, sealing of bricks and a partial cladding replacement. One CO<sub>2</sub> sensor was installed in each of the six suites. The sensor locations within the building are shown on the floor plan in Figure 3.5.

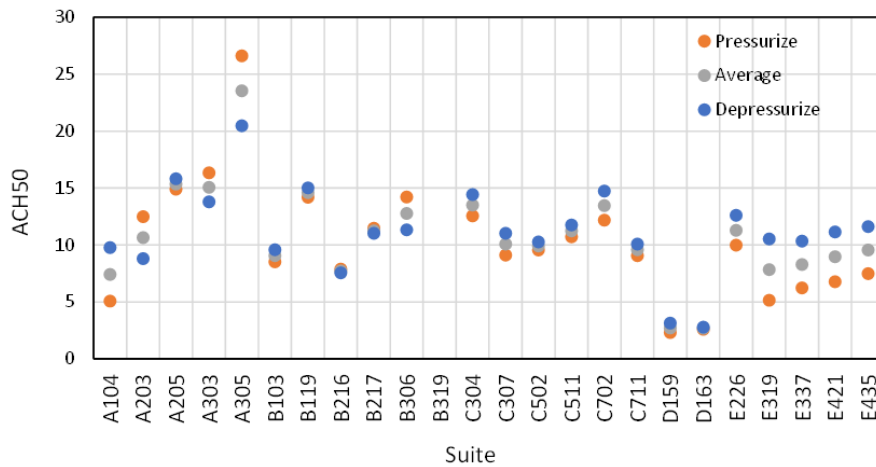
Figure 4.3 – Summary of suite air change rates at 50 Pa (ACH50) from post-retrofit blower door testing

The suite level airtightness results, expressed as an air change rate at 50 Pa (ACH50) are presented for pre-retrofit and post-retrofit blower door testing, respectively in Figure 4.2 and Figure 4.3.

Pre-retrofit, the ACH50 measurements across all of the buildings varied by an order of magnitude, ranging from 2.8 to 21.3 ACH50. This observed variability remained post-retrofit with airtightness values between 2.8 to 20.5 ACH50.

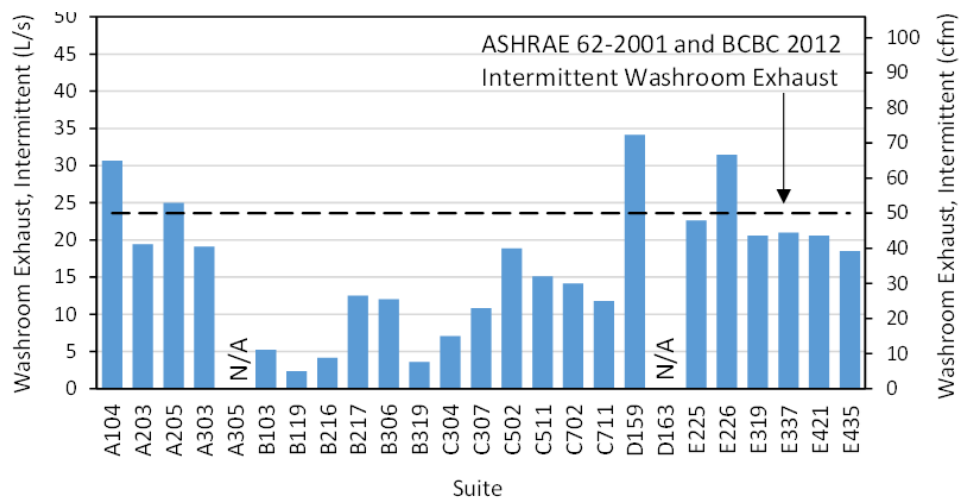
Figure 4.5 – Pre-retrofit washroom exhaust airflow rates (N/A indicates that no flow measurement was taken)

Rather than direct supply of outdoor air for ventilation, the suites in this study relied on either a combination or natural air infiltration through operable windows and/or the use of intermittent exhaust fans within the space, with make-up air coming from the corridor or other openings in the suite. The airflow rate provided by the intermittent washroom exhaust fans was measured and compared with code minimum values for each unit pre- (Figure 4.5) and post-retrofit (Figure 4.6). The measurements show that prior to the retrofits, most of the washroom exhaust fans provided airflow rates lower than the rates specified in the relevant codes and standards. Flow rates improved for many suites after the retrofits; however, around half of the measured units are still below code minimum rates. Note that four of five buildings underwent fan replacements or upgrades (Buildings A, B, D and E). Interestingly, Building A's exhaust fan flow rates did not improve significantly overall whereas Building C exhaust fan flow rates improved despite no note of fan retrofits.

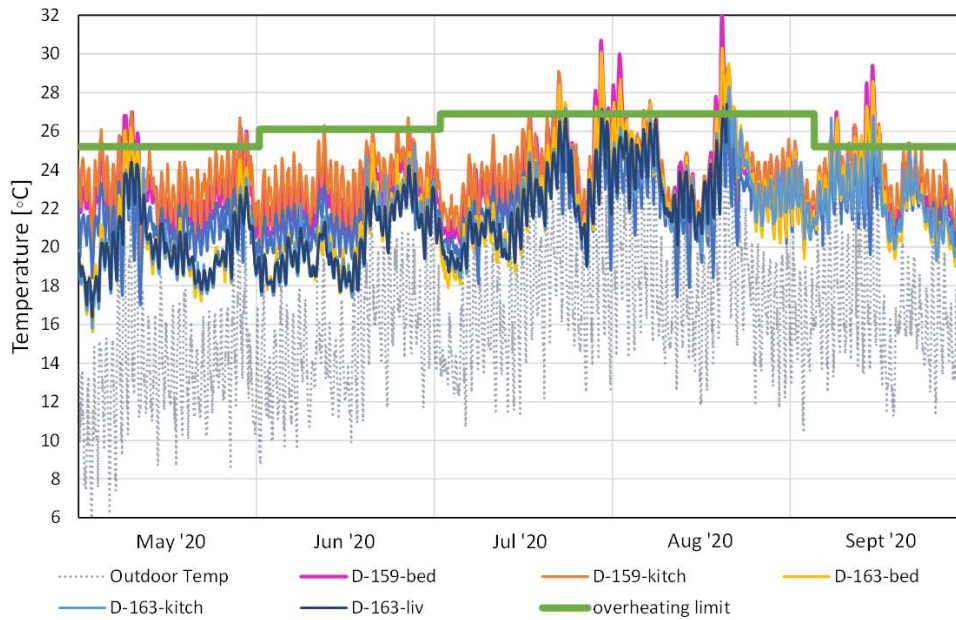
Figure 4.10 – Suite interior air temperature for Building D (2020, post-retrofit) against the summer overheating limit defined by BC Housing Design Guideline and City of Vancouver Energy Modelling Guidelines. Note that the acceptability limit varies by month.

The measured indoor temperatures during summer 2020 for all suites was compared against the overheating limit defined by BC Housing Design Guideline (COV Energy Modelling Guideline – Table 4). Figure 4.9 and Figure 4.10 are two examples of this comparison for Building C and Building D, respectively. See *Appendix C* for all overheating analysis plots. The plots show that the interior air temperatures in Building C exceed the overheating limit for a significant portion of the defined summer period. The suites in Building D, by comparison, exceeded the overheating limit far less. TABLE 4.3 lists all the measured suites and the number of overheating hours. Results suggest that overall, the suites across all buildings exceeded the overheating limit roughly 21% of the summer in 2020.

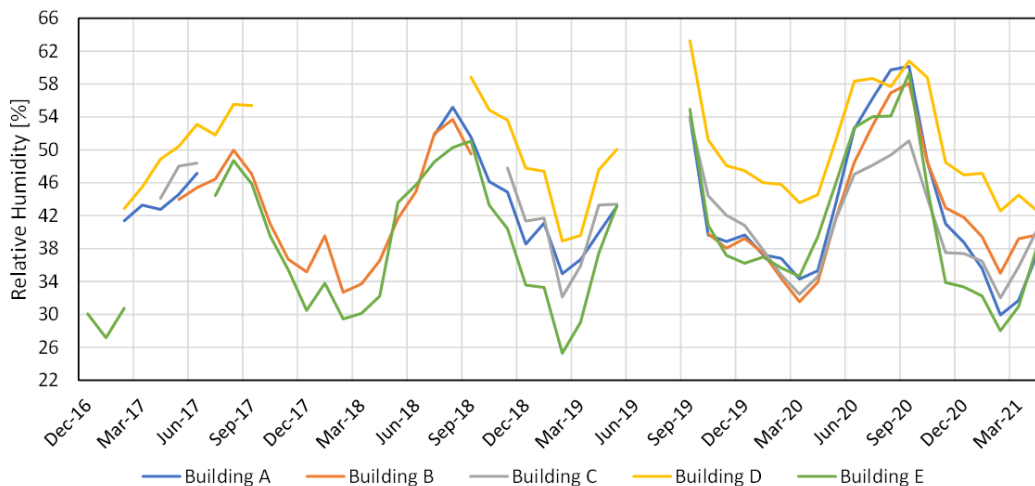
Figure 4.15 - Monthly average RH for each building. Gaps in data are either retrofit periods or missing data.

Figure 4.15 shows the average monthly RH for each building. Results show that RH is generally consistent for all buildings, with the exception of Building D, which experienced higher RH levels for the majority of the monitoring period. The monthly average RH readings are typically within the 30% to 60% design range for comfort. Generally, the reported monthly average RH levels did not reach above 60% (with the exception of a few cases), which indicates that the spaces do not typically experience excessive humidity. However, some of the spaces do show levels that are at the high end of the typical design scale and may be a concern. High RH is a concern in the winter due to potential condensation and is a concern in the summer because of the associated impacts on indoor comfort.

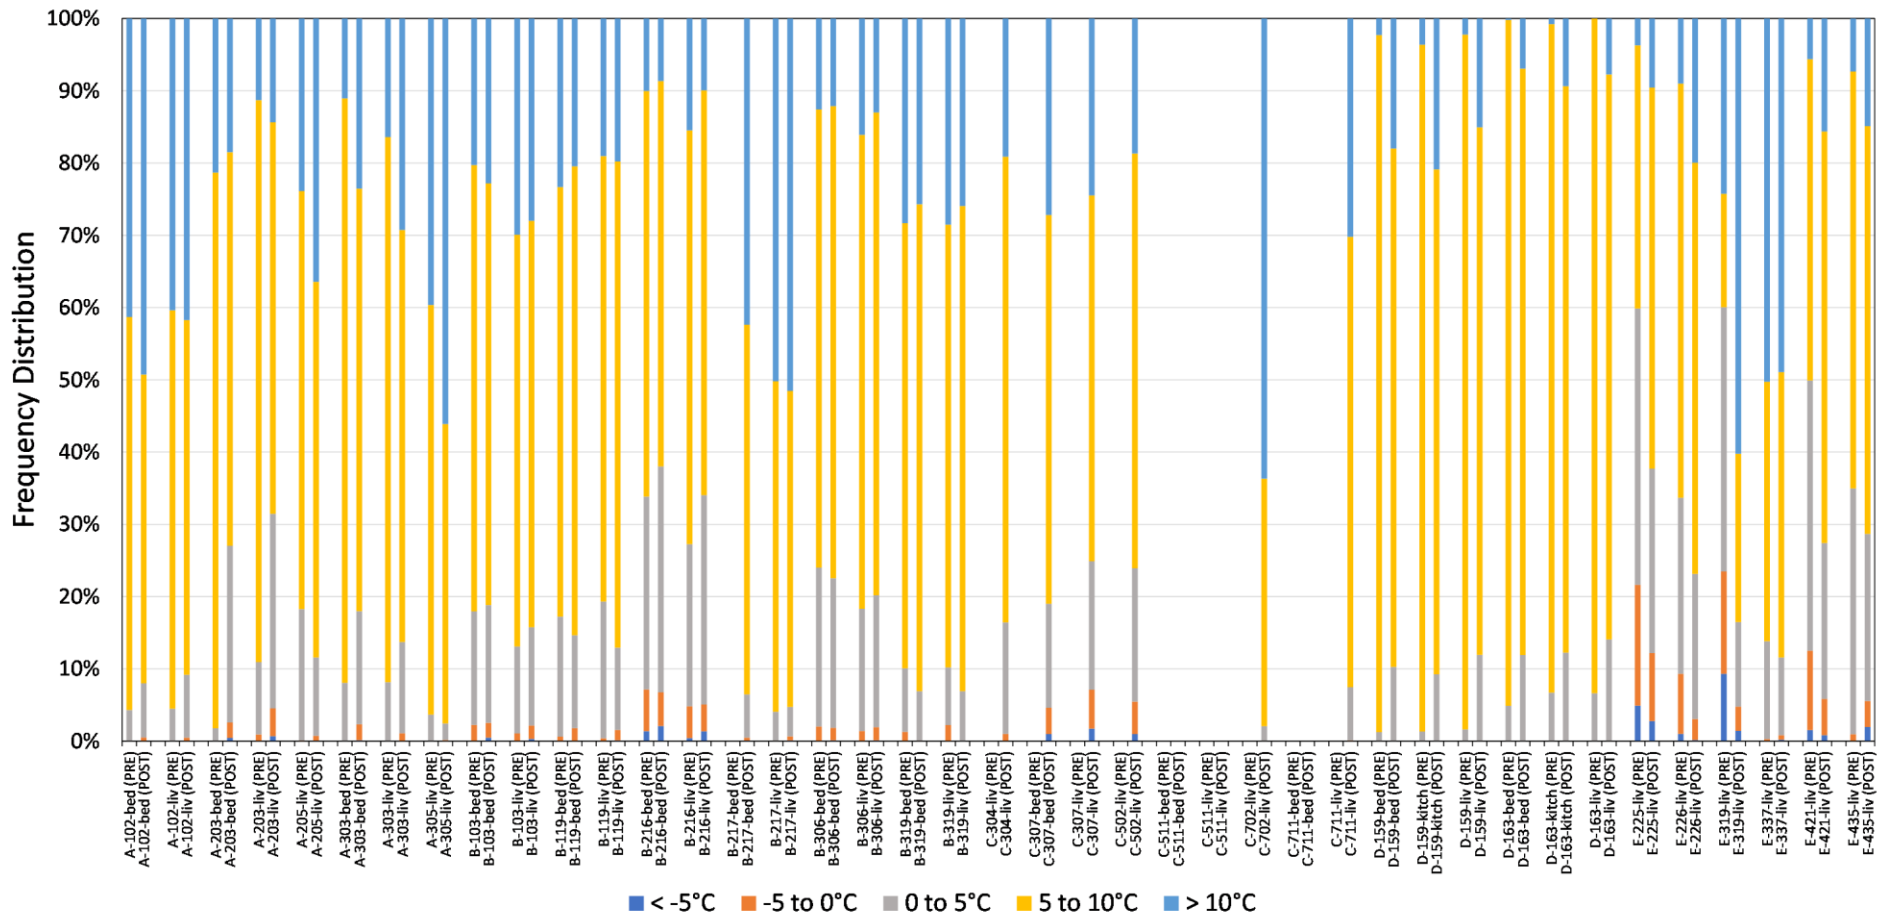
Figure 4.17 – Frequency distribution of dew point temperature between October and March (pre- vs. post-retrofit). Blank columns are the result of no measurements during the defined analysis period.

The distribution of dewpoint temperatures when condensation risk is greater (between October and March) is shown in Figure 4.17. The plot illustrates that the dew point temperature in the suites during cool outdoor conditions did not change significantly, other than a few cases such as Building E 319 living room and Building A 305 living room which show relatively greater distribution of dew point temperatures above 10°C compared to before the retrofits. These changes suggest that moisture build up in these suites is greater after the retrofits, perhaps a result of decreased ventilation or change in occupant behaviour.

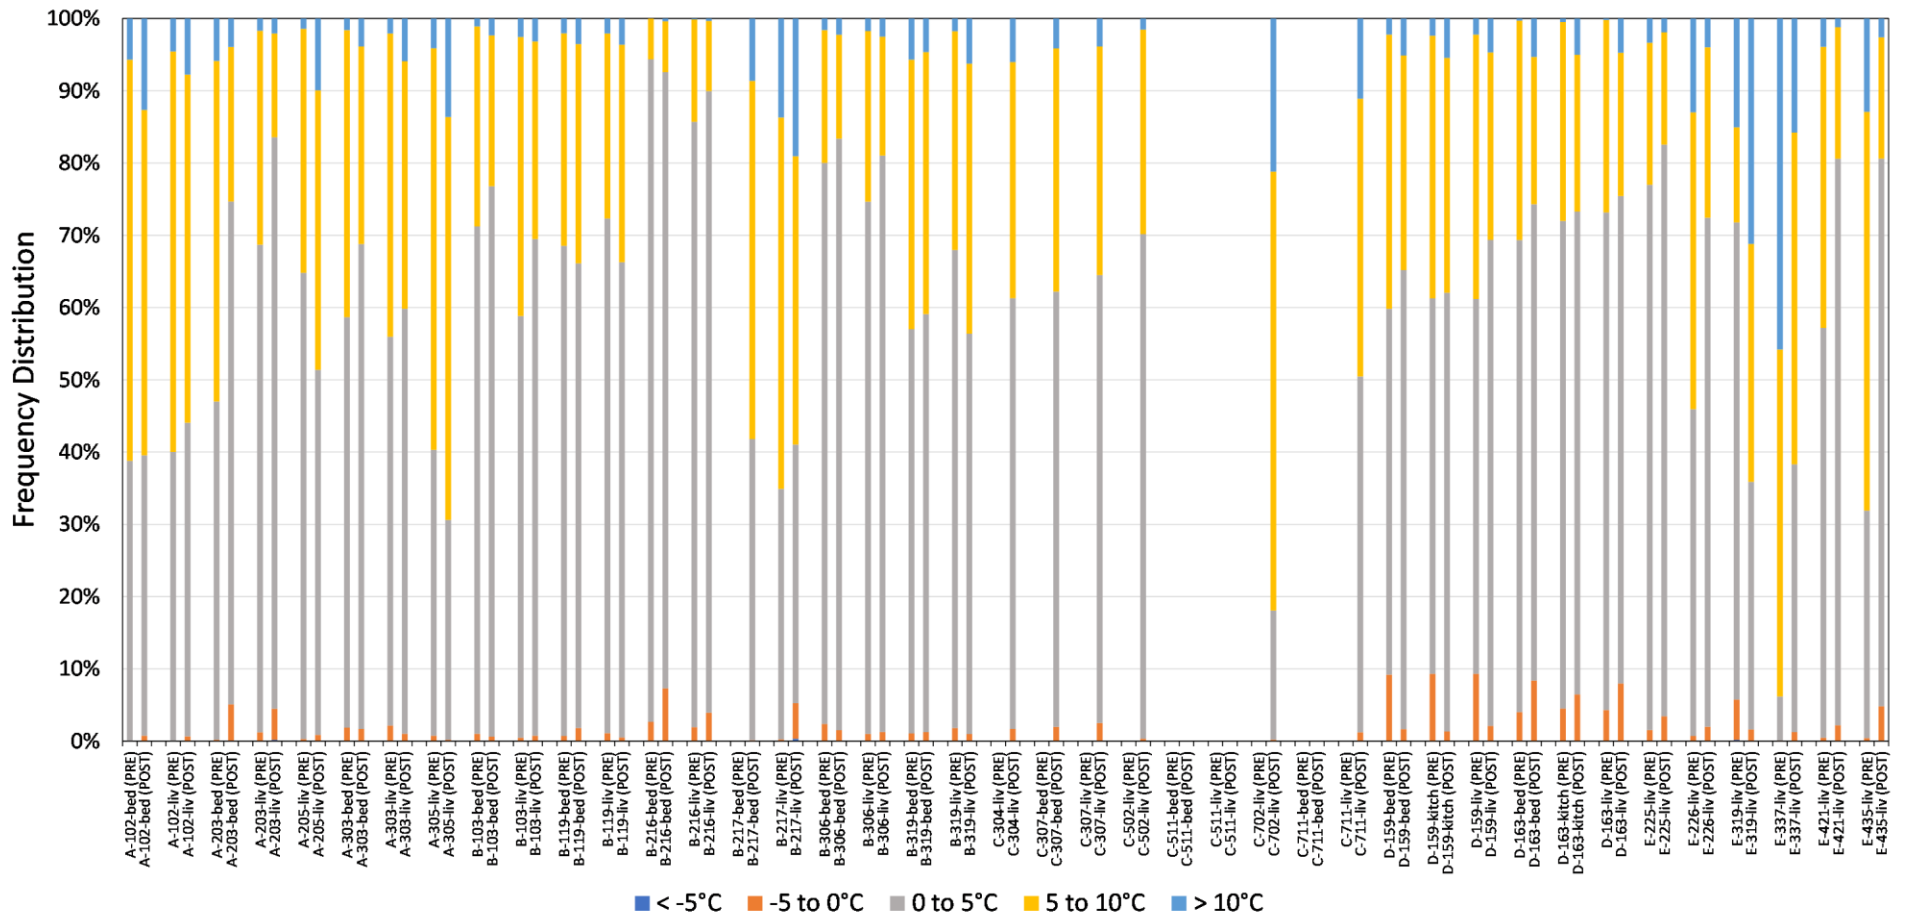
Figure 4.19 – Frequency distribution of delta dew point temperature between October and March (pre- vs. post-retrofit). Blank columns are the result of no measurements taken during the defined period.

The distribution of delta dewpoint temperatures when condensation risk is greater (between October and March) is shown in Figure 4.19. The plot illustrates that the delta dew point temperature in the suites during cool outdoor conditions did not change significantly, with the exception of Building E 319 living room.

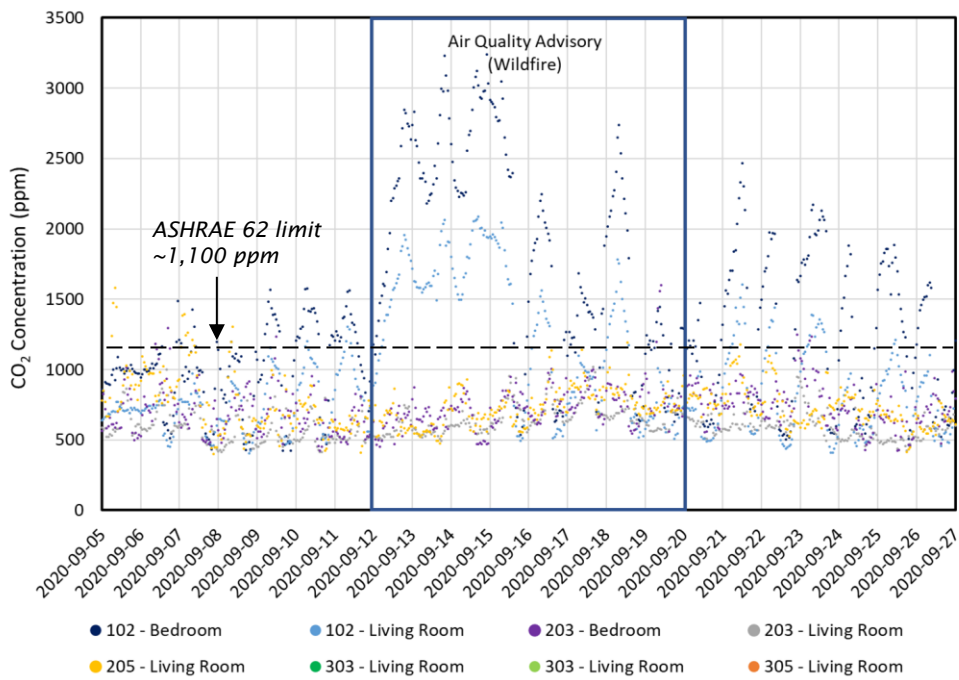
Figure 4.25 – CO<sub>2</sub> concentration measurements during the Metro Vancouver Air Quality Advisory (Building A)

*Figure 4.24* and *Figure 4.25* plot the air temperature and CO<sub>2</sub> concentrations during the September 2020 Metro Vancouver Air Quality Advisory for Building B and Building A, respectively. The plots include data from one week before and one week after the advisory for comparative purposes. The results show that the temperature in Building B did not significantly change as a result of the advisory; however, the CO<sub>2</sub> concentrations in Building A appear to have increased suddenly at the beginning of that period. This agrees with the public health recommendations to stay indoors with windows and doors closed. For similar plots of other measured buildings, see *Appendix F*.

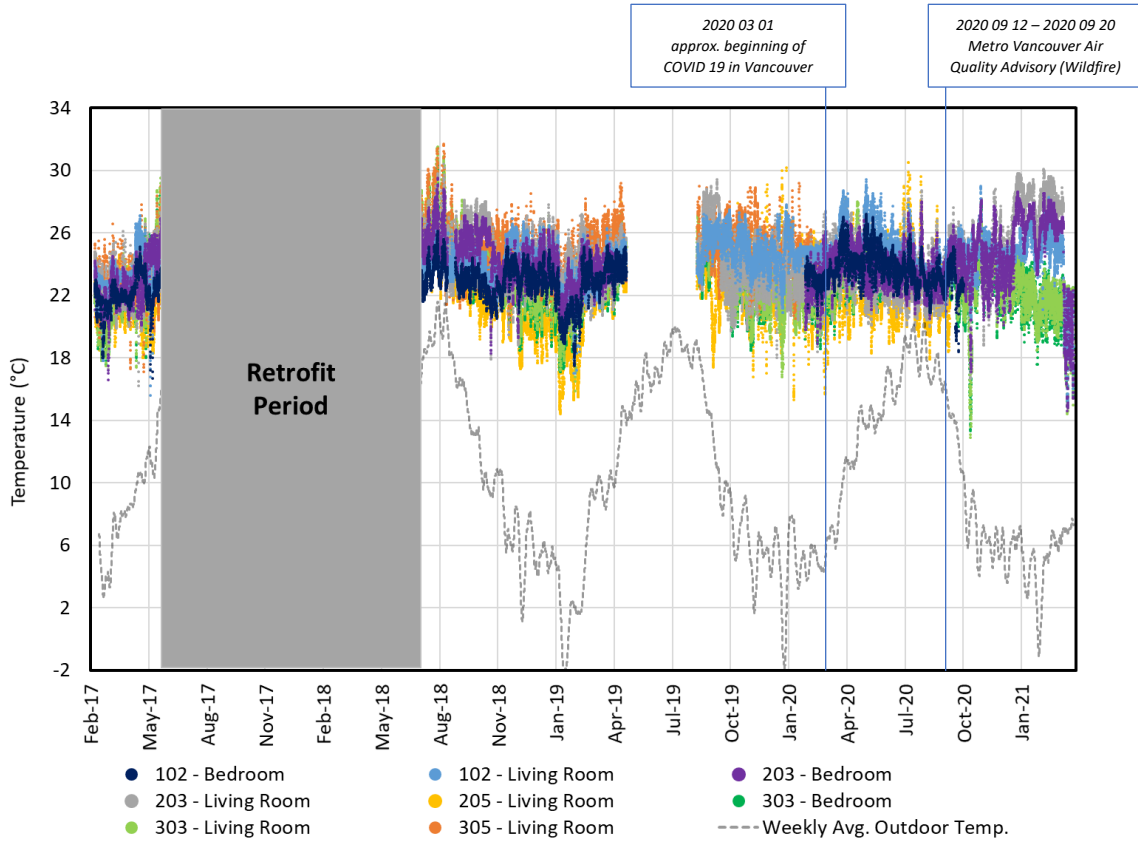
Appendix A.1 – Air temperature measurements throughout monitoring period (Building A)

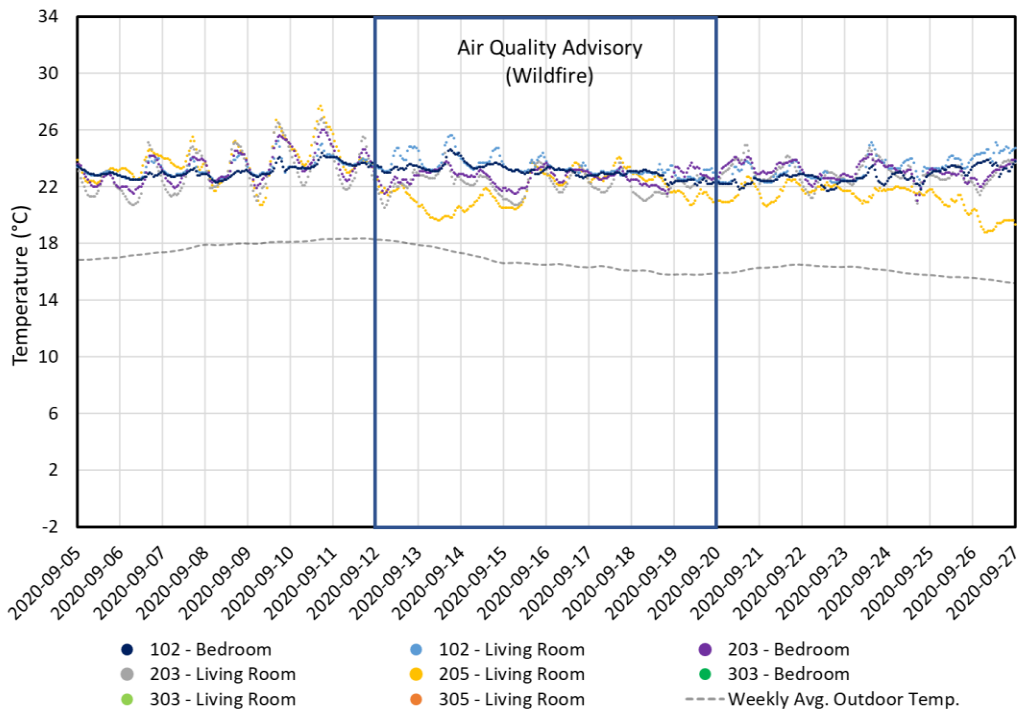
Appendix A.2 – Air temperature one week before, during and after the 2020 wildfire air quality advisory (Building A)

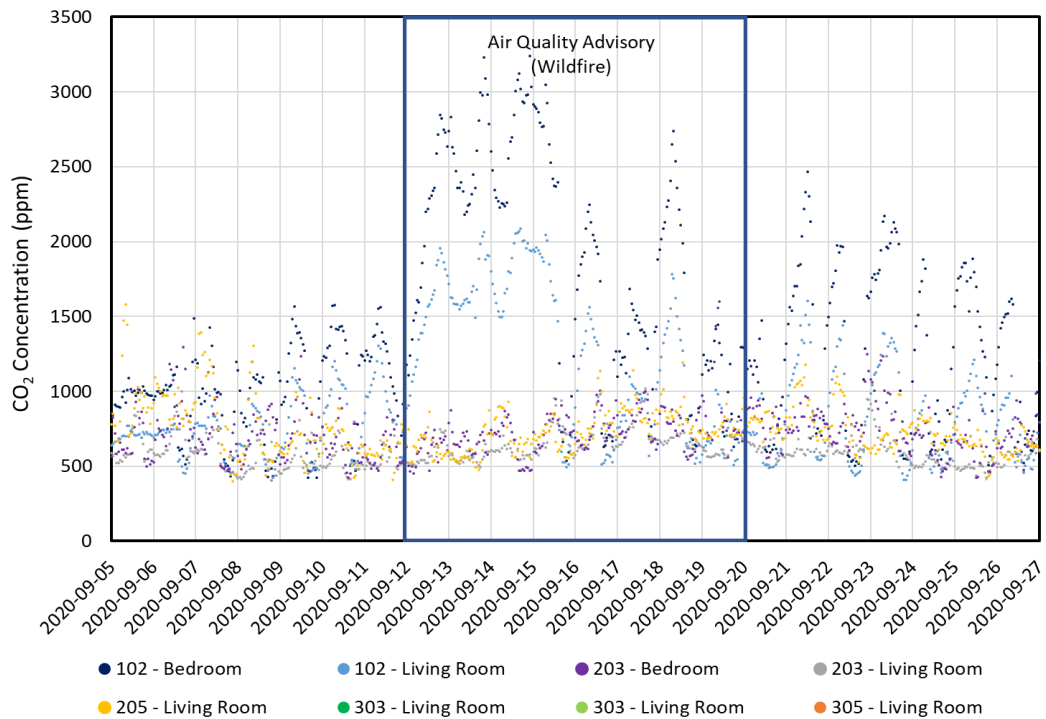
Appendix A.4 – CO<sub>2</sub> concentration one week before, during and after the 2020 wildfire air quality advisory (Building A)

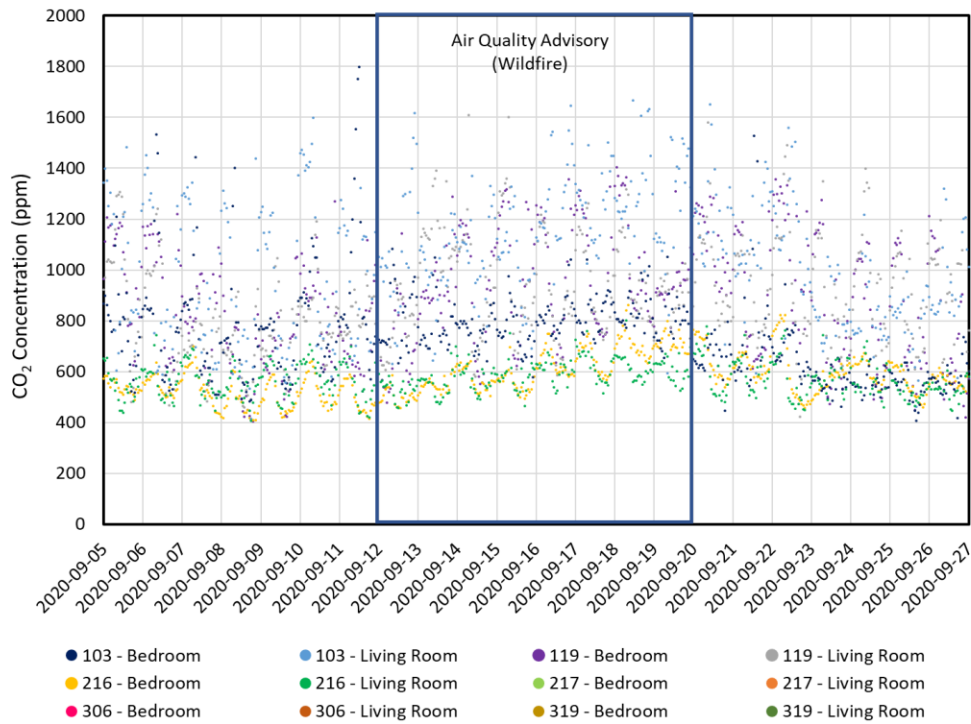
Appendix A.8 – CO<sub>2</sub> concentration one week before, during and after the 2020 wildfire air quality advisory (Building B)

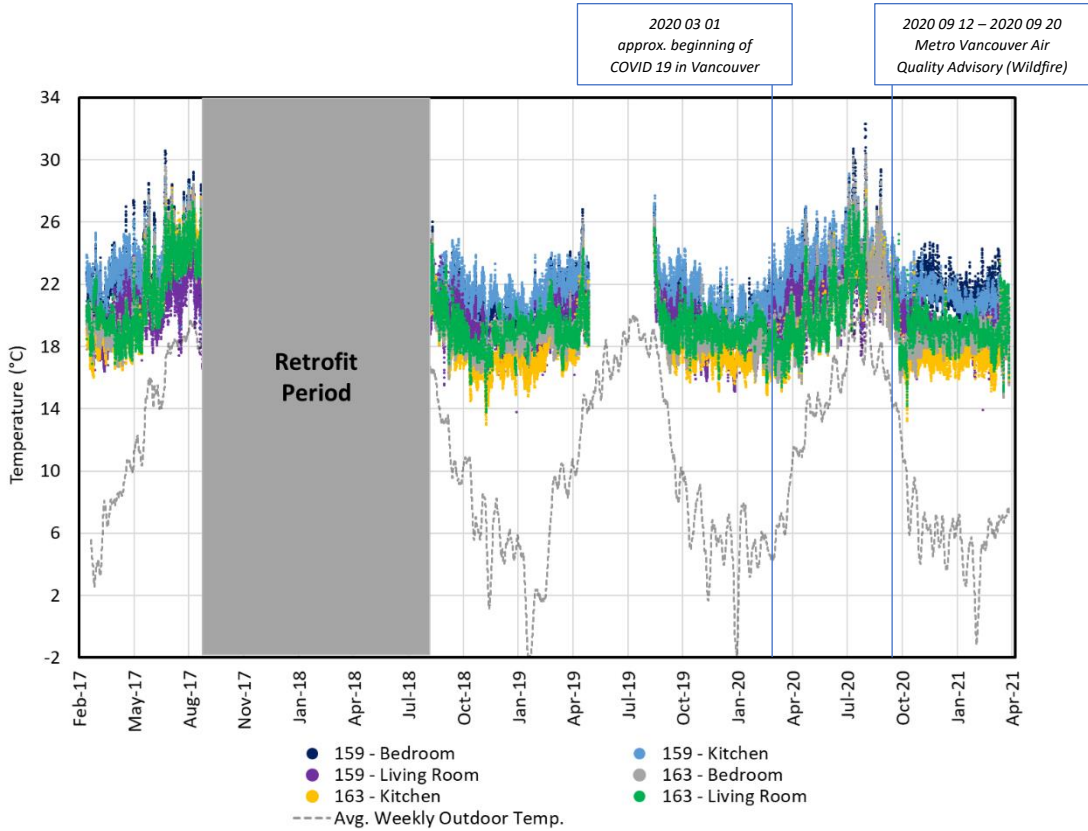
Appendix A.13 – Air temperature measurements throughout monitoring period (Building D)

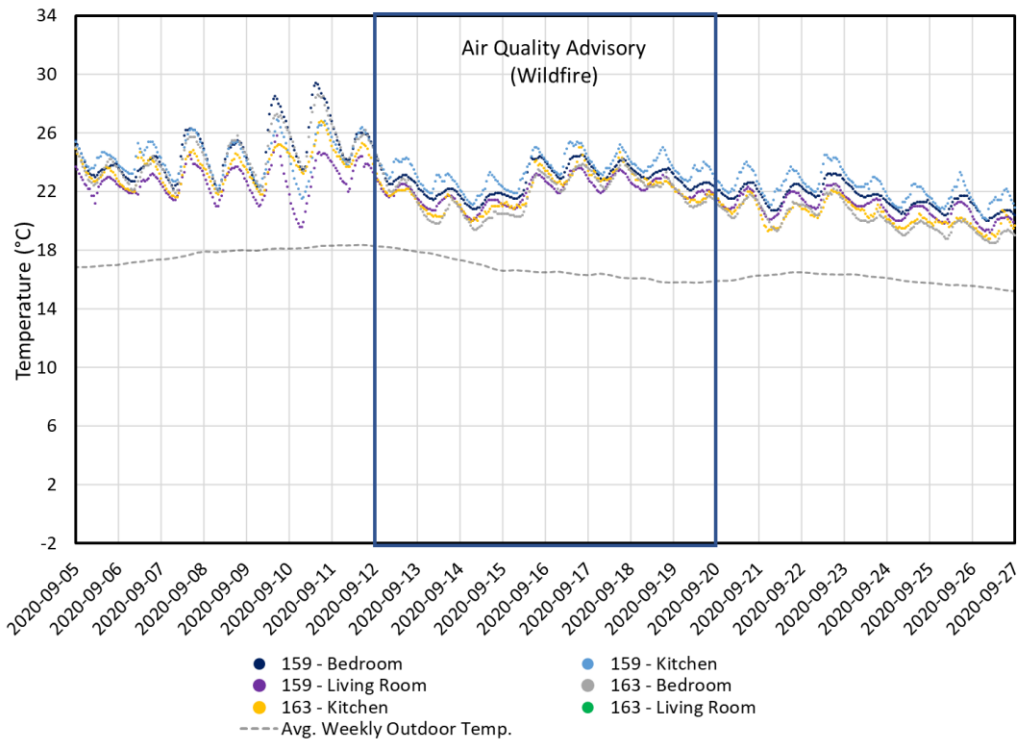
Appendix A.14 – Air temperature one week before, during and after the 2020 wildfire air quality advisory (Building D)

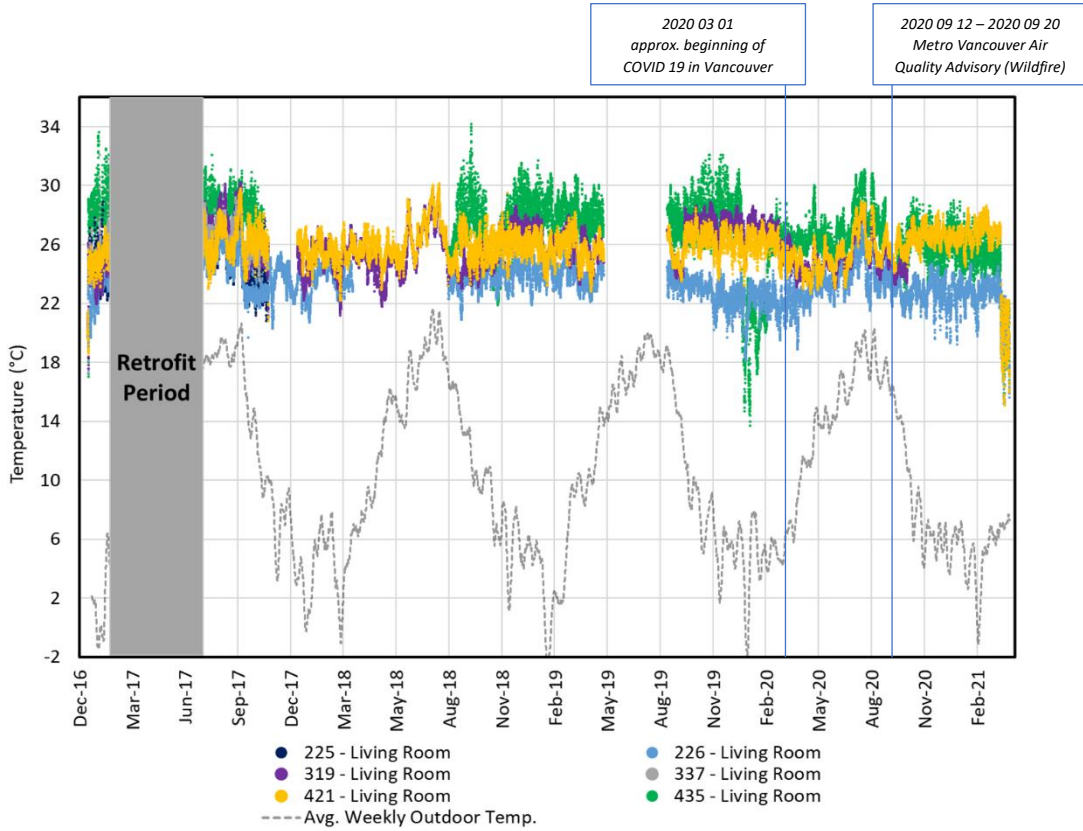
Appendix A.17 – Air temperature measurements throughout monitoring period (Building E)

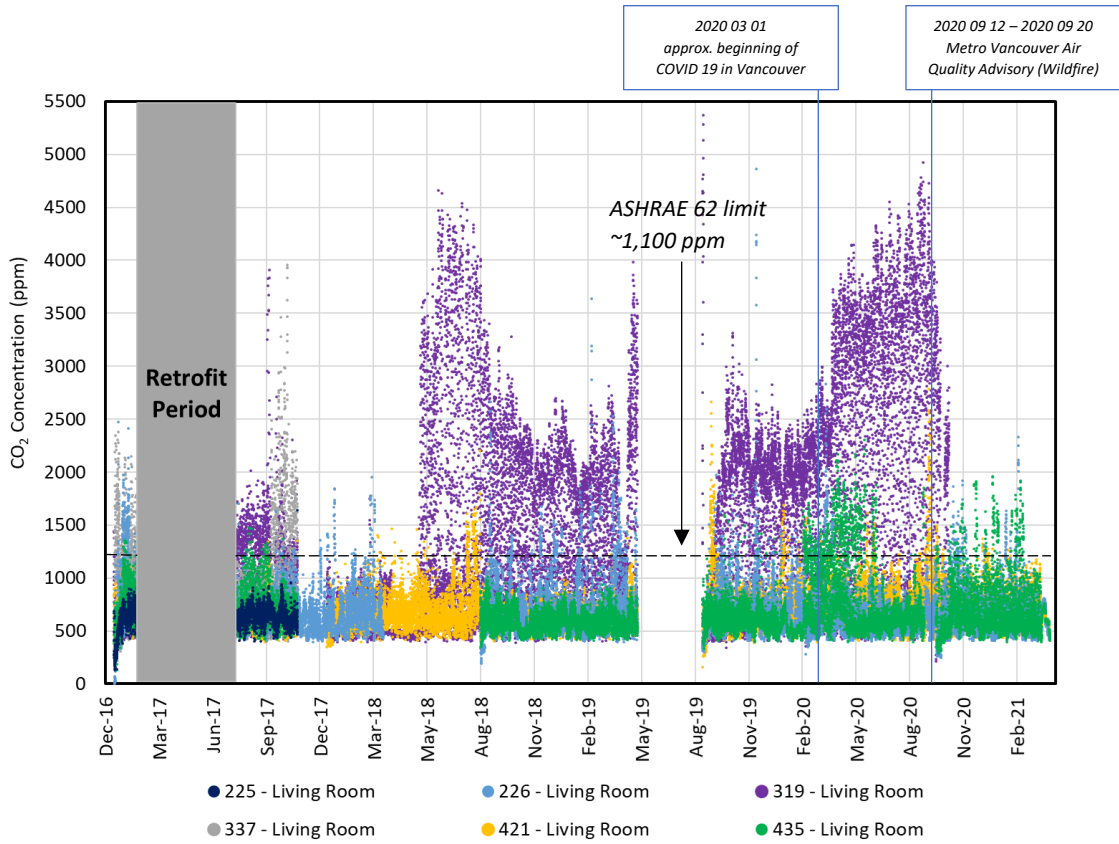
Appendix A.19 – CO<sub>2</sub> concentration measurements throughout monitoring period (Building E)

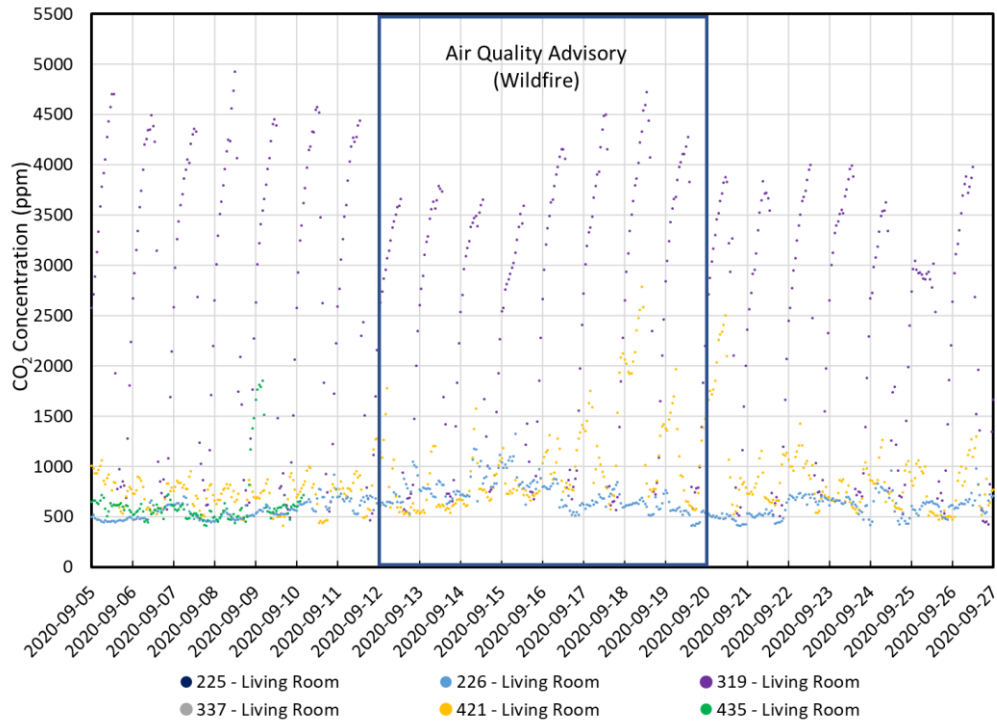
Appendix A.20 – CO<sub>2</sub> concentration one week before, during and after the 2020 wildfire air quality advisory (Building E)

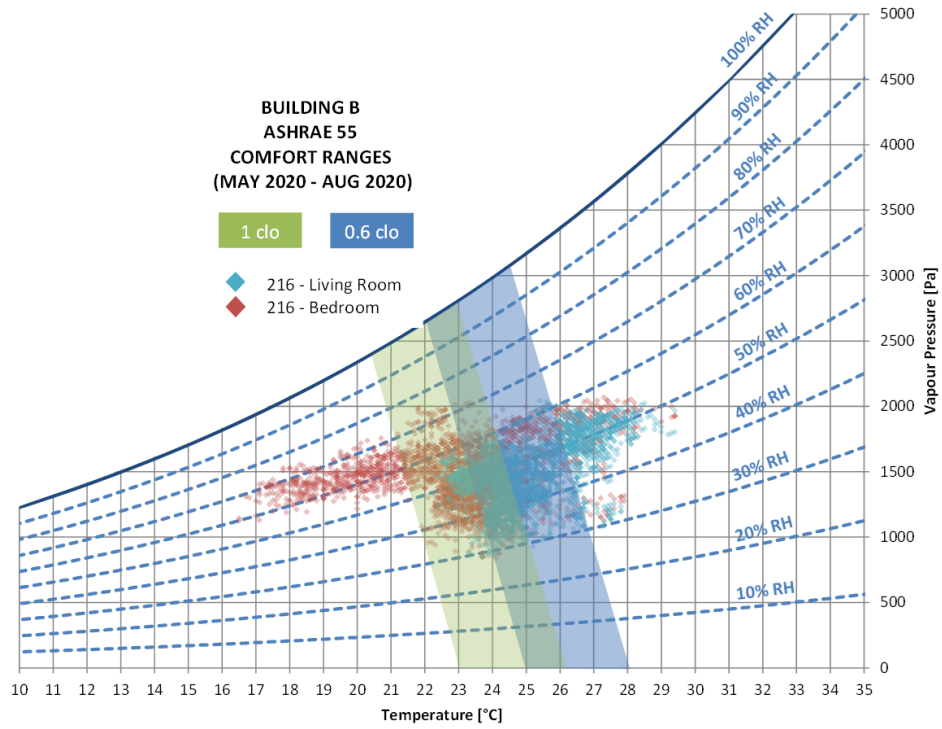
Appendix B.3 – Hourly air temperature measurements of two samples suites from Building B plotted on psychrometric chart (summer)

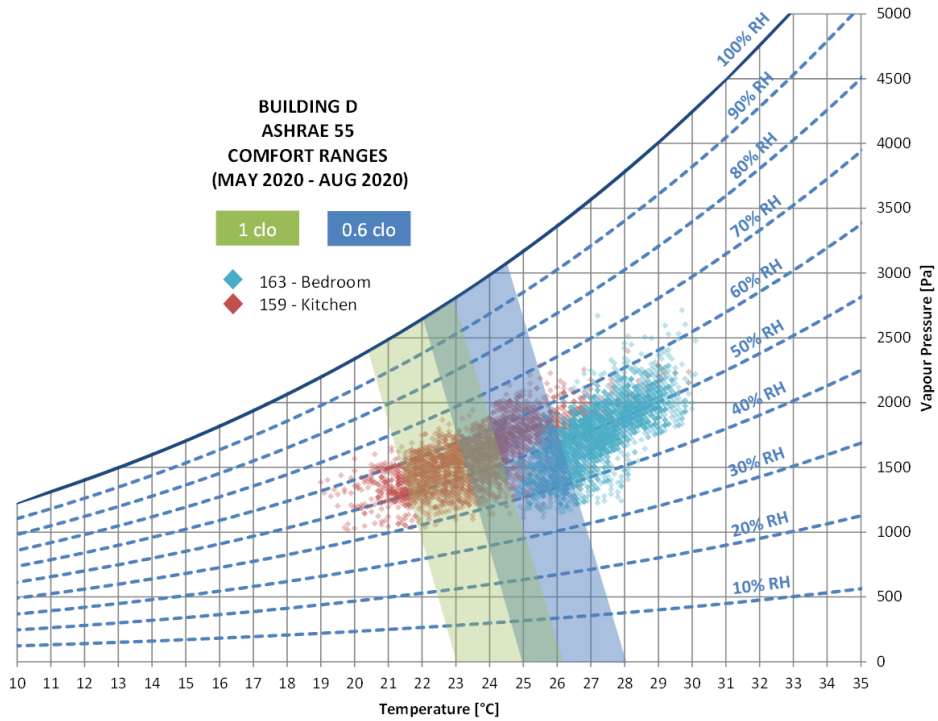
Appendix B.5 – Hourly air temperature measurements of two samples suites Building D plotted on psychrometric chart (summer)

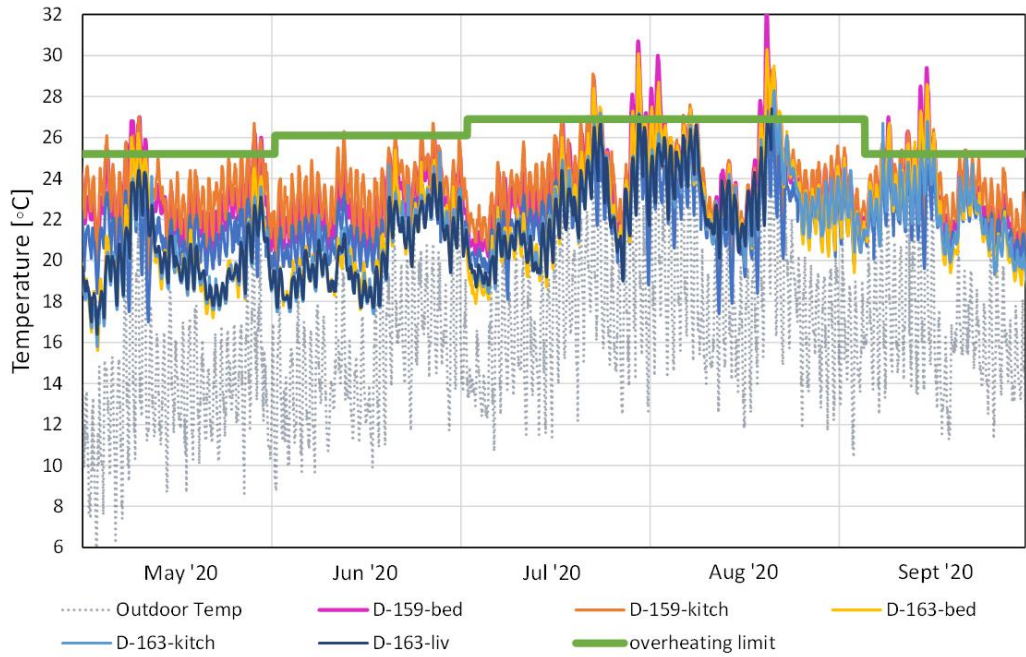
*Appendix C.7 – Suite interior air temperature for Building D (2020, post-retrofit) against the summer overheating limit defined by BC Housing Design Guideline and City of Vancouver Energy Modelling Guidelines.*

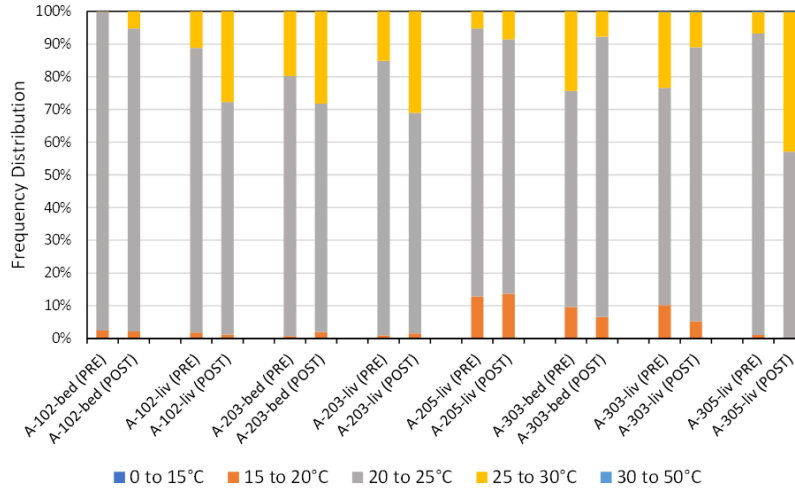
Appendix E.1 – Pre/post-retrofit air temperature frequency distribution for Building A

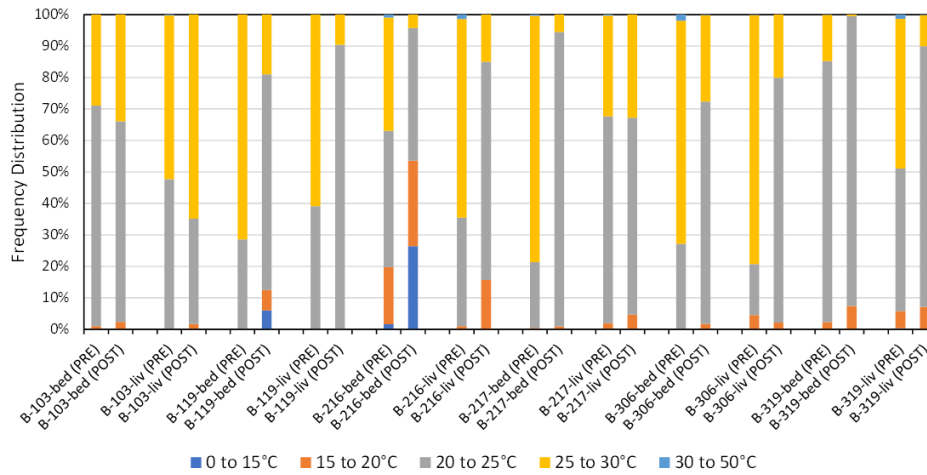
Appendix E.2 – Pre/post-retrofit air temperature frequency distribution for Building B

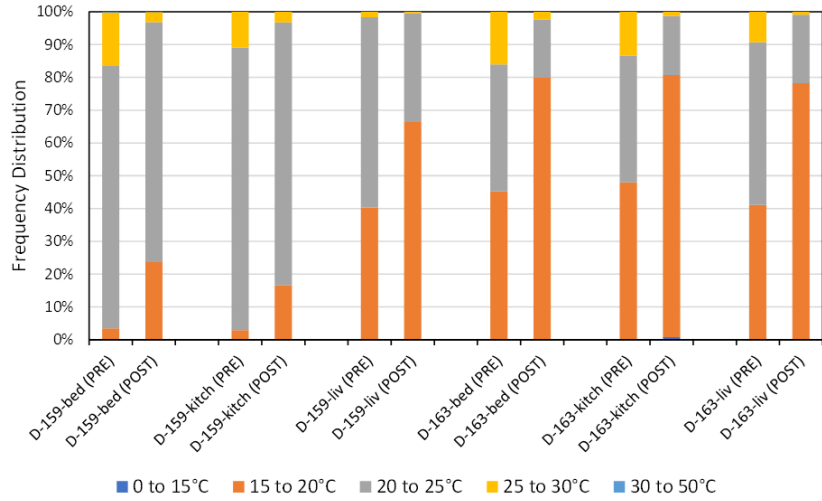
Appendix E.4 – Pre/post-retrofit air temperature frequency distribution for Building D
