# Indoor Environmental Quality of Social Housing Buildings in British Columbia

RDH Building Science Inc. conducted a monitoring study for BC Housing with the goal of understanding the indoor environmental quality (IEQ) of existing multi-unit social housing buildings in the Metro Vancouver area. The project objectives included identifying trends in the monitored temperature, humidity, and carbon dioxide (CO<sub>2</sub>) concentrations as well as analysing the IEQ impact of building retrofits and upgrades.

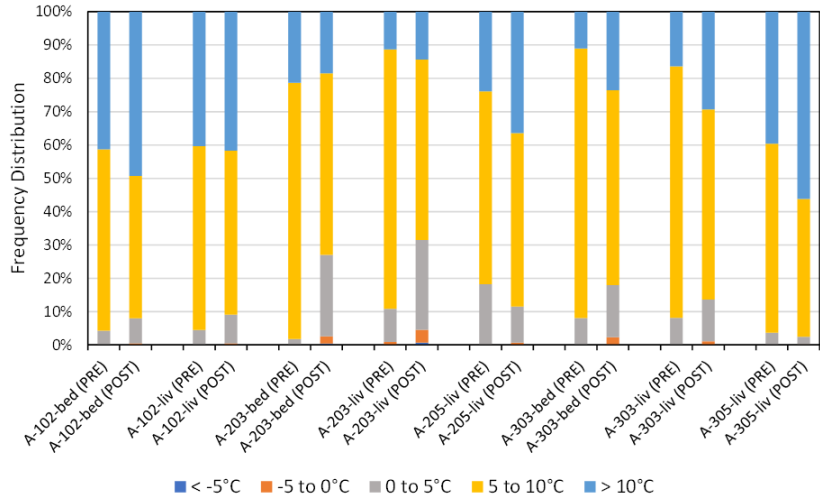
Appendix E.6 – Pre/post-retrofit dewpoint temperature frequency distribution for Building A between Oct-Mar

The distribution of dewpoint temperatures when condensation risk is greater (between October and March) is shown in Figure 4.17. The plot illustrates that the dew point temperature in the suites during cool outdoor conditions did not change significantly, other than a few cases such as Building E 319 living room and Building A 305 living room which show relatively greater distribution of dew point temperatures above 10°C compared to before the retrofits. These changes suggest that moisture build up in these suites is greater after the retrofits, perhaps a result of decreased ventilation or change in occupant behaviour.

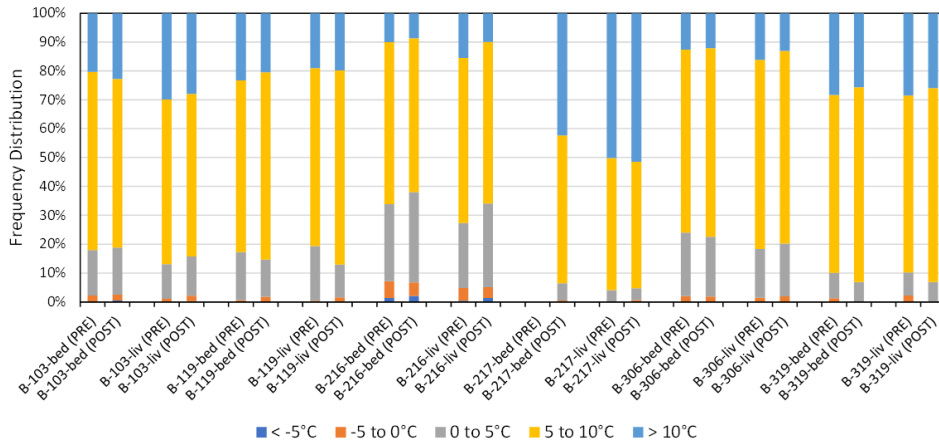
Appendix E.7 – Pre/post-retrofit dewpoint temperature frequency distribution for Building B between Oct-Mar

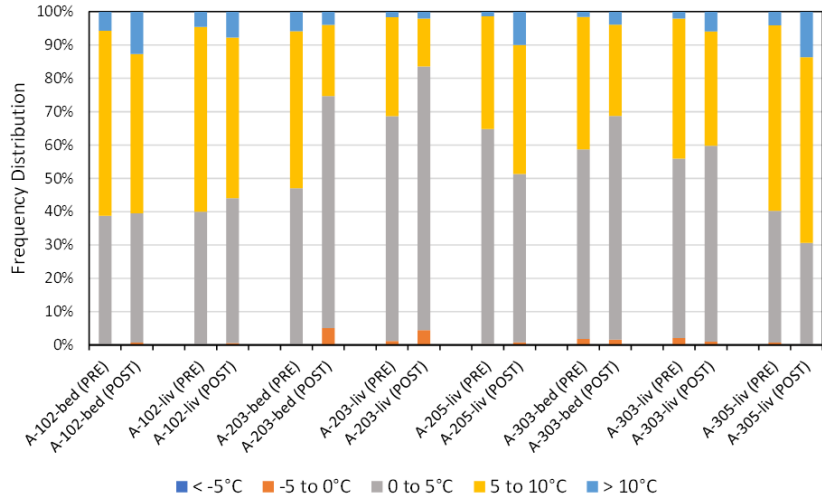
Appendix E.11 – Pre/post-retrofit delta dewpoint temperature frequency distribution for Building A between Oct-Mar

The distribution of delta dewpoint temperatures when condensation risk is greater (between October and March) is shown in Figure 4.19. The plot illustrates that the delta dew point temperature in the suites during cool outdoor conditions did not change significantly, with the exception of Building E 319 living room.

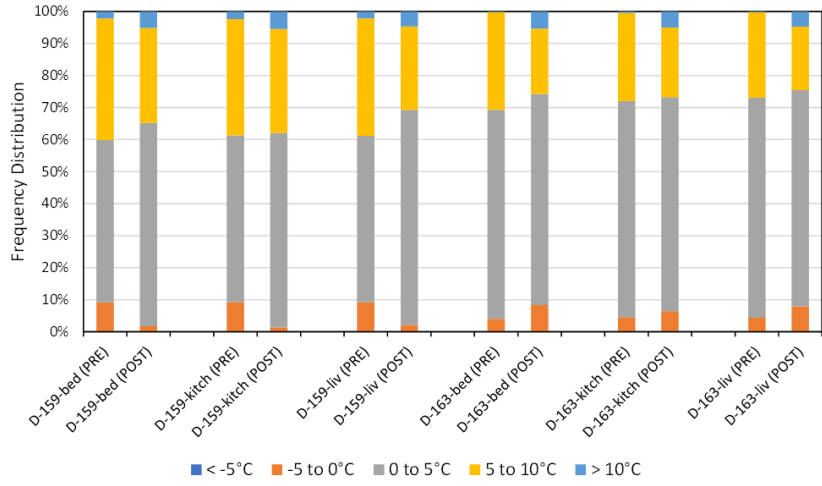
Appendix E.14 – Pre/post-retrofit delta dewpoint temperature frequency distribution for Building D between Oct-Mar

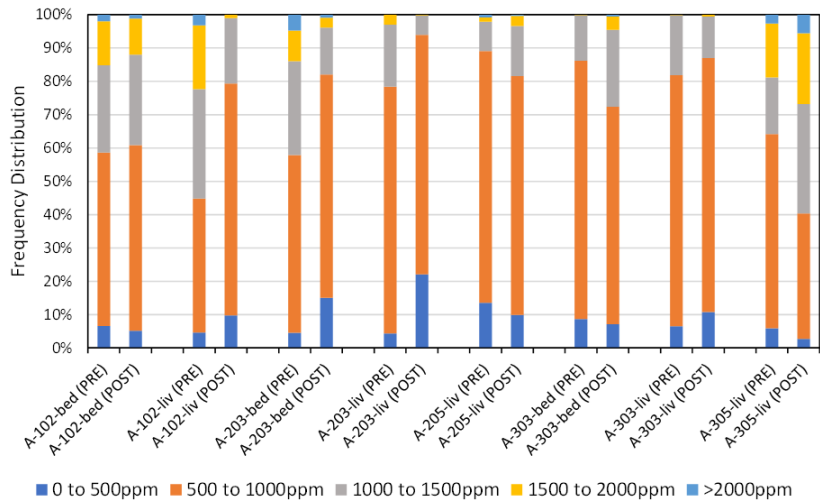
Appendix E.16 – Pre/post-retrofit carbon dioxide concentration frequency distribution for Building A

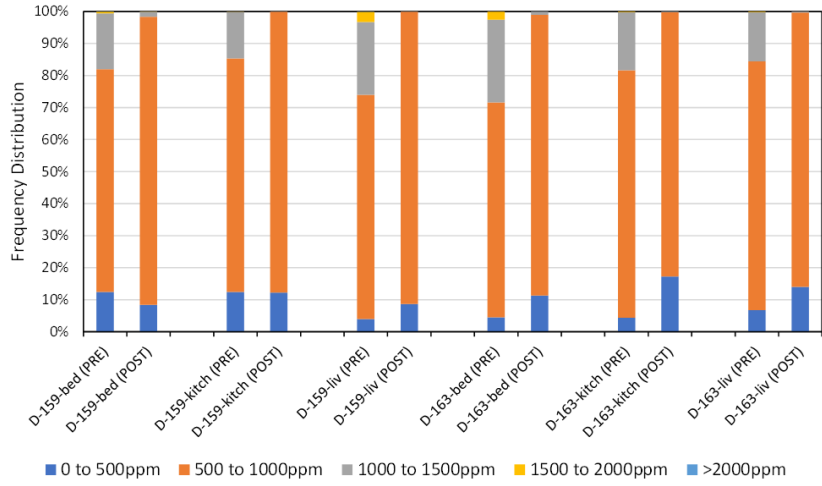
Appendix E.19 – Pre/post-retrofit carbon dioxide concentration frequency distribution for Building D

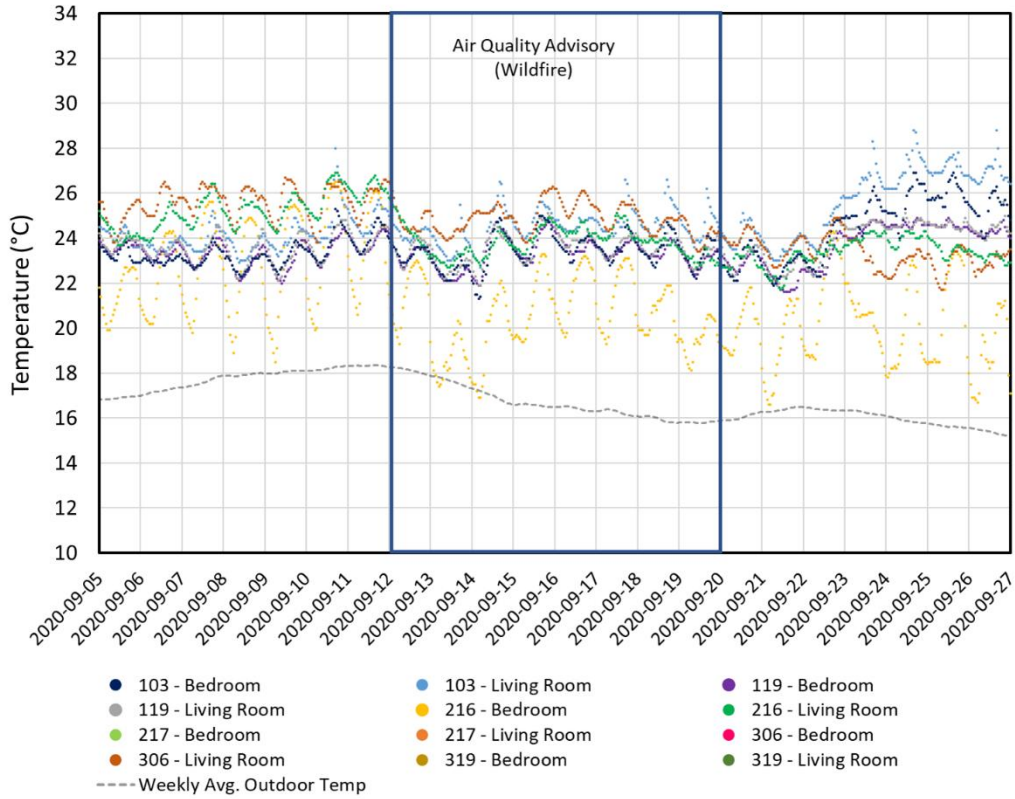
Appendix F.3 – Air temperature for three-week period during Air Quality Advisory (Wildfire) for Building B

*Figure 4.24* and *Figure 4.25* plot the air temperature and CO<sub>2</sub> concentrations during the September 2020 Metro Vancouver Air Quality Advisory for Building B and Building A, respectively. The plots include data from one week before and one week after the advisory for comparative purposes. The results show that the temperature in Building B did not significantly change as a result of the advisory; however, the CO<sub>2</sub> concentrations in Building A appear to have increased suddenly at the beginning of that period. This agrees with the public health recommendations to stay indoors with windows and doors closed. For similar plots of other measured buildings, see *Appendix F*.

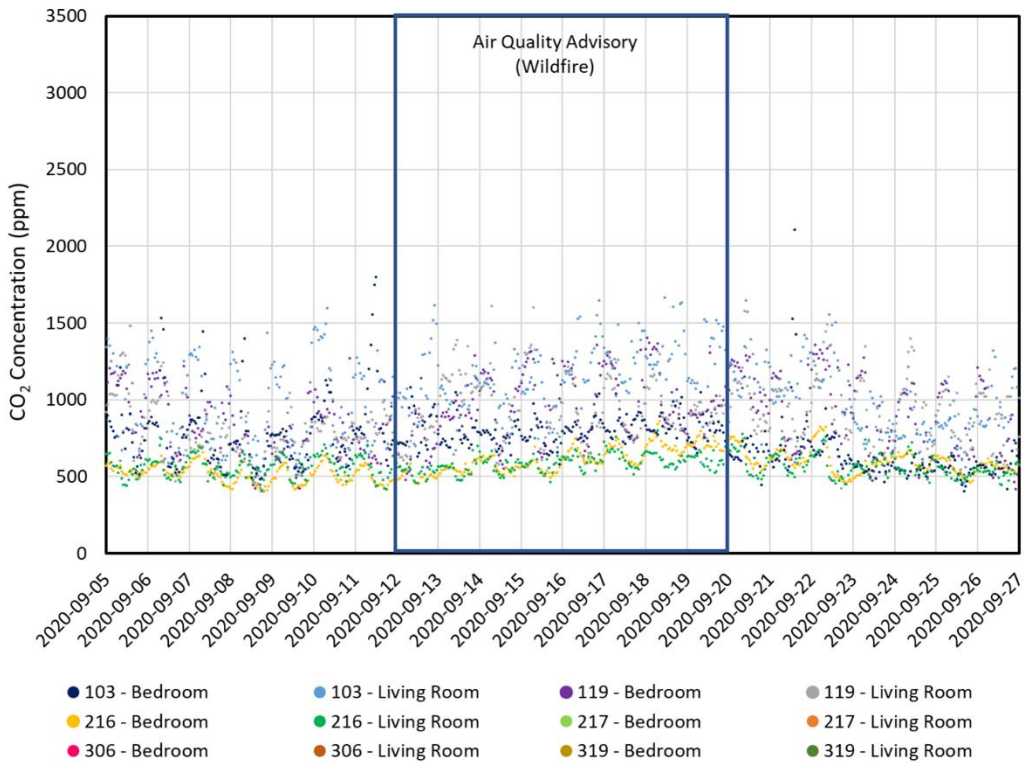
Appendix F.4 – Carbon Dioxide concentrations for three-week period during Air Quality Advisory (Wildfire) for Building B

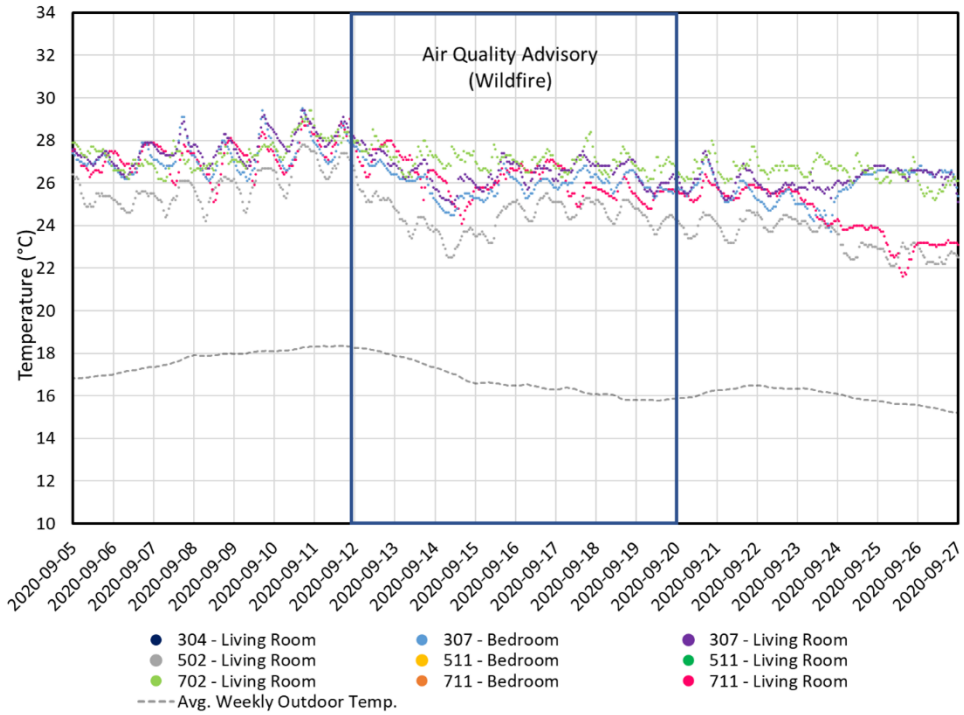
Appendix F.5 – Air temperature for three-week period during Air Quality Advisory (Wildfire) for Building C

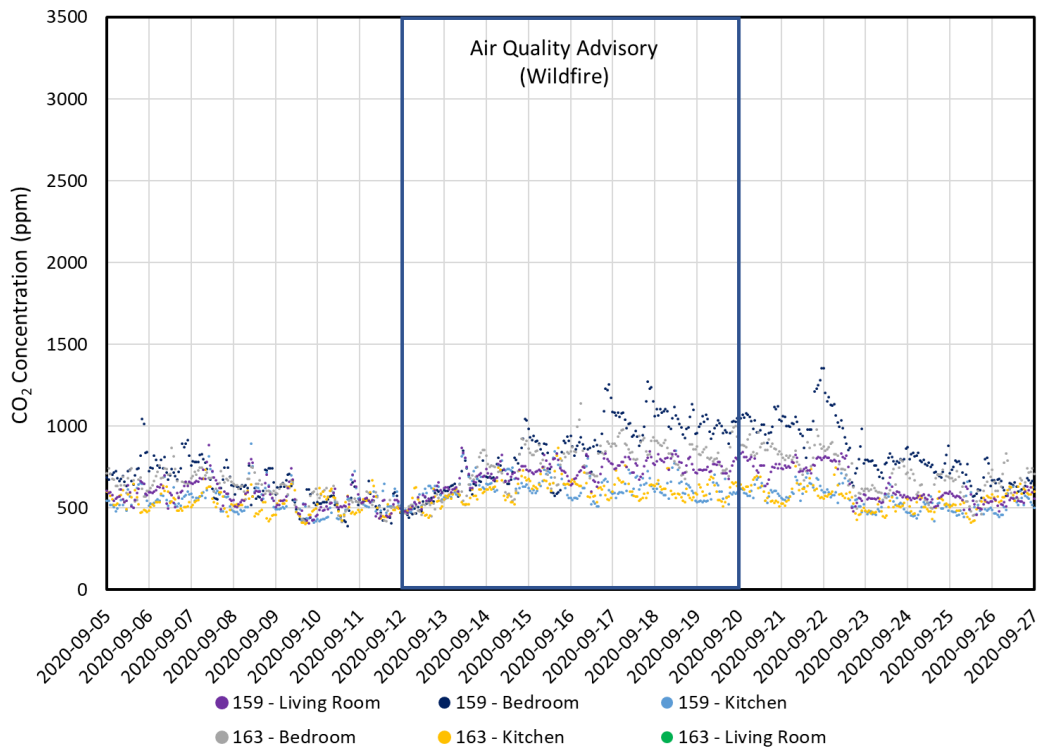
Appendix F.8 – Carbon Dioxide concentrations for three-week period during Air Quality Advisory (Wildfire) for Building D
