Library Gardens -Berkley, CA - Outcomes \rightarrow California Building Code and Berkeley \rightarrow California Senate Bill 721 (2018) → Apartments (multi-family residential with Municipal Code updated to include: 3 or more dwelling units) → Section 1202.7 - Added vented space under → Requires inspection of 15% of *Exterior* balconies, decks, etc. (1/150th of area) **Elevated Elements** Sections 1404.13, 2304.11.1, and \rightarrow Review on 6-year intervals 2304.11.4.2 - Materials to be naturally durable or PT wood and corrosion resistant metal components \rightarrow California Senate Bill 326 (2019) → 601.4 Structural Maintenance \rightarrow Essentially all elevated balconies, decks, \rightarrow Condos stairs, landings, handrails and all parts of \rightarrow Requires inspection of a "statistically weather-exposed areas Group R-1 or R-2 significant sample" of Exterior Elevated to be inspected on 5-year interval. Elements, for 95% confidence level, + 5% margin of error → Review on 9-year intervals RDH

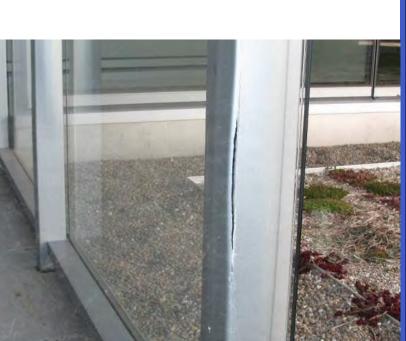
- ightarrow Freeze/Thaw can also manifest in other ways
- → Example of split railing - Photo taken in January 2009

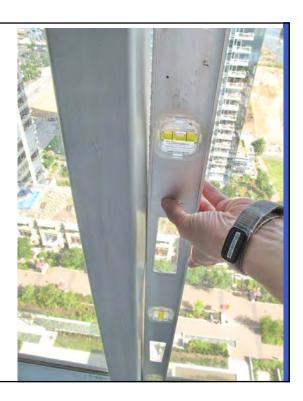
Portland Condo – Balcony Guards

Example of bowed railing post deformation as a result of frozen water and lack of drainage (photo taken August 2011).

ightarrow Condition observed at several balconies
