Building Enclosure Rehabilitation Guide: Multiunit Residential Wood-Framed Buildings

In its ongoing efforts to maintain multiunit wood-framed residential buildings, OHCS recognizes an increasing need for guidance related to the building enclosure systems. Recent failures leading to costly repairs and re-repairs emphasize this need. This guide has been prepared as one part of an ongoing effort to provide that guidance to the design and construction of wood-framed, multiunit residential buildings.

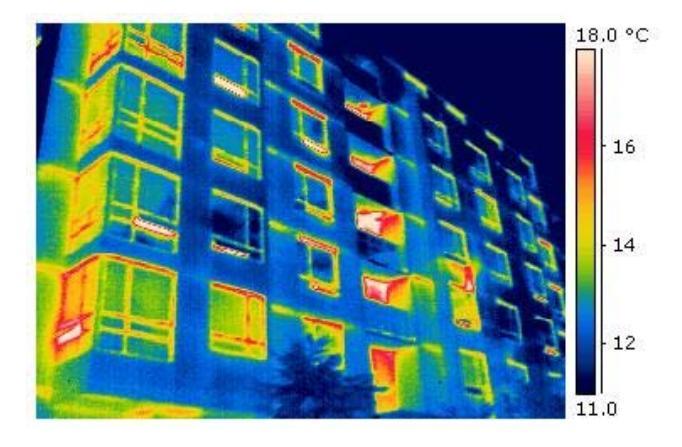
Figure 2-4 Infrared Image of Air Leakage

Infrared cameras detect surface temperatures. Although this can be an extremely useful tool that can often correlate temperature to moisture (especially in roofing applications), misinterpretation is prevalent. Temperature variations can result from thermal bridging, air leakage, or moisture storage. Only experience and understanding of building physics can effectively allow the consultant to distinguish between these sources of thermal anomalies and interpret the results. Readings are affected by exterior and interior temperatures, air pressure differences, and surface heat reflection from natural and other lighting sources. The images below are representative of the type of results derived from thermographic imaging. In Figure 2-4 below, we see colored red/orange/yellow zones that indicate warm air leakage and thermally inefficient window frames.

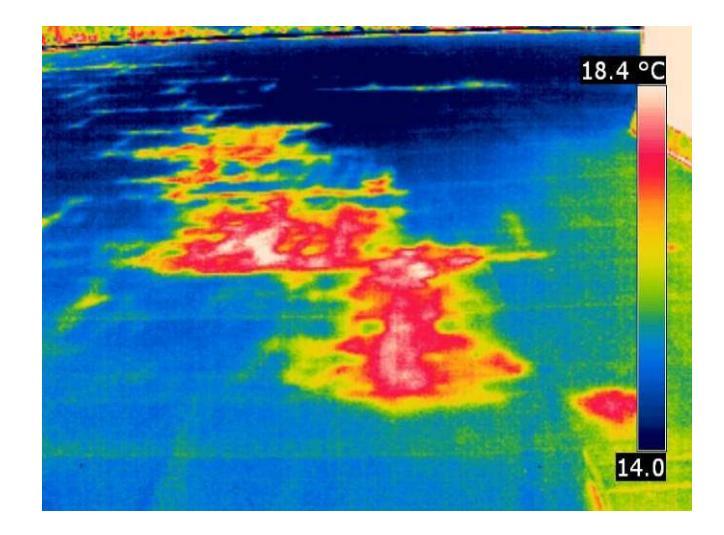
Figure 2-5 Infrared Image of Roof Membrane

In contrast, the warm areas in Figure 2-5 below likely indicate water leakage or other moisture accumulation below the roof membrane.

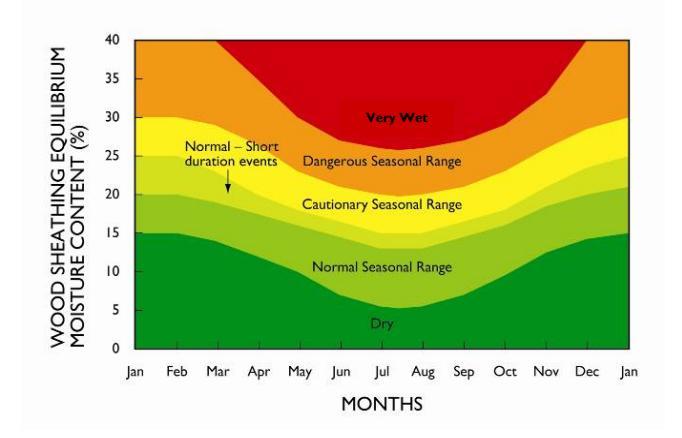
The seasonal fluctuations shown in Figure 2-6 relate to the sorption isotherm of the wood, or the relationship between the moisture content and the relative humidity (RH). For wood sheathing, as the relative humidity increases, so does the moisture content. However, the relationship is not linear and as RH increases, moisture content increases at a more rapid rate.

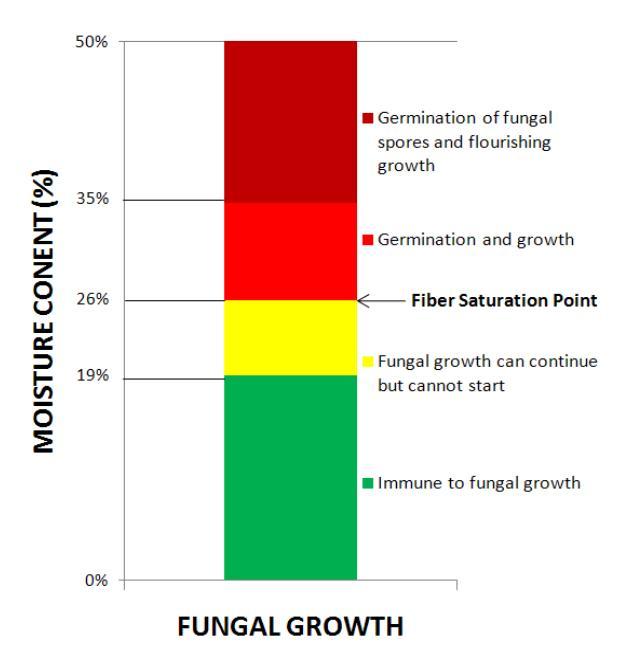
Figure 2-7 Fungal Growth in Wood

Assuming that all of the above is well understood by the consultant, measurement of the moisture content of wood components is an important evaluation tool because wood-decay fungi require elevated moisture content to initiate growth. Actual moisture contents above 26% are necessary to initiate growth of decay fungi, but once established, moisture contents above 19%, and generally around 23%, are sufficient to sustain the fungal growth (Figure 2-7). Wood is generally considered safe from wood-decay fungal growth below 19% moisture content.

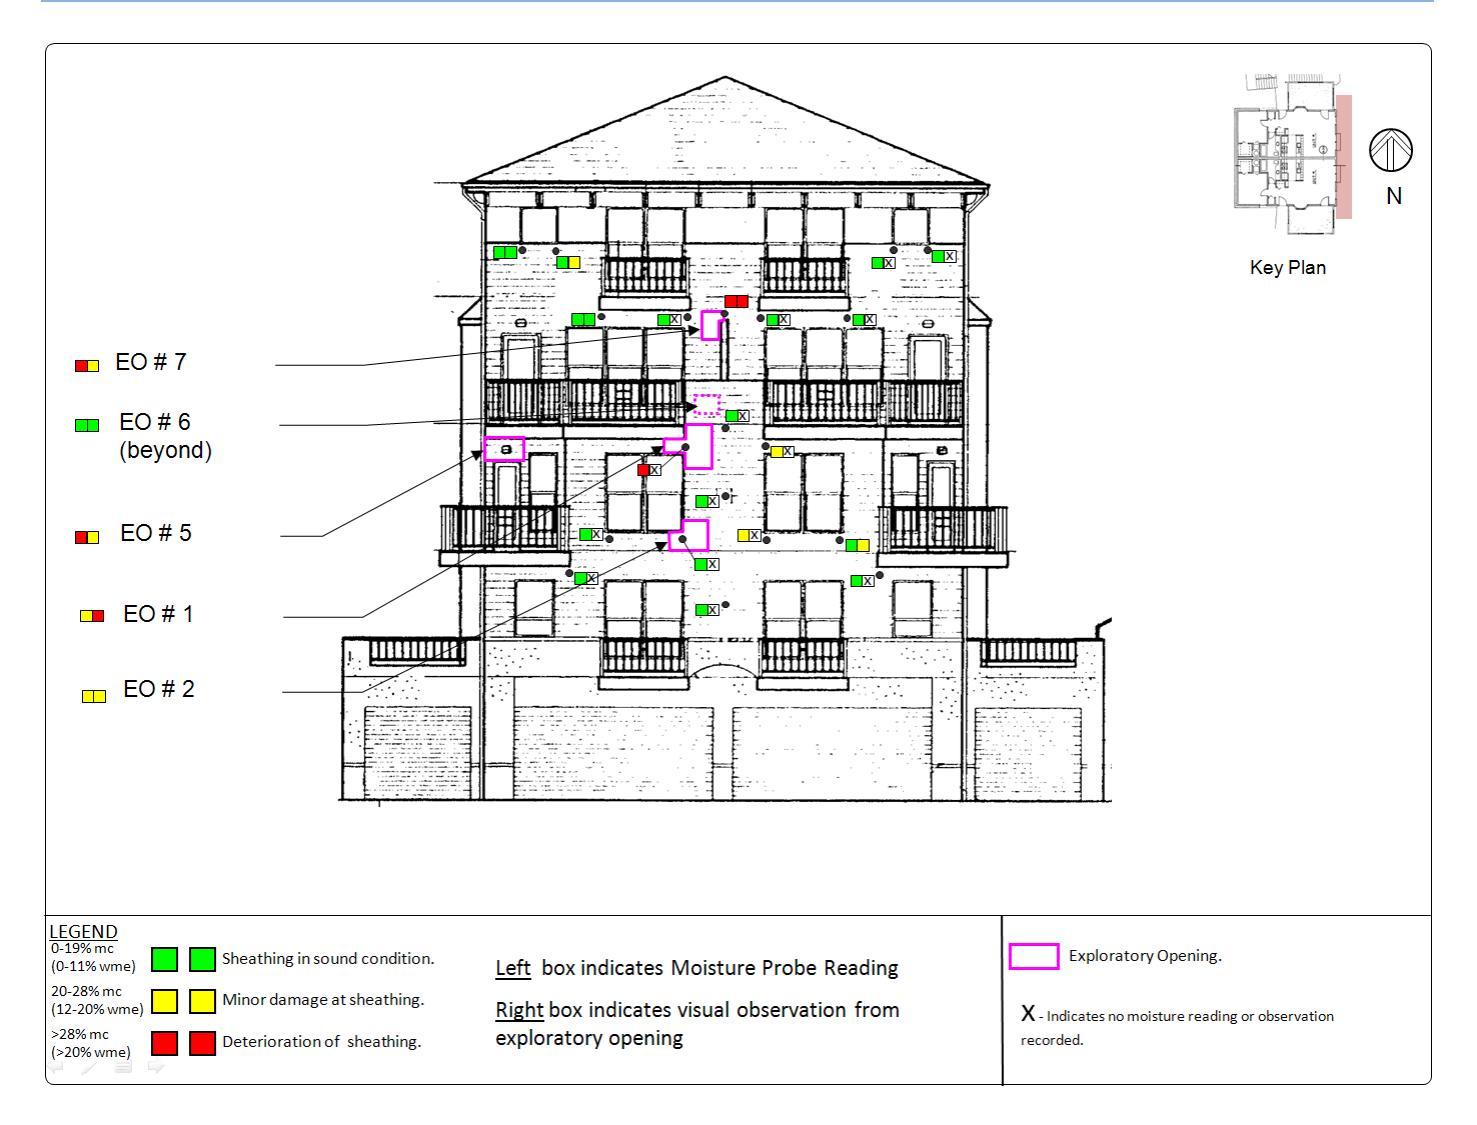
Figure 2-8 Presentation of Moisture Probe Results

Moisture meters should be calibrated regularly and according the manufacturer's requirements. It is typical to calibrate equipment a minimum of twice per year. While calibration should be done, the accuracy of the reading may not necessarily be critical. Preferably, results are used in conjunction with exploratory openings to verify actual conditions and are then used in relative scale compared to other readings taken with the same equipment on the same building. In fact hourly, daily, weekly, and seasonal fluctuations may dictate that moisture content readings be used only as a relative indication of moisture content in the wood material and not as an absolute reading (Figure 2-6). Temperature and wood species correction factors also need to be obtained. This information is typically available from the moisture meter manufacturer.

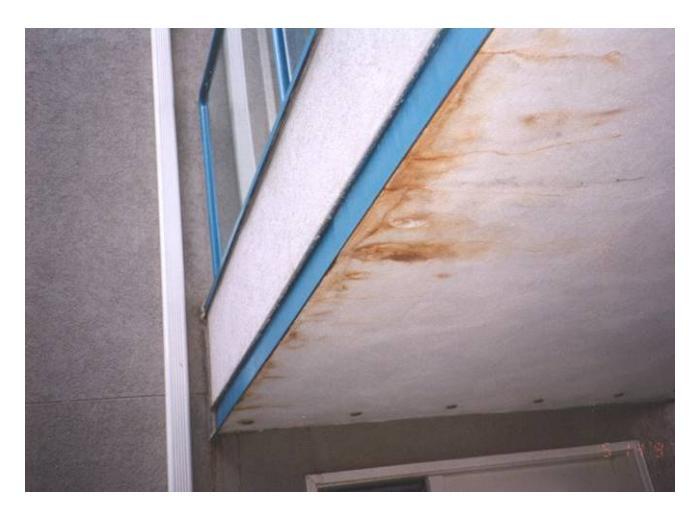
Figure 2-9 Dark Stains on Underside of Balcony

Dark staining running out from behind cladding (Figure 2-9) is an indication of wood decay resulting from the breakdown of the cellulose fiber that provides wood most of its strength and stiffness.

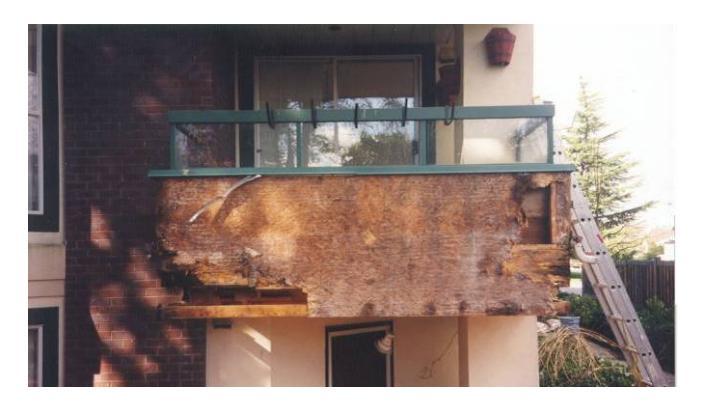
Figure 2-10 Deteriorated Balcony Framing and Sheathing

Wood decay often lowers structural integrity of wood framing and results in excessive deflection of cantilevered balconies. This decay often exhibits as springy balcony floors or spongy balcony floor sheathing. The degree to which the structural integrity of the balcony has been affected cannot be determined from a visual inspection alone. The consultant should err on the side of caution if he or she suspects wood decay. The owner should notify building occupants to limit loadings or to stay off the balconies completely until further investigation can be completed.

Guards constructed of lumber-framed walls with finishes on both sides are prone to decay if they are not adequately waterproofed and vented (Figures 2-10, 2-11, and 2-12). If they can be easily displaced at the top or at their connection to the balcony structure, they may have been weakened by decay. Open-type guards constructed of wood or metal should also be tested qualitatively by forcing the top back and forth by hand. Movement at the connections to the balcony floor or the building wall may indicate either corrosion of fasteners or decay of the member into which the fasteners are embedded. In the case of guards built of wood, visible decay in the pickets, posts, or rails is an obvious sign of structural deterioration. If there is any doubt as to the stability of balcony guards, the owner should advice the building occupants to stay off the balconies until the guards can be tested to confirm their adequacy.

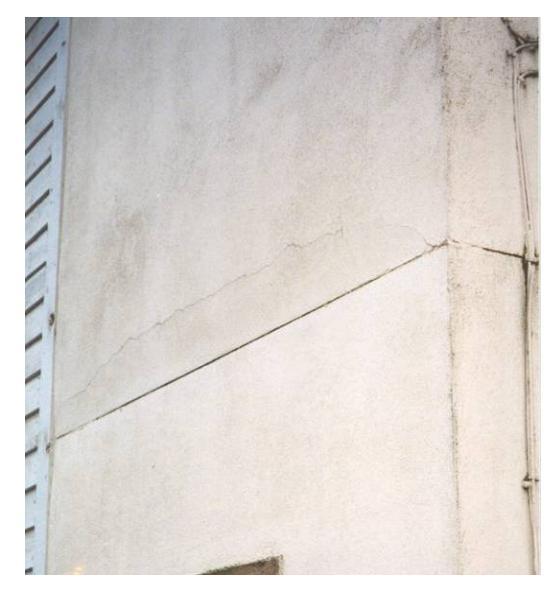
Figure 2-13 Cracked and Bulging Stucco at Floor Line

If the exterior finish is stucco and is bulging or cracked, a danger may exist that the stucco is detaching from the structure and could fall. The fall zone should be barricaded until the investigation can be completed.

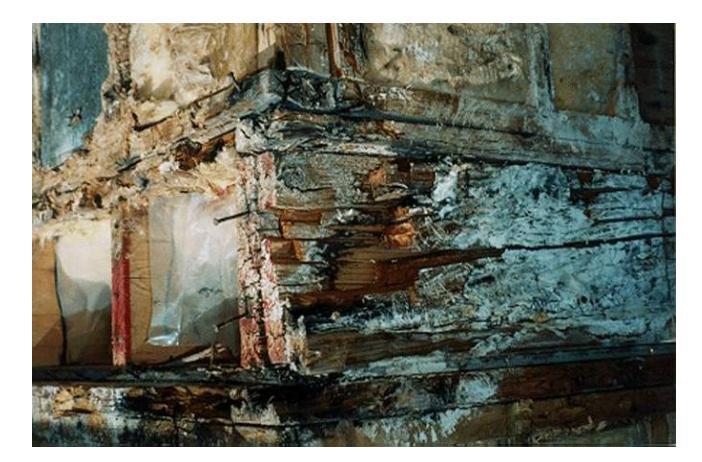
Figure 2-14 Decayed Rim Joist

Decay within the edge-of-the-floor framing may compromise the vertical load capacity of the floor if the ends of the floor joists are deteriorated at their point of bearing (Figure 2-14). If this is suspected because of such observations as spongy or sagging floors, precautionary shoring should be installed inside the building to support the joists or, alternatively, the room areas above and below the affected location should be barricaded. These situations should always be assessed by a structural engineer.

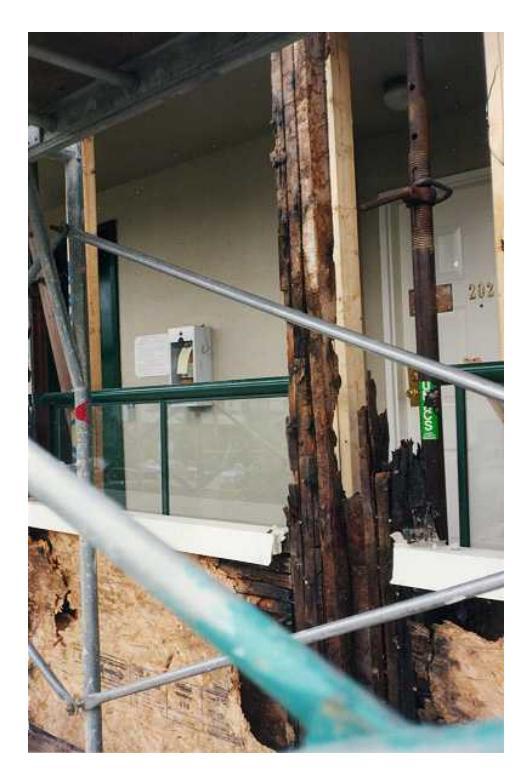
Figure 2-15 Decayed Walkway Post with Temporary Shoring Visible Behind

Structural damage in isolated members such as posts, beams, and lintels is often readily apparent from visual observation because of sagging or settling (Figure 2-15). As there is less redundancy in the structure where such members are involved, the consultant should recommend precautionary shoring or barricading.

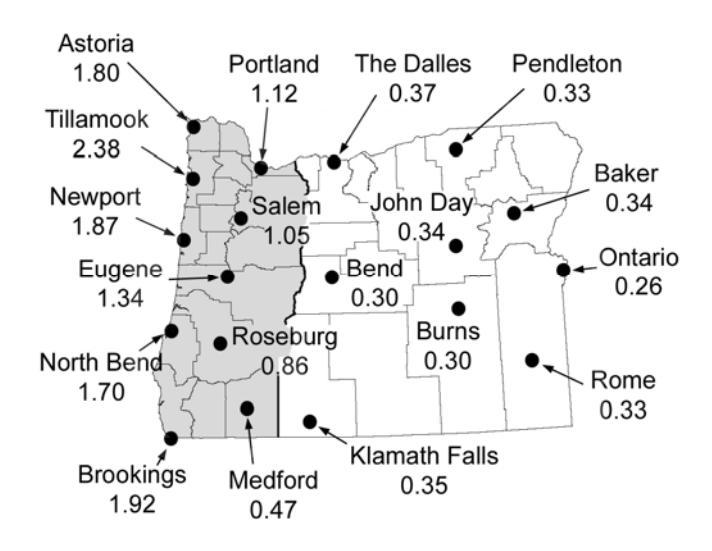
Figure 3-1 presents an overlay mapping of the Moisture Index to the OEESC climate zone map. When compared to the climate zone map, it is evident that values below about 0.5 correlate quite well to Zone 5, while values above 0.5 correlate to Zone 4. There are some exceptions around the Medford area. It is also the case that values above 1.0 correlate with cities directly on the coast or cities with annual rainfall averages in excess of about 39 inches.

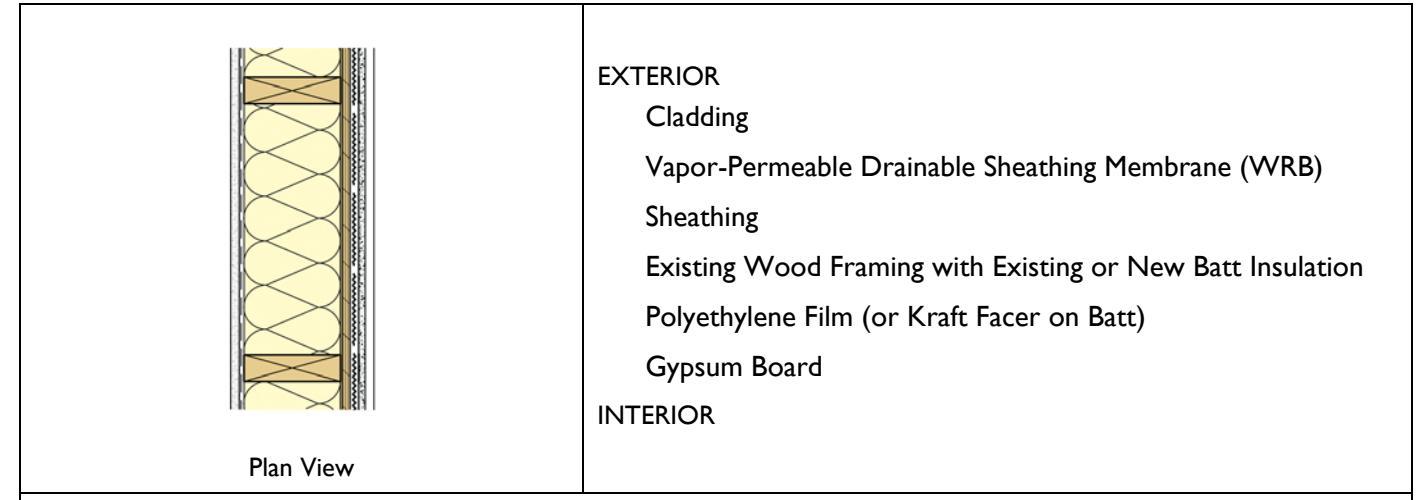
WATER-SHEDDING SURFACE

This wall assembly anticipates control of the majority of exterior moisture at the exterior cladding, while recognizing that some incidental moisture will likely migrate beyond the exterior cladding. There is little capacity for this incidental moisture; therefore this assembly should be used with caution or for targeted repair areas only. Note that vinyl siding tends to permit a greater amount of moisture to penetrate past the water-shedding surface than other cladding materials. This moisture has some capacity to drain down the WRB behind the exterior cladding and out of the assembly at cross-cavity flashing locations. The lack of air space further limits drying of the drainage space through ventilation or evaporation.

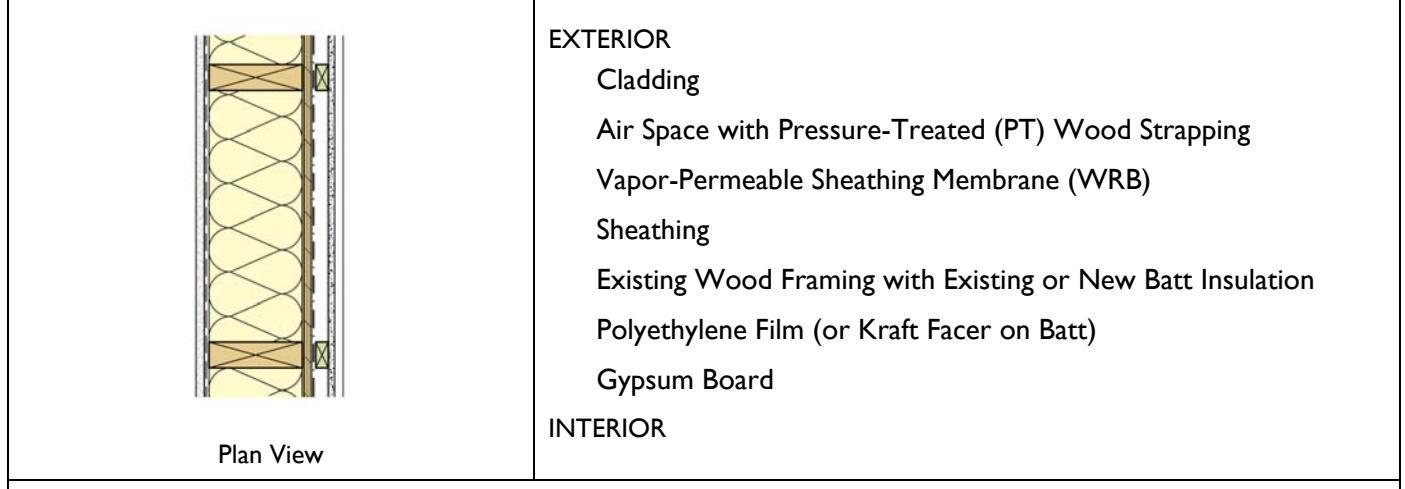
W-2: Type 2 Wall Assembly - Exterior Air Barrier

WATER-SHEDDING SURFACE

This wall assembly anticipates control of the majority of exterior moisture at the exterior cladding, while recognizing that some incidental moisture will likely migrate beyond the exterior cladding. This assembly allows moisture to drain through the cavity formed behind the exterior cladding and out of the assembly at cross-cavity flashing locations. Evaporation and ventilation further facilitate drying of the cavity.

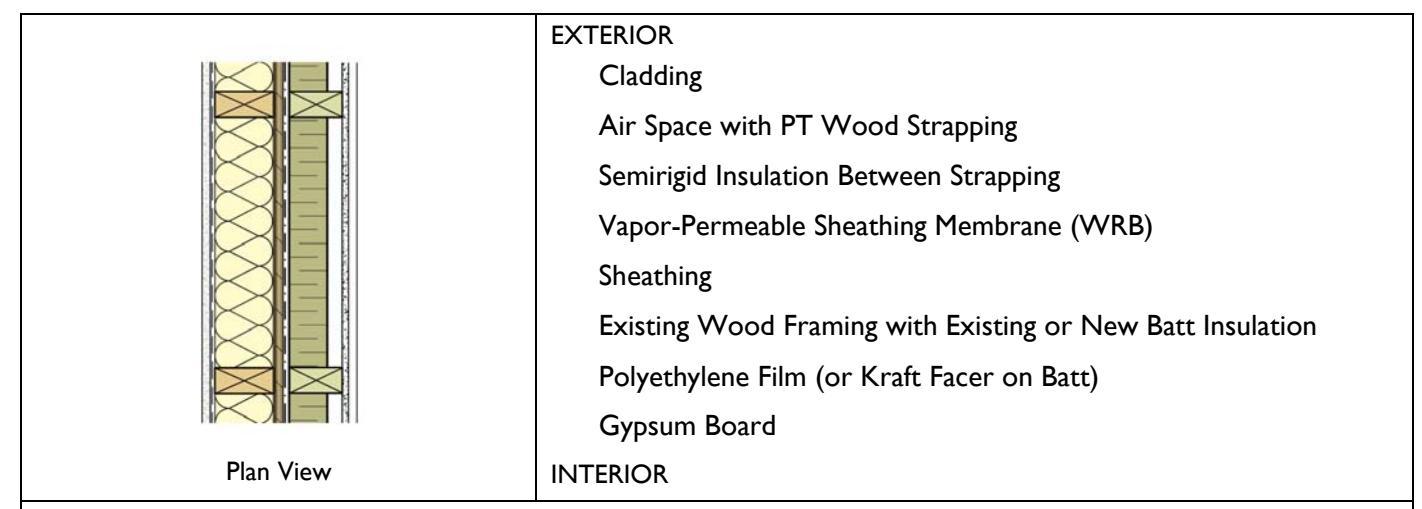
W-3: Type 3 Wall Assembly - Exterior Air Barrier, Split Insulation

WATER-SHEDDING SURFACE

This wall assembly anticipates control of the majority of exterior moisture at the exterior cladding, while recognizing that some incidental moisture will likely migrate beyond the exterior cladding. Any moisture that does penetrate past the cladding is allowed to drain through the cavity formed behind the exterior cladding and out of the assembly at cross-cavity flashing locations. Evaporation and ventilation facilitate further drying of the cavity.

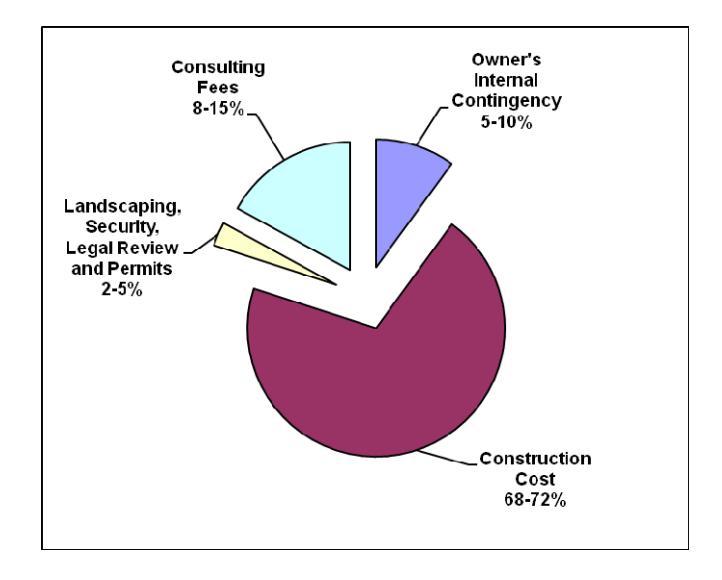
Figure 5-6 Distribution of Costs

Figure 5-6 graphically represents the cost distribution for a typical project budget where construction costs are anticipated to be in the order of one million dollars. The costs do not include consultant fees during the evaluation stage and assume a traditional project delivery model. As shown, sales tax is not a factor in Oregon.

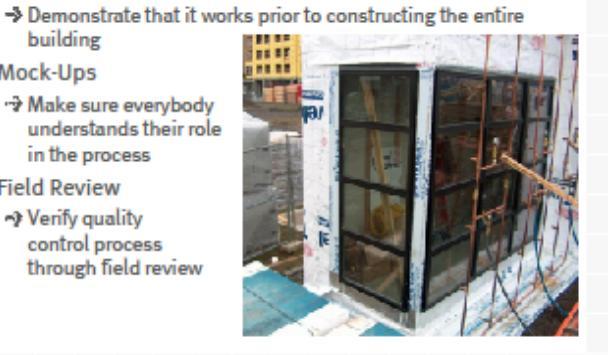
Figure 6-1 Window Testing

Windows and their integration into the wall assembly should be a primary focus of testing activity. This is equally true if new windows are being installed or if the existing windows are being retained. Testing of the existing windows provides confirmation of acceptable performance of the window assembly and/or identifies repair and maintenance activity that may be appropriate to prolong their useful service lives.

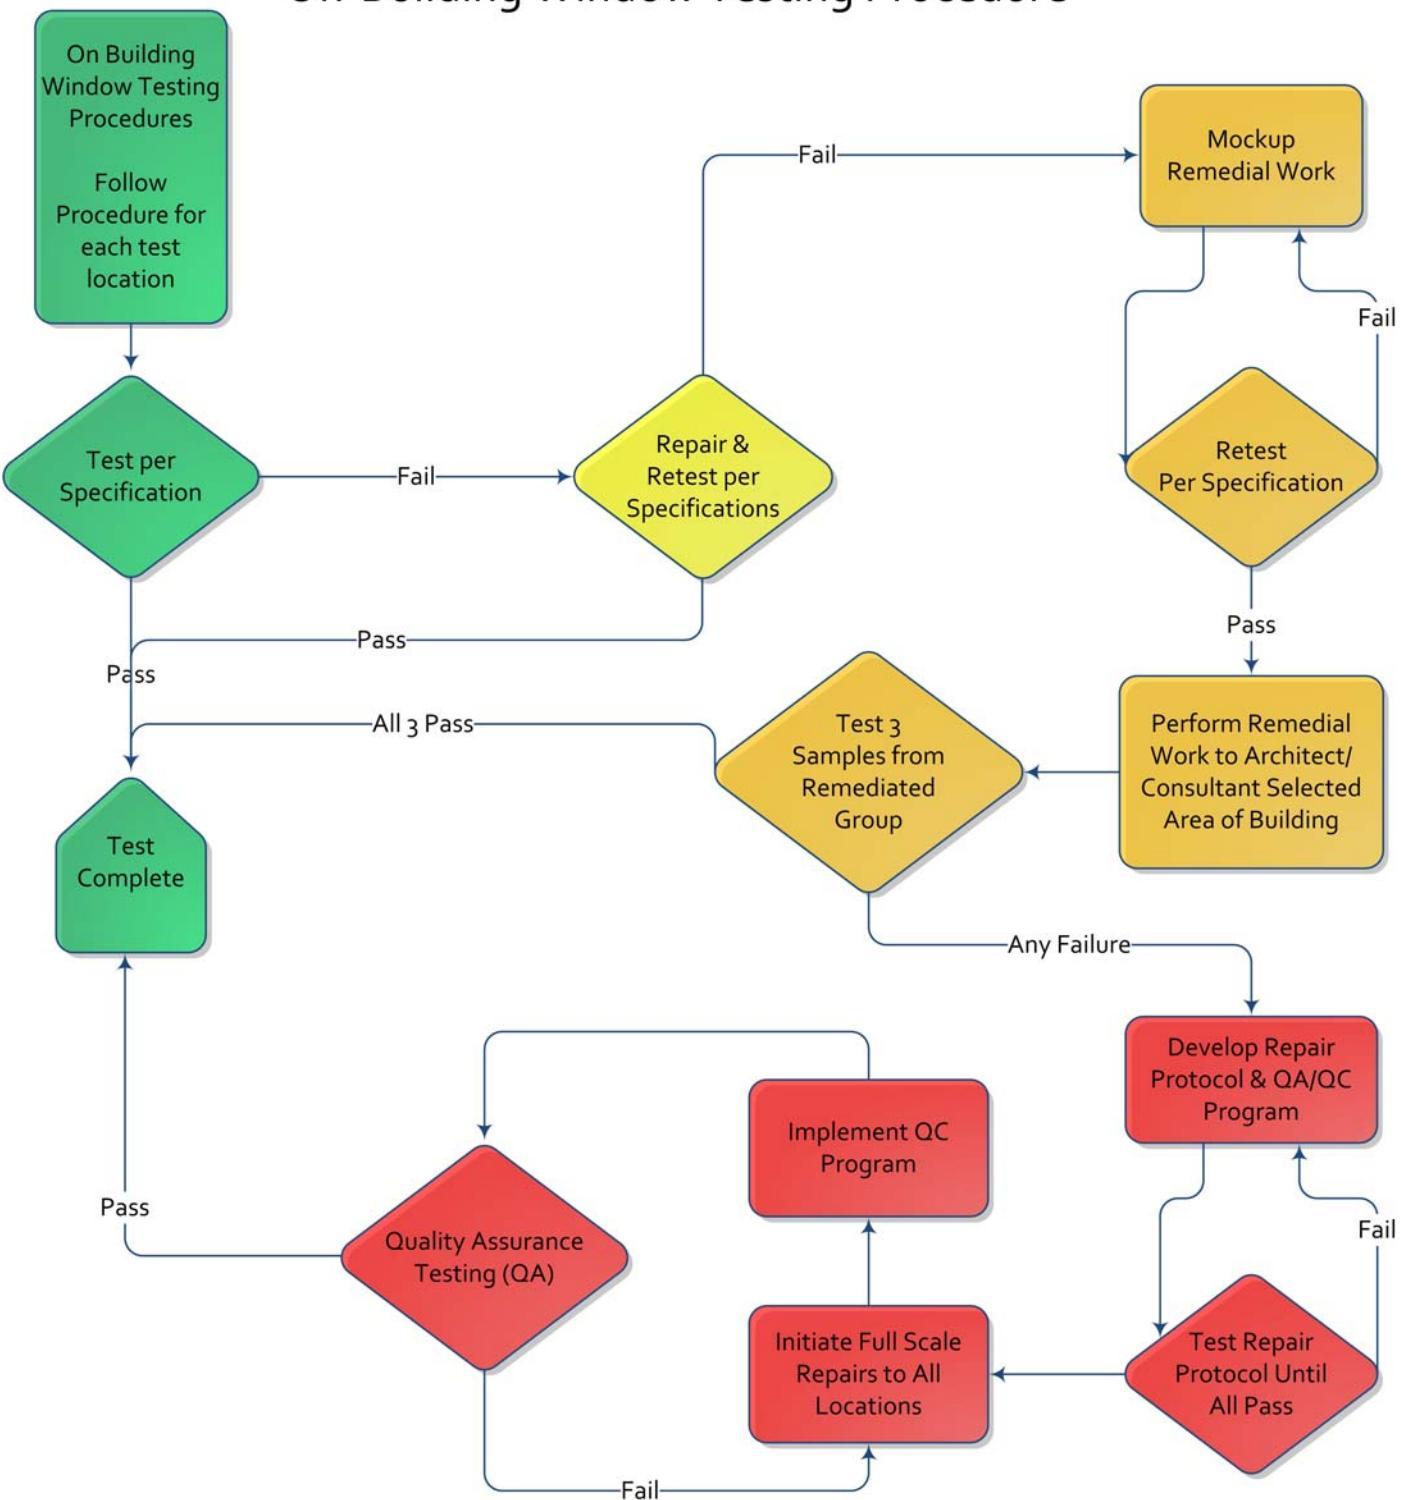
Figure 6-2 Window Test Flowchart

One of the more common concerns between the owner and the contractor is clarity on which party is responsible for retesting in the event that the initial tests This should be clearly stated in the project fail. specifications, but a path for testing and retesting is helpful so that all parties are clear on the intent. Figure -2 below shows one option for a flowchart of the mockup testing procedures, retesting requirements, and associated quality control processes that may be required if continued failure pursues.

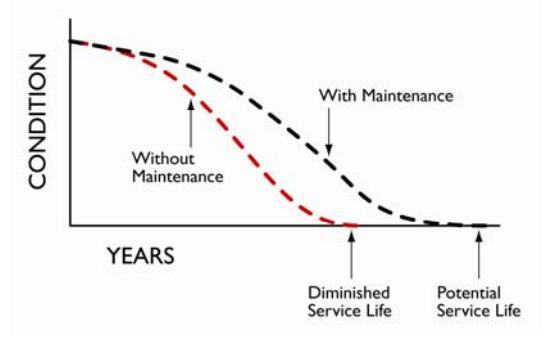
Figure 8-4 Maintenance and impact on service life

Without adequate maintenance, the building assets will deteriorate faster and their service life may be diminished. The figure below**Error! Reference source not found.** conceptually illustrates the impact that maintenance has on the service life of elements of the building enclosure.

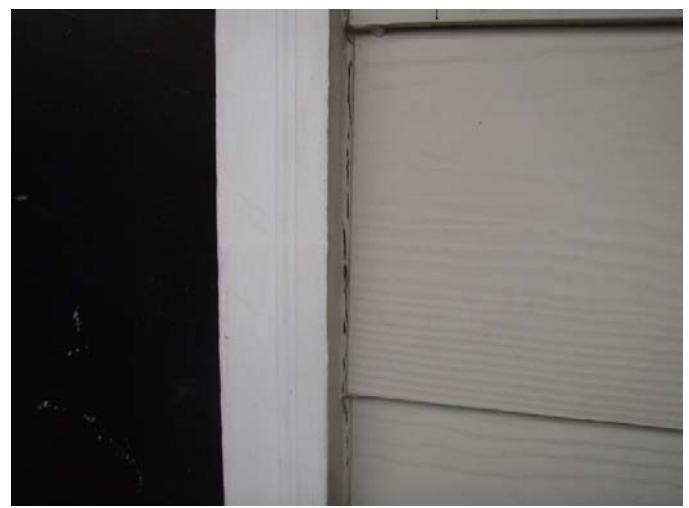
(W1) Sealant Condition

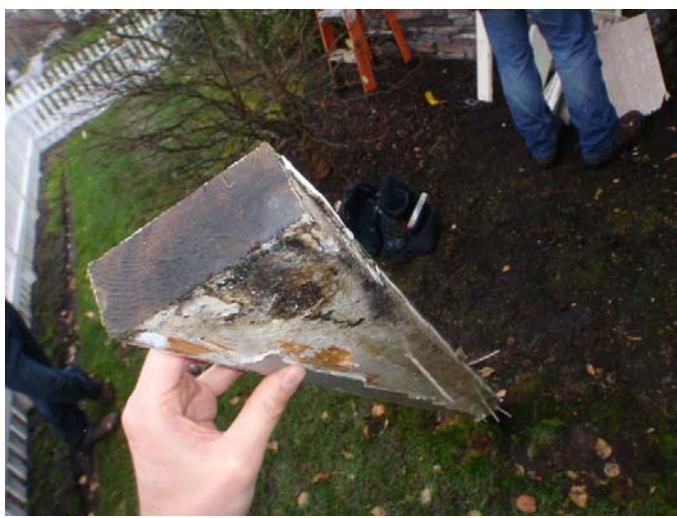
(W4) Unprimed Wood

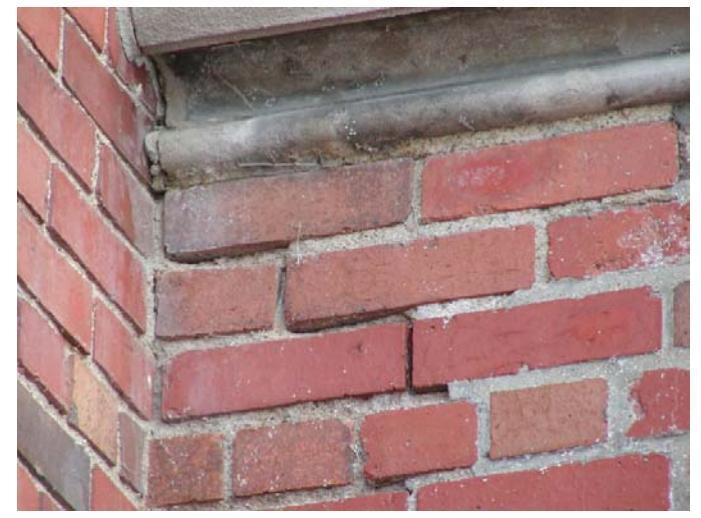
(W37) Grout Degradation

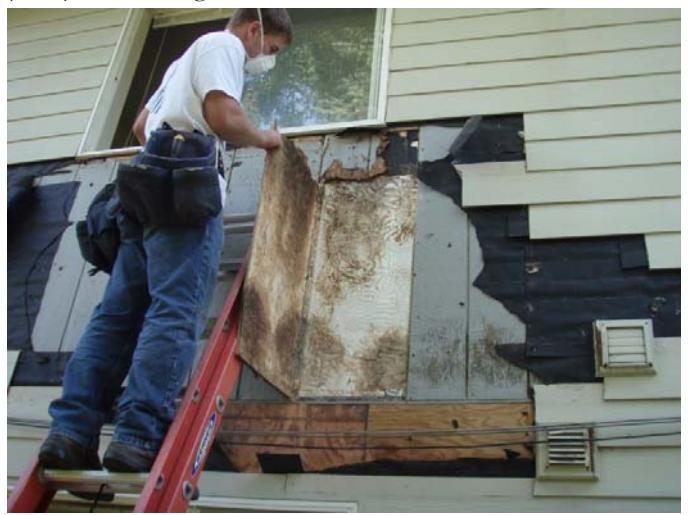
(WD2) Lack of Sill Flashing

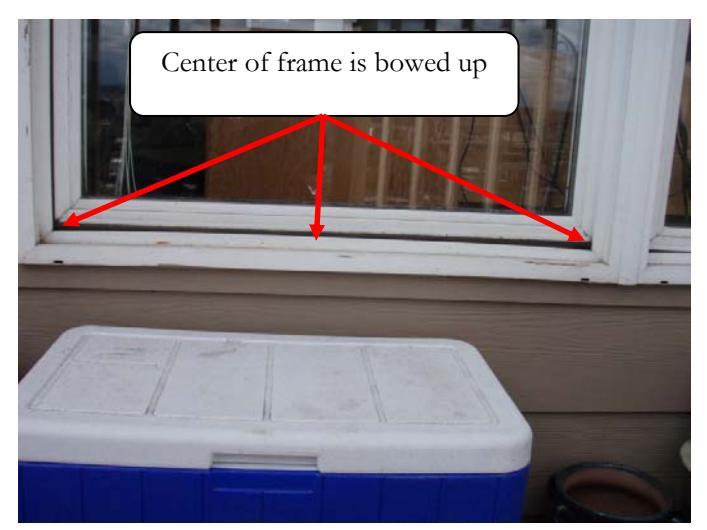
(WD10) Warped Vinyl, Broken Balances

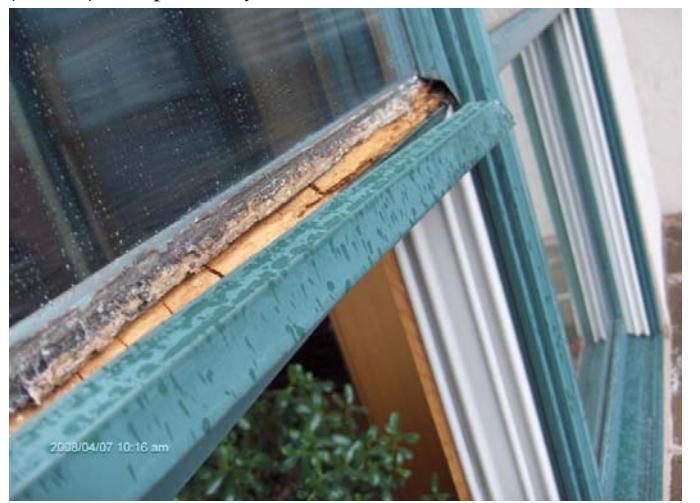
(WD15) Metal Clad Wood

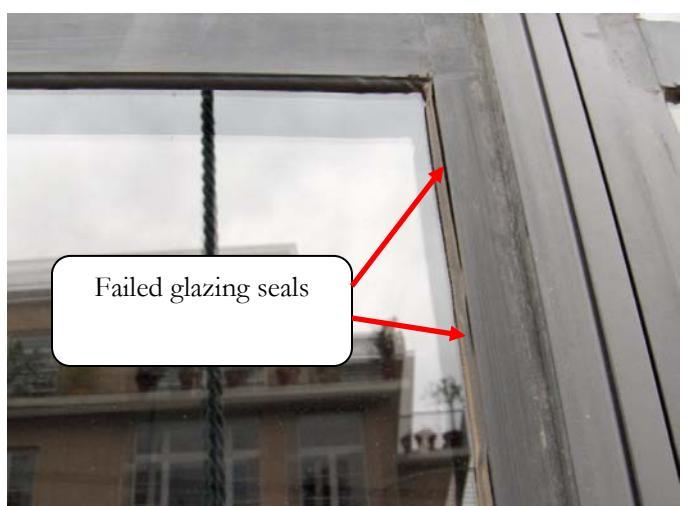
(WD13) Worn, Torn, Missing Gaskets or Seals

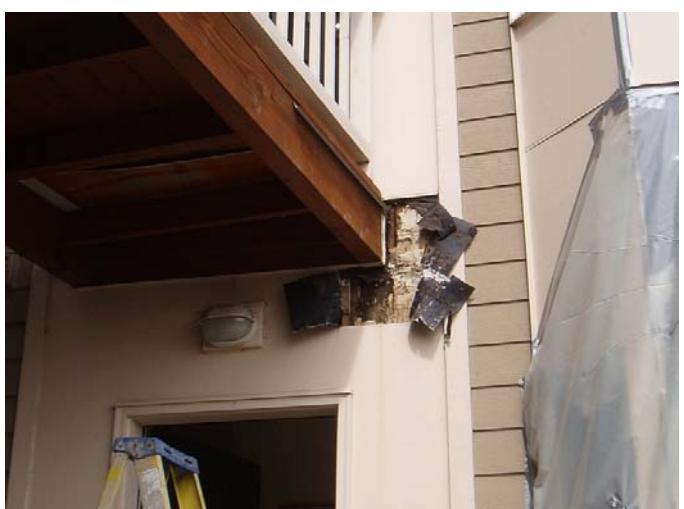
(BD1) Deck to Wall Saddle Flashing

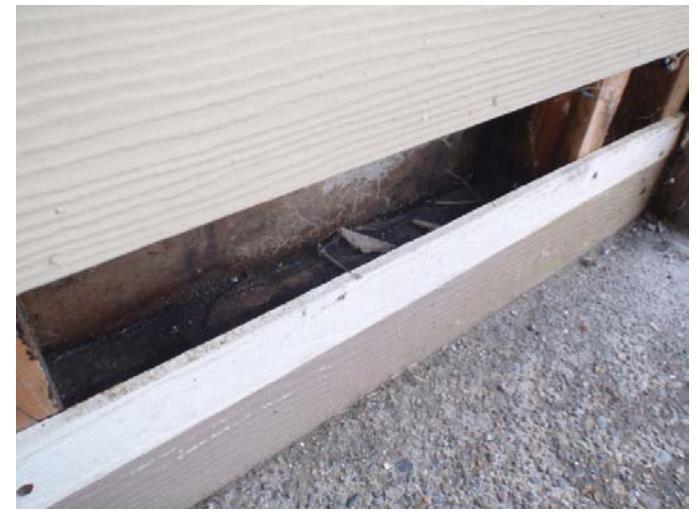
(BG3) Buried Sill Plate at Foundation
