STATE OF THE ART REVIEW OF UNVENTED SLOPED WOOD-FRAMED ROOFS IN COLD CLIMATES

Jonathan Smegal, John Straube, Aaron Grin, Graham Finch
RDH Building Science Inc.

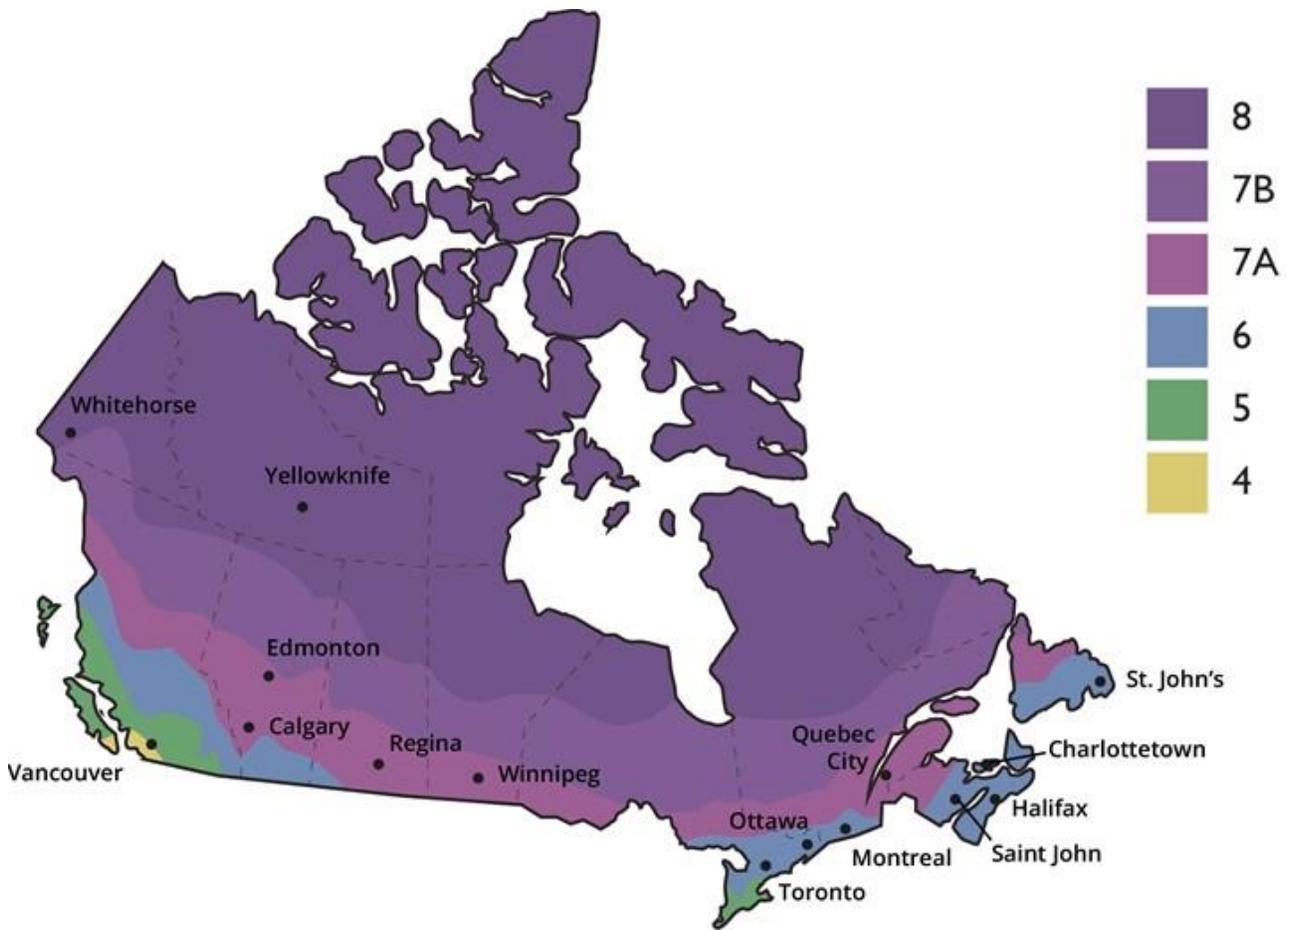
Figure 3: RDH climate zone map of Canada
