Failing Forward: Learning from Forensic Investigations

Brian Hubbs, P.Eng.
John Straube, PhD, P.Eng.

Case Study: High-Rise Condensation

40

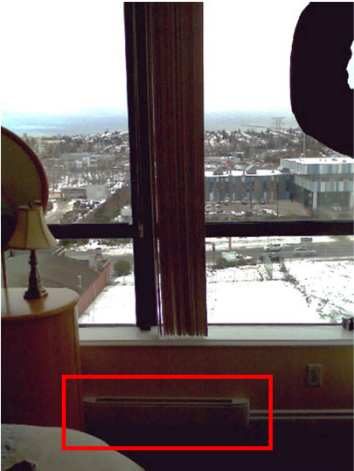
Heating From Baseboard Heater - Limited
